AE monitoring and structural modelization of the Asinelli Tower in Bologna

SUMMARY. The Acoustic Emission (AE) technique was used to assess the structural stability of the Asinelli Tower, the tallest building in the city of Bologna, which, together with the nearby tower, named Garisenda, is the renowned symbol of the city. AE is a passive, non-destructive structural evaluation technique based on the spontaneous emission of pressure waves by evolving fracture processes. The monitoring program was carried out with the aid of a USAM tool, which is part of the equipment used at the Fracture Mechanics Laboratory of the Department of Structural Engineering at the Politecnico di Torino. This tool makes it possible to conduct a complete analysis of AE signals, acquire a huge quantity of data from on site monitoring, and identify the microcracks triggering the damage processes in a structure.

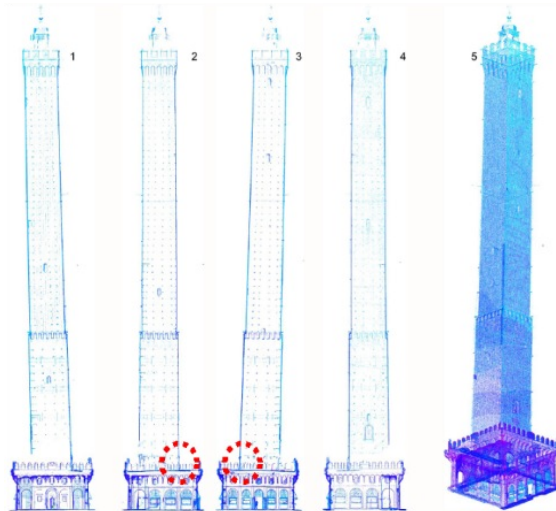
Figure 2. Front views and axonometric view of the Torre degli Asinelli. These views, supplied by the Municipality of Bologna, are taken from the measurements of the exterior of the structure made by Prof. Alessandro Capra by laser scanning. Faces (1) South; (2) East; (3) North; (4) West; (5) Axonometric view. The transducers were applied to the north-east corner of the tower, in the zones marked with a circle.

The studies conducted in the early twentieth century by F. Cavani [8] revealed that the Asinelli Tower leaned westward by 2.25 m; this is the reason why it is known as the tallest leaning tower in Italy. The latest measurements, made in 2009 by Prof. A. Capra by laser scanning, on behalf of the municipality, showed an overall inclination of 1.51 degrees and a deviation from verticality of 2.38 m. Thus we find that the deviation increased by 13 cm in the course of approx. one century, that is to say at an average rate of 1.30 mm/year. Figure 1 shows the Asinelli Tower and the adjacent Garisenda Tower in the city center of Bologna. Figures 2 and 3 show the front elevations and the cross-section of the Asinelli Tower and a plan view indicating the zone of application of the AE sensors.

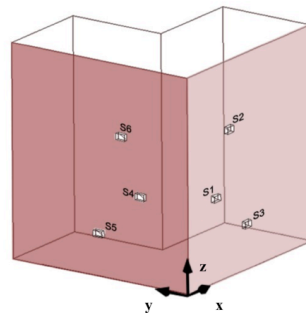
Figure 5. Axonometric scheme of the points of application of the AE sensors at the north-east corner of the tower.

The coordinates of the sensor application points are given in Table 1. The origin of the coordinate system of reference, as can be seen in Fig. 5, is at the bottom corner of the masonry at the intersection with the outer surface of the terrace surrounding the tower.

Sensors	x	y	z
S1	51.50	0.00	98.00
S2	78.00	0.00	171.0
S3	110.00	0.00	53.00
S4	0.00	63.50	102.00
S5	0.00	121.06	50.00
S6	0.00	89.00	167.00

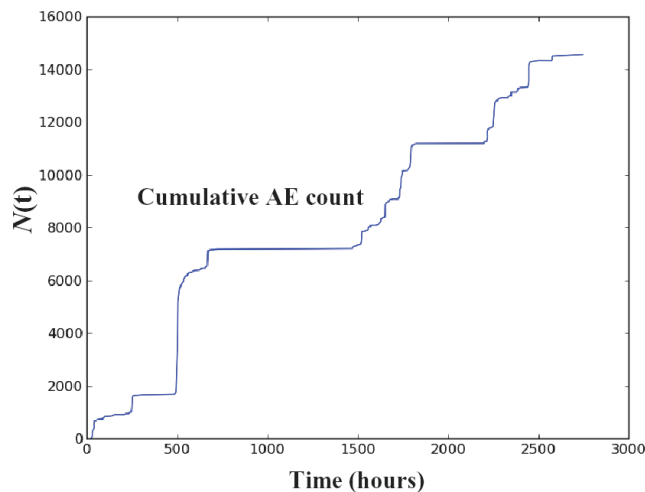
Figure 6. Cumulative AE count based on the data collected at the northeast corner of the tower, from 5:40 PM of 23 September 2010, to 1:00 PM of 28 January 2011.

Figure 6 shows a plot of the cumulative AE count obtained on the basis of the number of events detected per monitoring day. The curve was plotted starting from the date of application of the sensors to the time the sensors were permanently removed. Throughout the monitoring period, the threshold level for the detection of the input signals coming from the PZT transducers was kept at 100 mV. Based on the authors' experience, in fact, this level is the most significant for the detection of AE signals from damage processes in non-metallic materials such as concrete and masonry [1,2,5,9].

From the curve in Fig. 6 it can be seen that the masonry is actually undergoing a damage process. The plot of the cumulative AE count, in fact, is characterized by jumps reflecting sudden increases in N that are seen to occur at certain time intervals. The discontinuities in the cumulative AE count curve denote the critical moments during which the release of energy from the microcrack formation process is greatest.

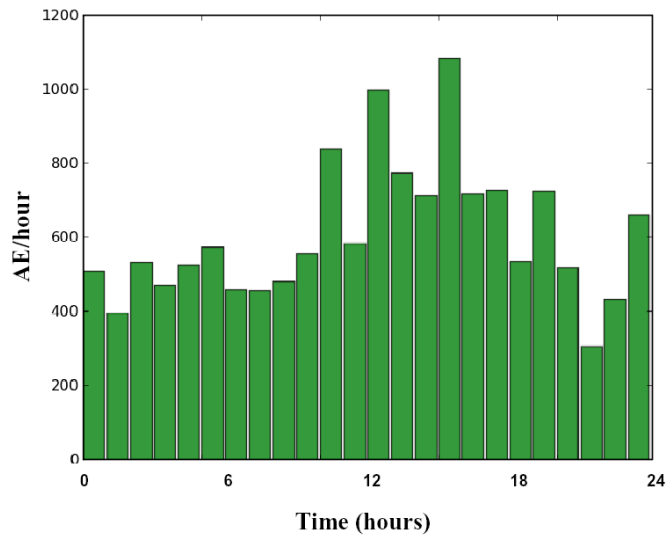
Figure 7. AE count hourly distribution chart over a 24 hour time span, as determined for the entire monitoring period.

The AE count hourly distribution chart over a 24 hour time span, as determined for the entire monitoring period, is shown in Fig. 7.

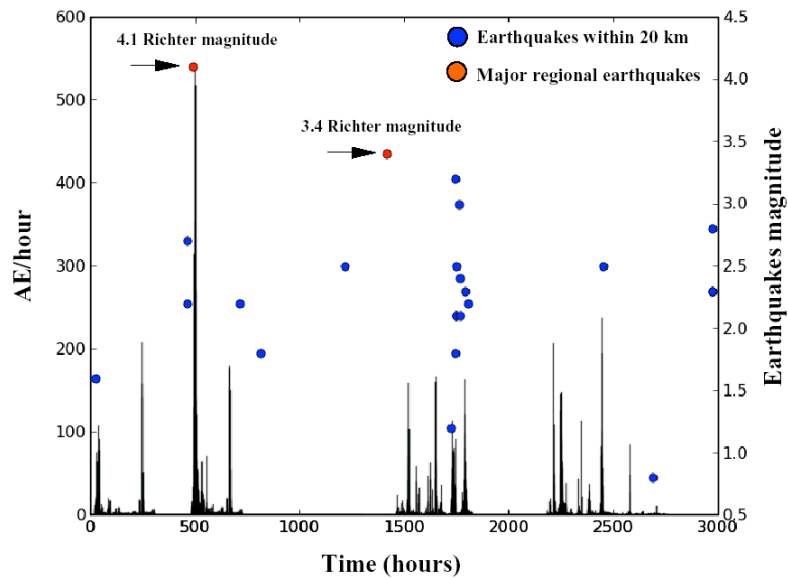
Figure 8. Historic series of the AE differential count and the earthquakes detected within a 20-km radius from the Bologna city center. The chart also shows the two strongest regional earthquakes, which occurred in Rimini area and in the Modena Apennines. This chart refers to the entire monitoring period.

The chart in Fig. 8 shows the AE count rate per hour, the earthquakes recorded within a 20-km radius from the city center, and the two strongest quakes that hit the region. All the quakes, the two most important ones (denoted with red dots) and the weaker ones (blue dots), are shown as a function of time of occurrence and magnitude.

Fig. 8 reveals a *correlation between the AE events recorded experimentally and the seismic events*. As can be seen, in fact, the energy peaks measured through the AE count rate almost invariably occurred during a seismic event. In particular, the highest AE count peak (ca 500) was detected on 13 October, at 11:43 PM, when the Rimini area was hit by the 4.1 magnitude quake. Hence, this seismic event is the pulse phenomenon that resulted in the highest damage effect on the tower.

The second strongest earthquake, i.e., the 3.4 magnitude quake that hit the Modena Apennines on 21 November at 4:10 PM, does not introduce any significant change to the chart shown in Fig. 8, since the AE activity detected during this event was rather limited.

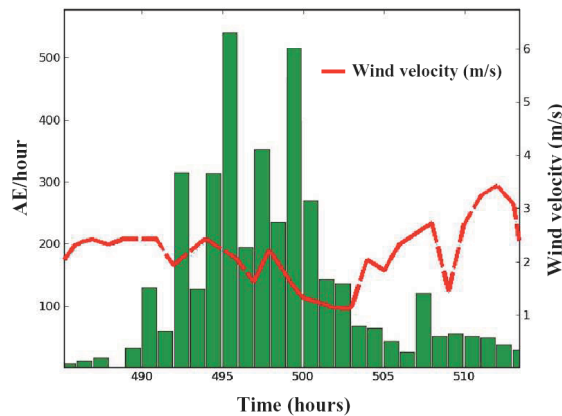
Figure 9: AE rate and wind velocity measurements during the monitoring period in a time window of 30 hours just after the earthquake of 13 October 2010.

In the chart of Fig. 9 are represented in detail the AE count rate and the wind velocity in a time window of 30 hours just after the earthquake that hit the Rimini area on 13 October 2010. The graph shows that the peaks in the AE count rate do not correspond with those of the wind velocity.

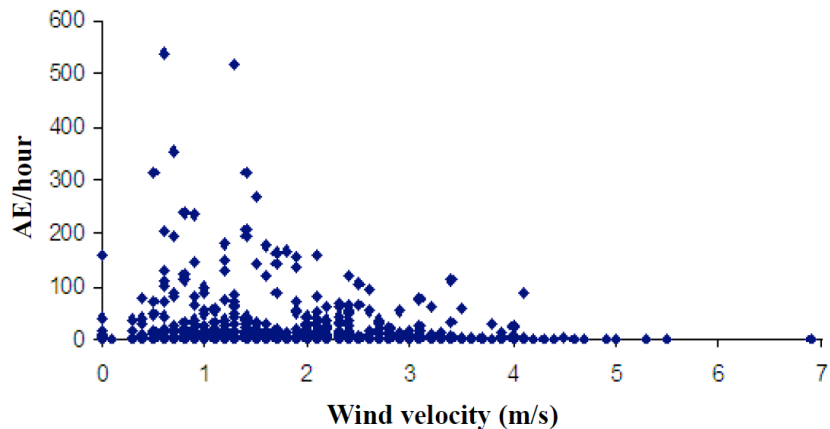
Figure 10: Chart relating the wind velocity and the AE count rate during all the monitoring time, the two time series seem to be statistically unrelated.

Moreover, the chart of Fig 10 relates the wind velocities and the AE count rate obtained during all the monitoring period (2915 hours). This graph makes clearer that the two phenomena are completely statistically unrelated.

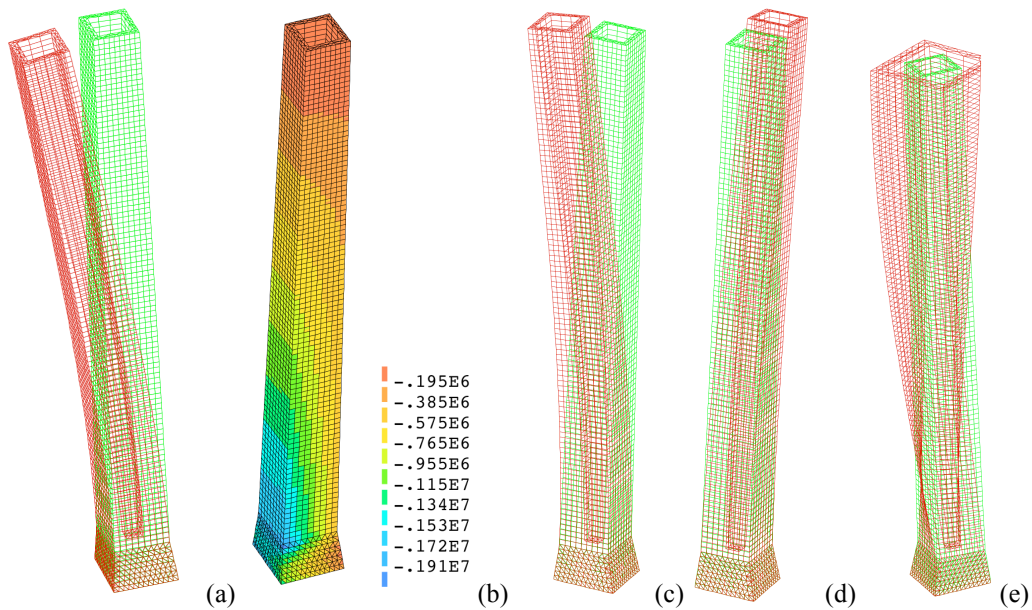
Figure 11. Deformation due to the effect of gravity (a); vertical stress expressed in MPa (b); first modal shape (c); second modal shape (d); fifth modal shape (e).

The preliminary linear elastic analysis considered only the self-weight of the tower (Fig. 11a). It was possible to assess that the elastic deformation of the tower is about 8 cm, which is about 1/30 of the present total deviation from verticality.

The level of stress in the masonry of the tower (Fig. 11b) is generally low, although in proximity of the monitored area, the level of vertical stress approach 2.1 Mpa, which can be critical in case of very poor masonry.

The preliminary modal analysis showed that the first mode is bending in the west-east plane, with a resonance frequency of 0.357 Hz (Fig. 11c). The second mode is bending in the orthogonal plane, with an eigen-frequency equal to 0.365 Hz (Fig 11d). The third eigen-frequency is 1.75 Hz, and the fourth is 1.78 Hz. The fifth mode is torsional (Fig. 11e) with an eigen-frequency of 3,07 Hz. Those results agree quite well with more detailed dynamic analyses carried out by other Authors [11].

The maximum vertical stress in the tower is compatible with the acquire rate of acoustic emissions from the monitored region. The fact that the first modal shape tends to increase the stress in the same area agrees well with the increase of acoustic emissions connected with seismic events.
