DETACHMENT ANALYSIS OF DEHUMIDIFIED REPAIR MORTARS APPLIED TO HISTORICAL MASONRY WALLS

An innovative laboratory procedure for the pre-qualification of repair mortars is described. The tested mortars are suitable for use with new dehumidified plasters applied to historical masonry walls. Long-term plaster detachment frequently occurs because of the mechanical incompatibility of mortar. The procedure consists of the application of static loads to mixed stone block-mortar specimens with particular characteristics, in terms of geometry and adhesion at the interface. A numerical simulation based on the cohesive crack model was used to follow the experimental data, in order to describe the evolutionary phenomenon of detachment as a function of a small number of parameters. The methodology is currently being used at Sacro Monte di Varallo Special Natural Reserve (UNESCO heritage site) in Piedmont (Italy).

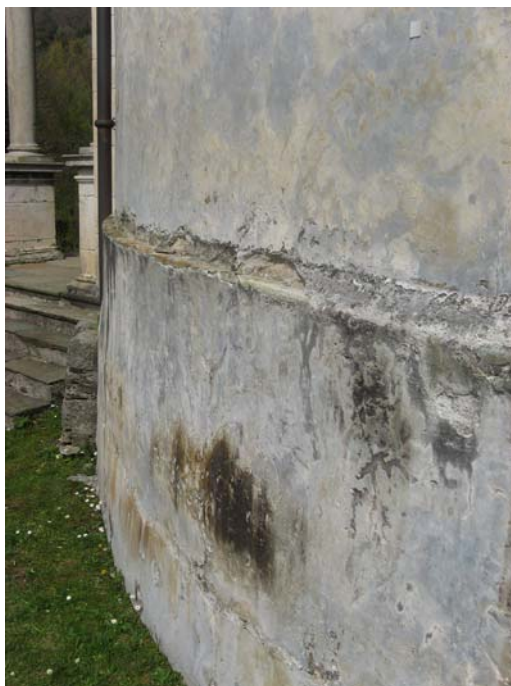
Figure 2. Detachment of historical exterior plasters at Transfiguration Chapel because of the rising damp effects due to capillary action or rain infiltration

Because of the rising capillary damp, the freeze-thaw cycles and the abundant rain and snow precipitations that characterize this mountain area, the historical plaster of the chapels has been subjected to progressive material decay over the long term (Figures 2-3).
