Detachment analysis of dehumidified repair mortars applied to historical masonry walls

DETACHMENT ANALYSIS OF DEHUMIDIFIED REPAIR MORTARS APPLIED TO HISTORICAL MASONRY WALLS

An innovative laboratory procedure for the pre-qualification of repair mortars is described. The tested mortars are suitable for use with new dehumidified plasters applied to historical masonry walls. Long-term plaster detachment frequently occurs because of the mechanical incompatibility of mortar. The procedure consists of the application of static loads to mixed stone block-mortar specimens with particular characteristics, in terms of geometry and adhesion at the interface. A numerical simulation based on the cohesive crack model was used to follow the experimental data, in order to describe the evolutionary phenomenon of detachment as a function of a small number of parameters. The methodology is currently being used at Sacro Monte di Varallo Special Natural Reserve (UNESCO heritage site) in Piedmont (Italy).

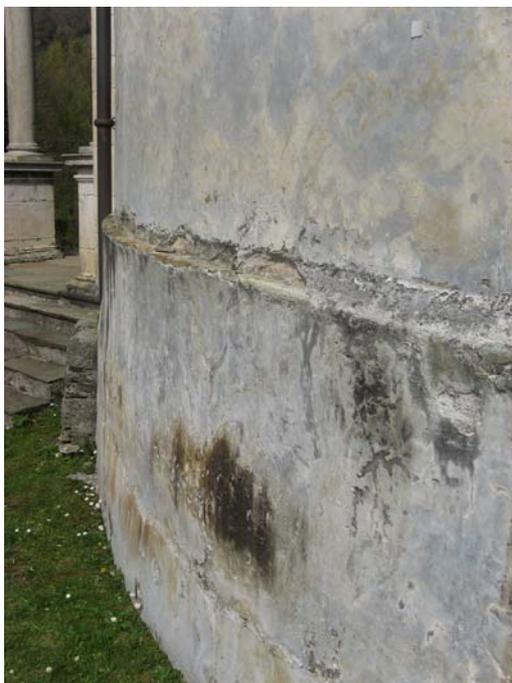
Figure 2. Detachment of historical exterior plasters at Transfiguration Chapel because of the rising damp effects due to capillary action or rain infiltration

Because of the rising capillary damp, the freeze-thaw cycles and the abundant rain and snow precipitations that characterize this mountain area, the historical plaster of the chapels has been subjected to progressive material decay over the long term (Figures 2-3).

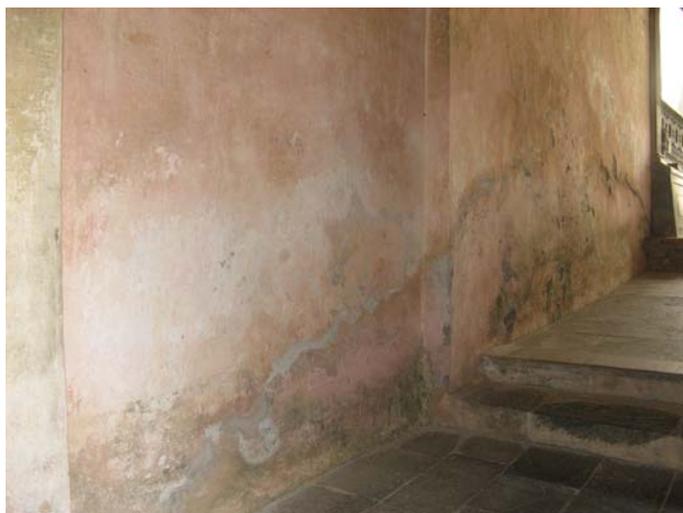
Figure 3. Detachment of historical plasters because of the rising damp effects due to capillary action at Sacro Monte di Varallo

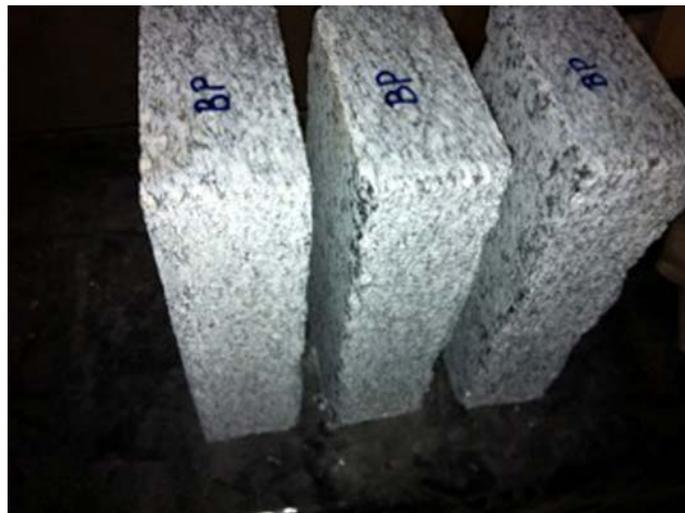
Figure 5. Adherence surface of stone treated by pneumatic drill

Four assembled specimens have been tested in compressive static load. This composite specimens were prepared by joining a stone block (similar to that of the Sacro Monte masonry) to symmetrical layers of repair mortar on the two shorter vertical sides of the stone block. It was obtained from cut stone placed in designed steel mould and joined to 40 mm thick layer of strengthening mortar cast onto it (Figure 4). This particular typology of assembled specimen has been tested already in precedents experimental researches to appraise the mechanical compatibility between strengthening mortars and historical masonry (Grazzini, 2006). The ad hoc geometry of this stone block-mortar specimens was able to test the adherence between the repair mortar and the masonry structures. The stone surfaces in contact with the mortar were treated by a specific pneumatic drill in order to improve the adherence (Figure 5).
