**REVISIT**

**TO MOLENVLIET PROJECT**

## INTRODUCTION

Derived from a prize-winning design, Molenvliet Project (Papendrecht, the Netherlands) was realised in 1976. This project coalesced the merits of Support Building in an all-sided scope of tissue, support and infill level, and was appraised by Prof. John Habraken as “the first blown Support/Infill project”.

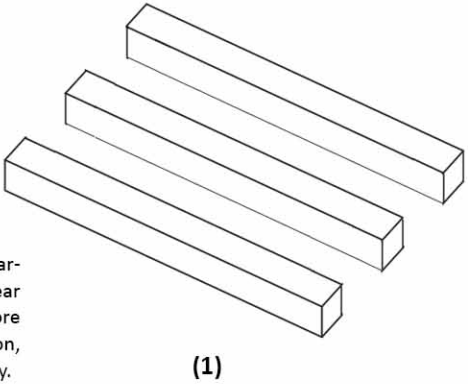
Ordinary housing

Normally, housing is arranged as rows. And linear open space, which is more suitable for transportation, is created correspondingly.

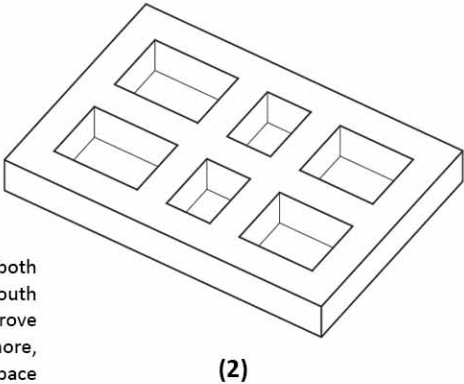
Element 1:  
Courtyard

Arranging dwellings in both east-west and north-south directions helps to improve the density. What's more, the concentric open space is created to promote neighbourhood communication.

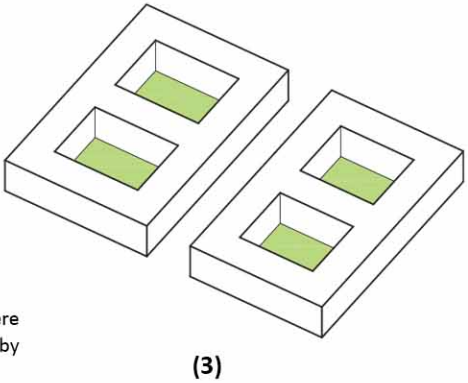
Element 2:  
Parking street

The four courtyards were divided into two groups by a central road.

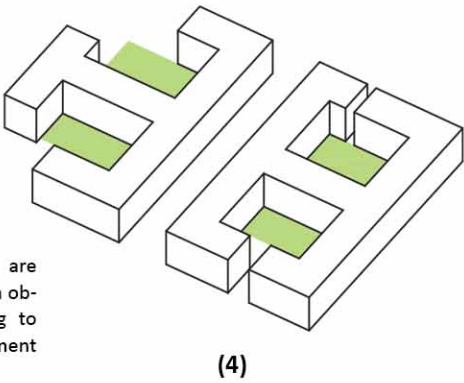
Element 3:  
Connecting Alleys

The four courtyards are never isolated, but with obvious breaks according to the original environment and existing buildings.

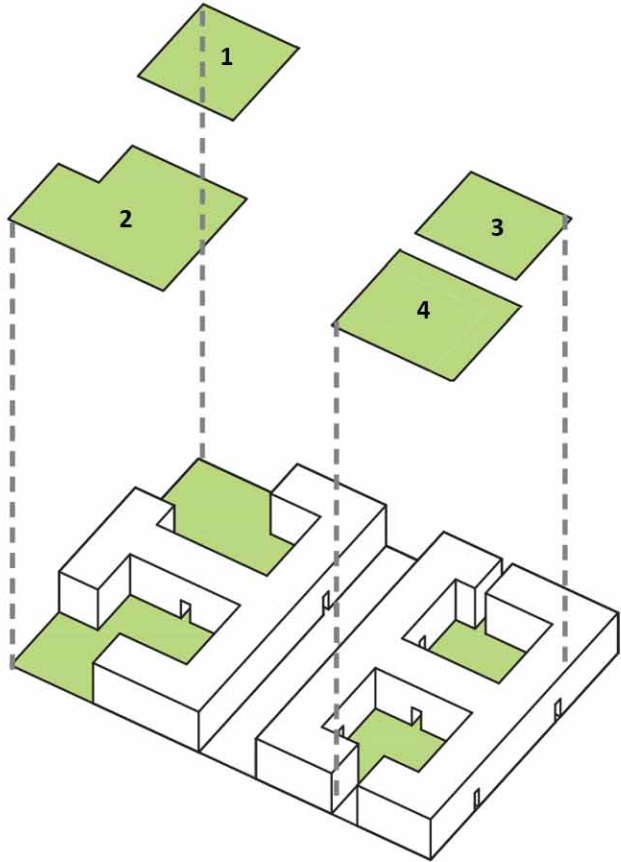
The courtyards as the concentric open space were adapted not only to promote neighbourhood communication, but also to achieve high density.

- 1. Entrance courtyard
- 2. Garden courtyard
- 3. Entrance courtyard
- 4. Garden courtyard

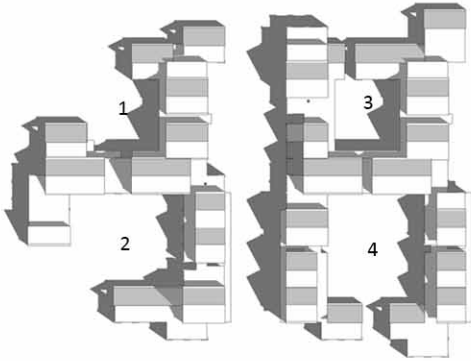
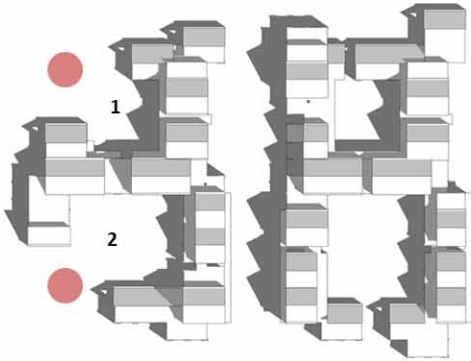
Two kinds of courtyards were designed. All the entrances for each apartments were organised in the entrance courtyards, while garden courtyards consist of private or shared gardens. They were completely different design. However, one garden courtyard were changed without the users approval.

Two big breaks were made as response to the existing buildings.

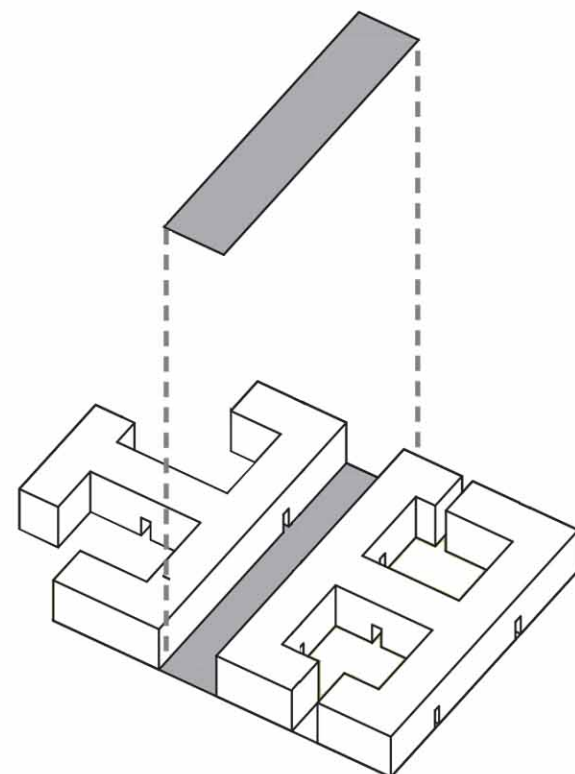
The cars are planned to be parked in the street. This form is attributed to a car-free neighbourhood, and in addition indicated a slow speed on the street. Influenced by Alexander, the footway along the street was raised.

The central way is for cars, their driving and parking. This pattern is inspired by Christopher Alexander's pattern language. According to it, the walking road should be at least 18 inches (457.2mm) above the driving road. In Molenvliet, the height is only 300 mm.

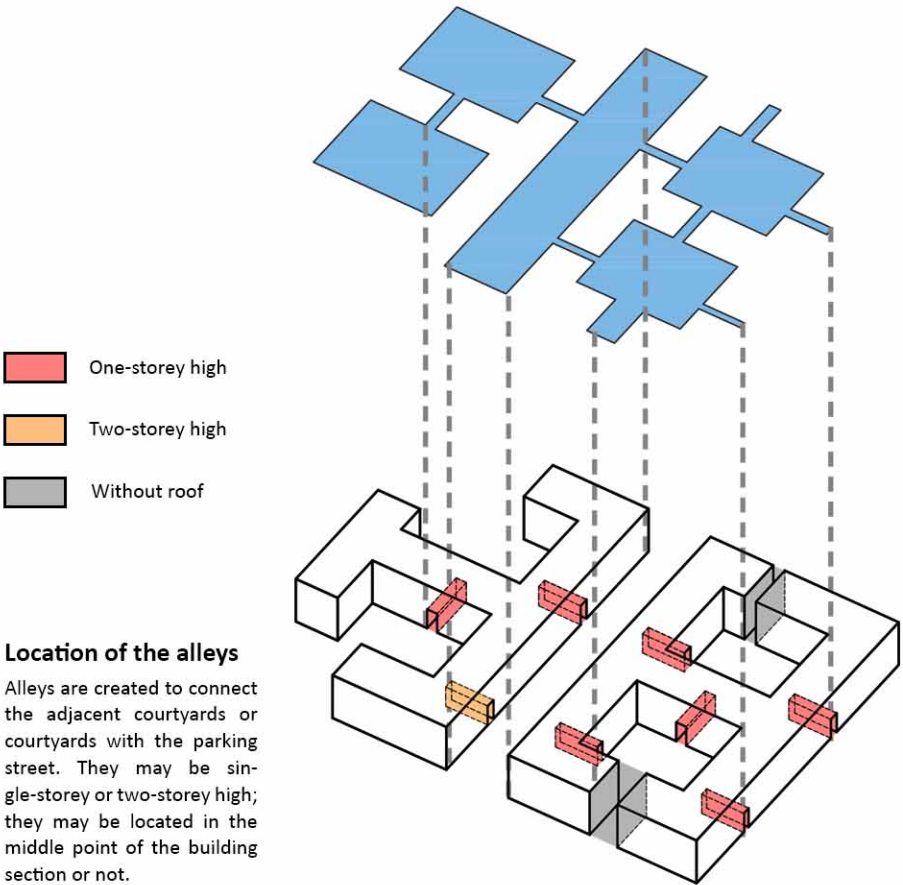
The ways created by the alleys.

Alleys were designed to connect both the adjacent courtyards and courtyard with the street. Once needed, these alleys could also be blocked conveniently by adding some doors.

“Different alleys lead us to different directions”. This is a representative comment which was acquired in the interview with users. From this image, we may find how many ways is allowed in this project. Walking in this community is also a way to have fun.

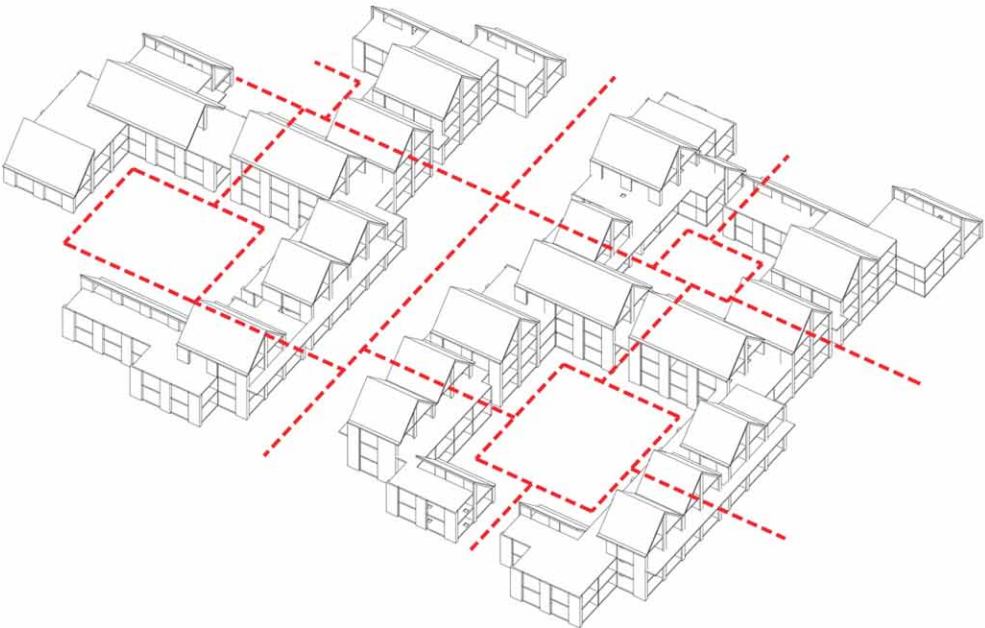
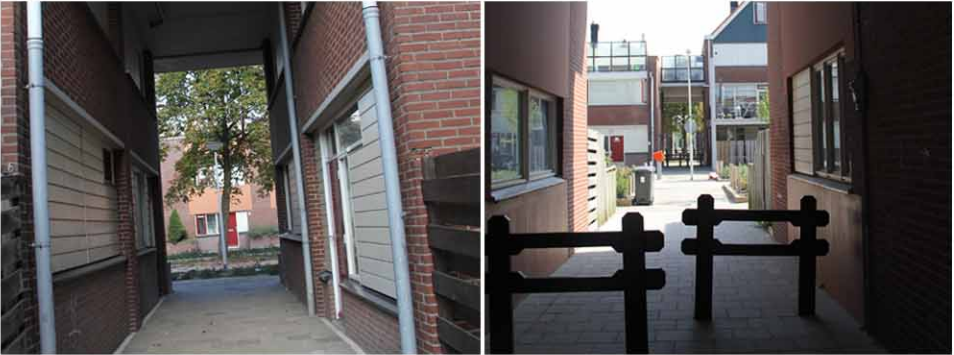
The alleys can be open or partially closed.

Alleys were designed to connect both the adjacent courtyards and courtyard with the street. Once needed, these alleys could also be blocked conveniently by adding some doors.

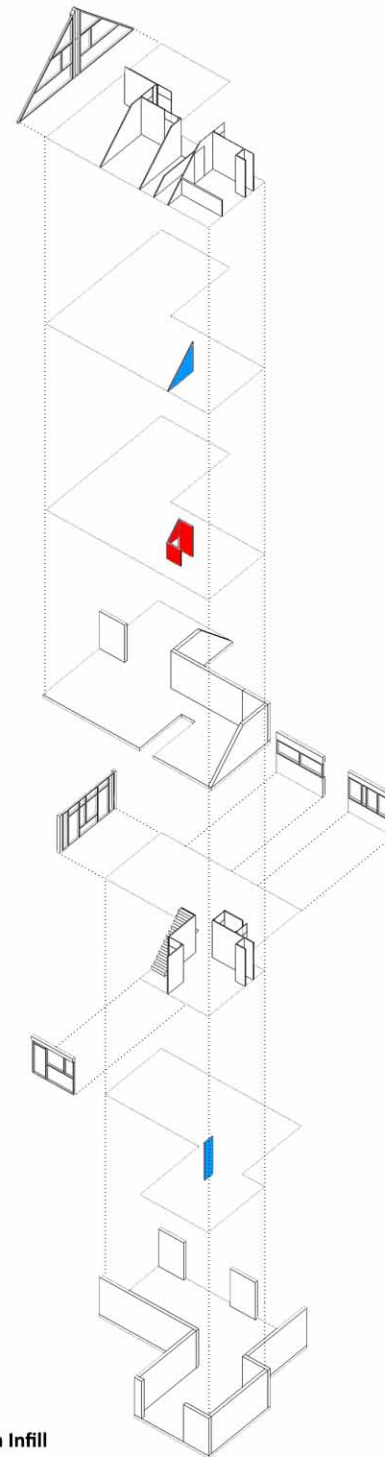
**Separation of Support from Infill**

**Infill (upper floor):**  
Colour and materials of the windows were selected by original users.

**Infill (upper floor):**  
Partitions were designed according to original user's demand.

**Remove (upper floor):**  
by the user. A small part of partition in the bathroom was removed.

**Add (upper floor):**  
by the user. A new partition was added.

**Support (upper floor):**  
by architect

**Infill (lower floor):**  
Colour and materials of the windows.

**Infill (lower floor):**  
partitions were designed according to original user's demand.

**Remove (upper floor):**  
by the user. A small part of partition in the kitchen was removed.

**Support (lower floor):**  
by architect

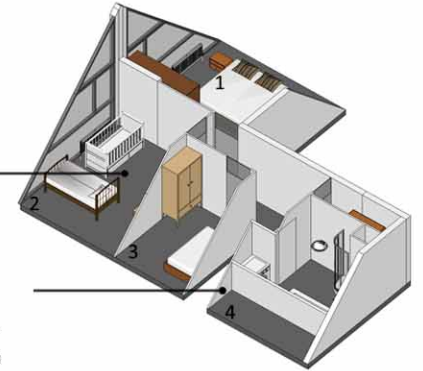
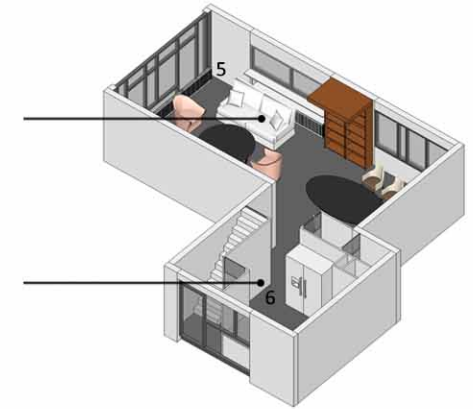
**Fig. Current living situation**

The equipments in the bathroom were completely changed by the tenants. In order to hold the washing machine, a partition was moved a little.

As the original design, the living room is still combined with dining room. Till now, the tenants are very satisfied with this spacious space.

The equipments in the kitchen was changed by the users. And the housing corporation paid some fee.

1. Main bedroom
2. Second bedroom
3. Second bedroom
4. Bathroom
5. Living room & Dining room
6. Kitchen

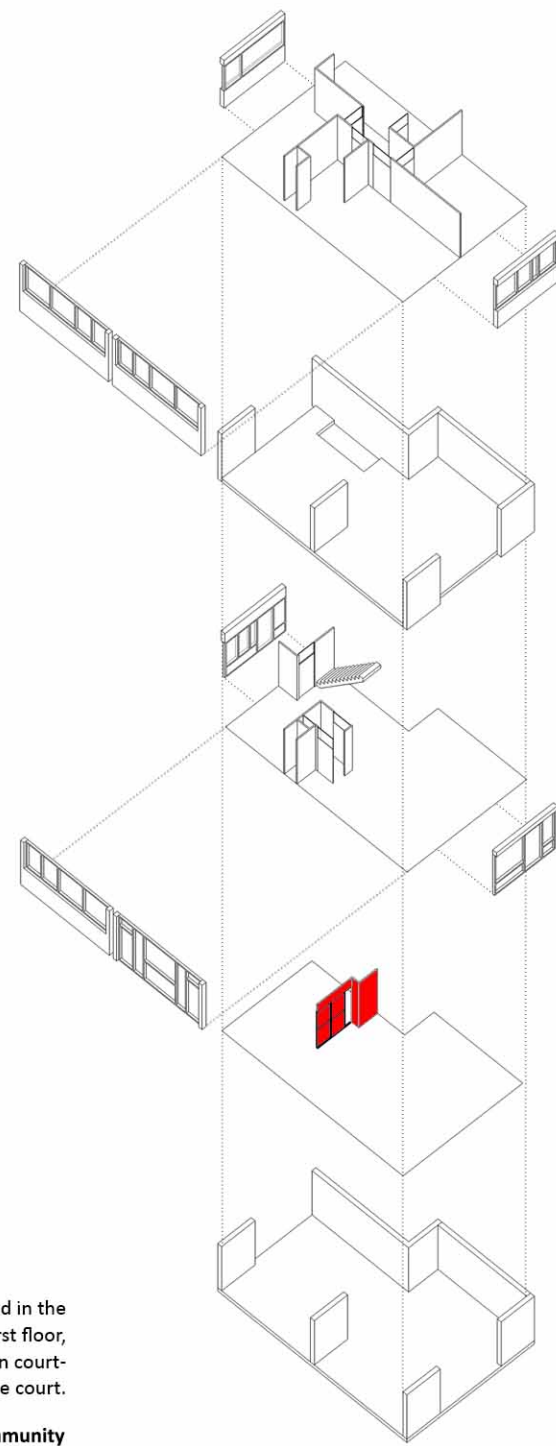
**Separation of Support from Infill**

**Infill (upper floor):** partitions were designed according to original user's demand.

**Infill (upper floor):** Colour and materials of the windows were selected by original users.

**Support (upper floor):** by architect

**Infill (lower floor):** partitions were designed according to original user's demand.

**Infill (lower floor):** Colour and materials of the windows were selected by original users.

**Add (lower floor):** A partition was added to separate the living room from kitchen.

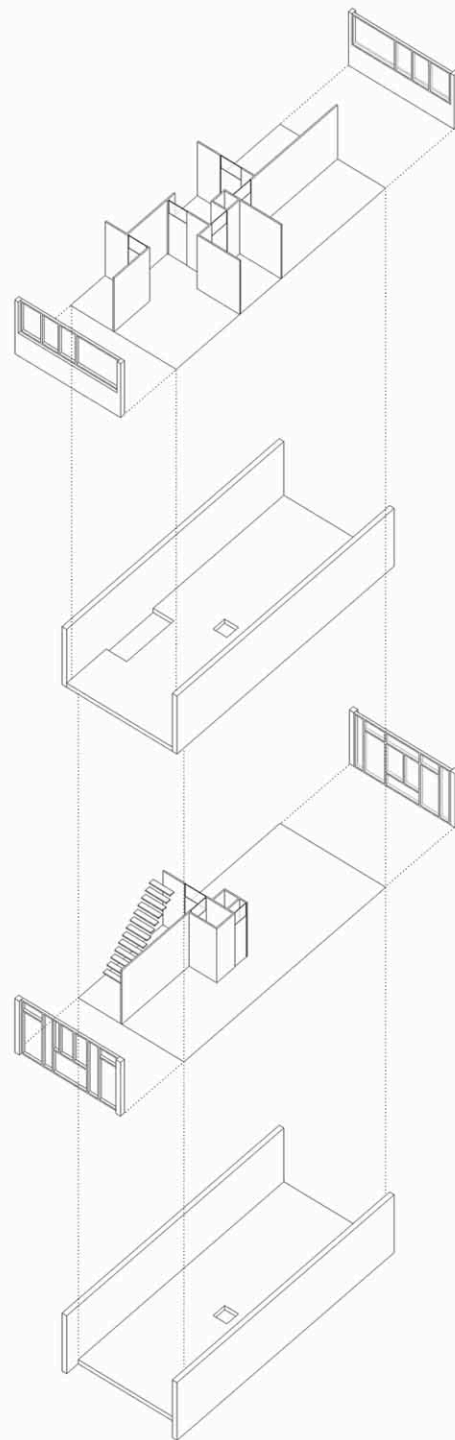
Fig. Separation of Support from Infill

**Infill (upper floor):**  
The colour and materials of the window are selected by the user.

**Infill (upper floor):**  
partitions were designed according to the user's demand.

**Support (upper floor):**  
by architect.

**Infill (lower floor):**  
The colour and materials of the window are selected by the user.

**Infill (lower floor):**  
partitions were designed according to the user's demand.

**Support (lower floor):**  
by architect.

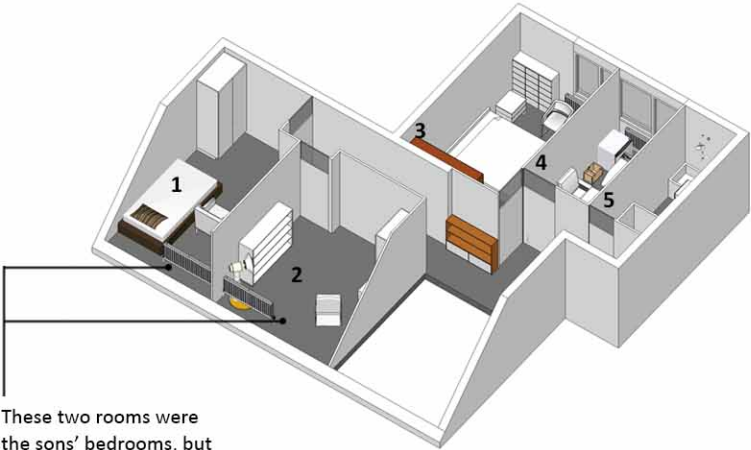
**Current Living Situation**

These two rooms were the sons' bedrooms, but now they are left empty.

The users fought with the architect for a toilet in ground floor and finally got it. It is proved to be necessary as time goes by.

The internal staircase was strengthened several times in the past years.

- 1. Bedroom
- 2. Bedroom
- 3. Main bedroom
- 4. Housework room
- 5. Bathroom
- 6. Living room
- 7. Storage
- 8. Dining room & Kitchen

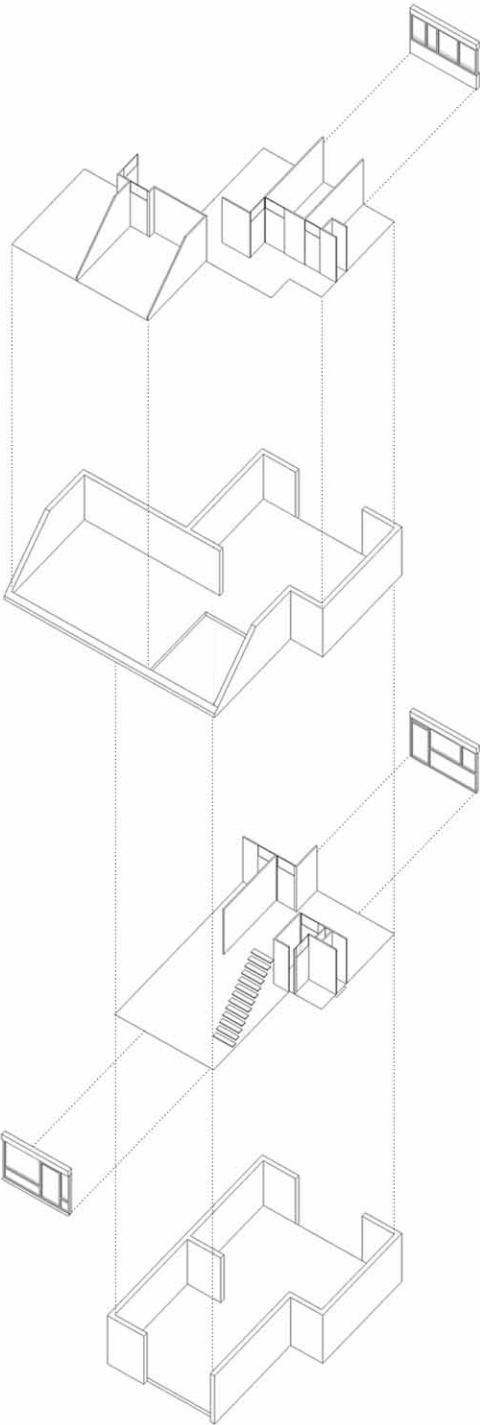
**Separation of Support from Infill**

**Infill (upper floor):**  
Colour and materials of the windows were selected by original users.

**Infill (upper floor):**  
partitions were designed according to original user's demand.

**Support (upper floor):**  
by architect

**Infill (lower floor):**  
partitions were designed according to original user's demand.

**Infill (lower floor):**  
Colour and materials of the windows were selected by original users.

**Support (lower floor):**  
by architect

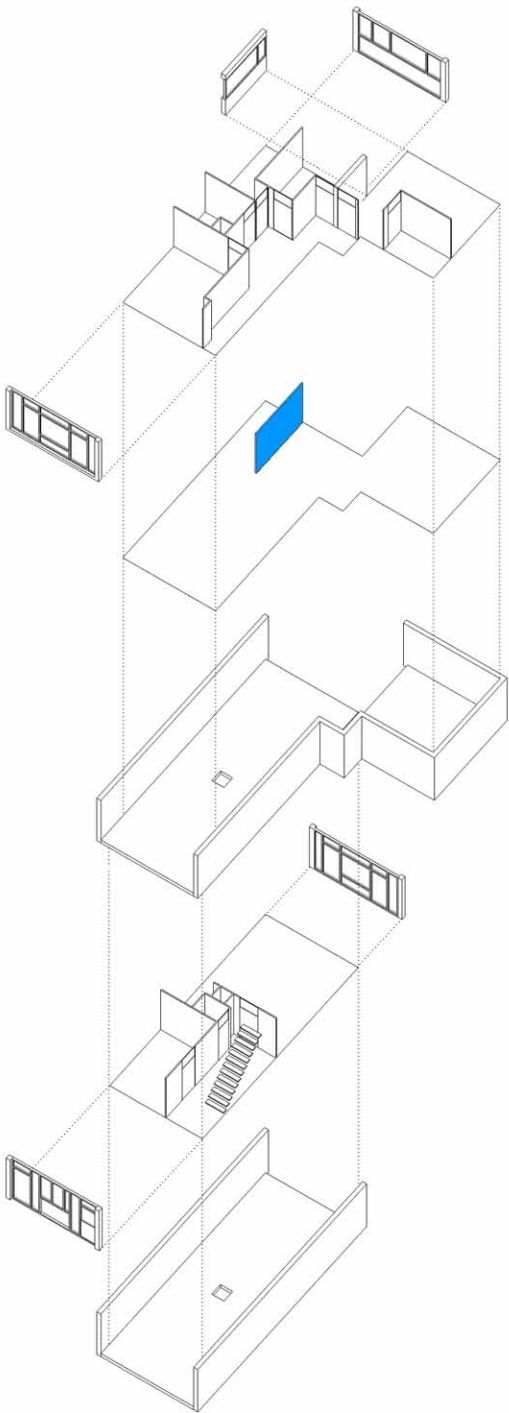
**Separation of Support from Infill**

**Infill (upper floor):**  
Colour and materials of the windows were selected by original users.

**Infill (upper floor):**  
Interior space was divided according to first users' requirement.

**Remove:**  
A partition between two bedrooms were removed by one user.

**Support (upper floor):**  
by architect

**Infill (lower floor):**  
Colour and materials of the windows were selected by original users.

**Infill (lower floor):**  
Interior space was divided according to first users' requirement.

**Support (lower floor):**  
by architect

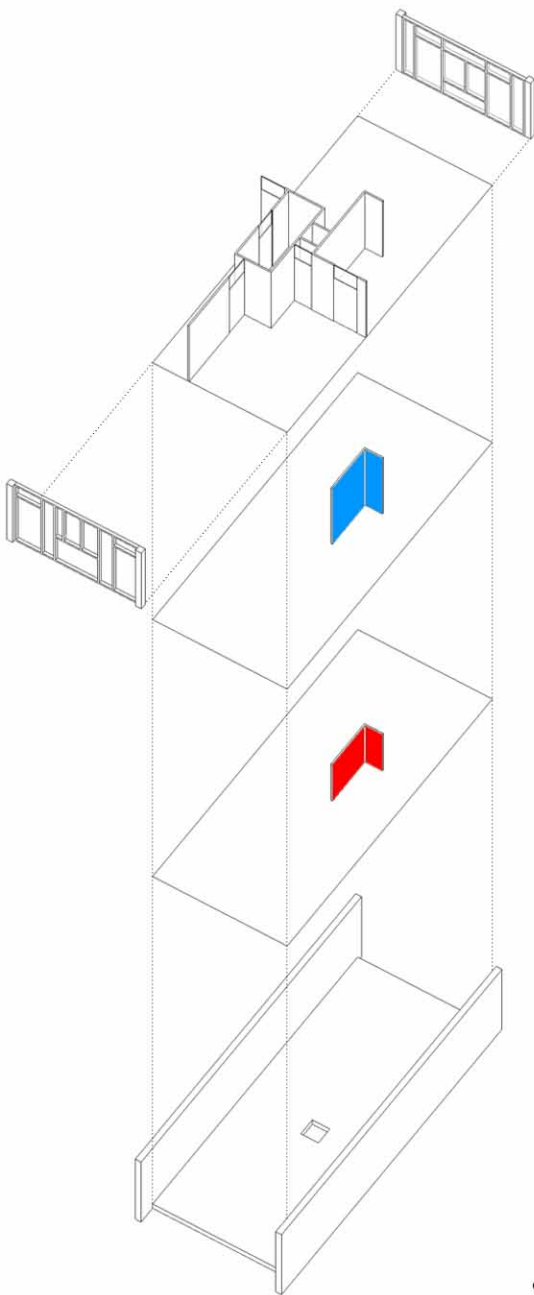
Separation of Support from Infill

**Infill:**  
Colour and materials of the windows were selected by original users.

**Infill:**  
partitions were designed according to original user's demand.

**Remove:**  
a partition of the kitchen was removed.

**Add:**  
A new partition with lower height was built.

**Support (lower floor):**  
by architect

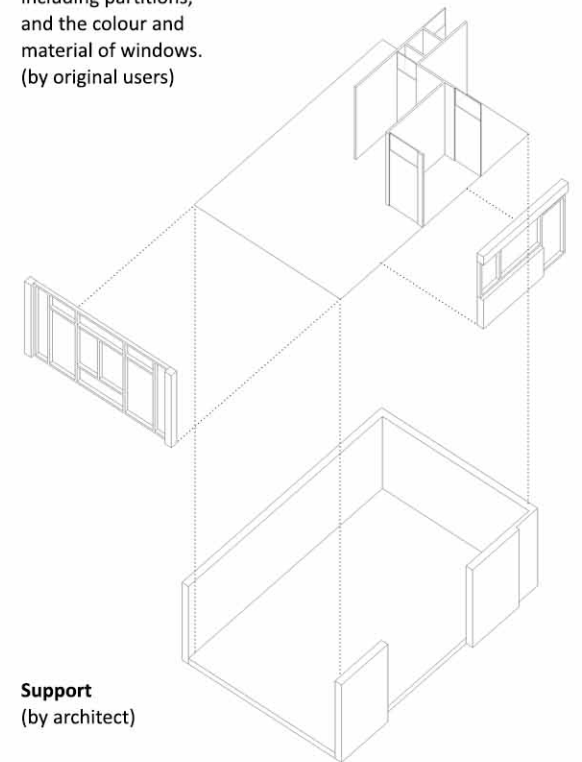
**Fig: The separation of Support and Infill**

**Infill:**

including partitions, and the colour and material of windows. (by original users)

**Support**  
(by architect)

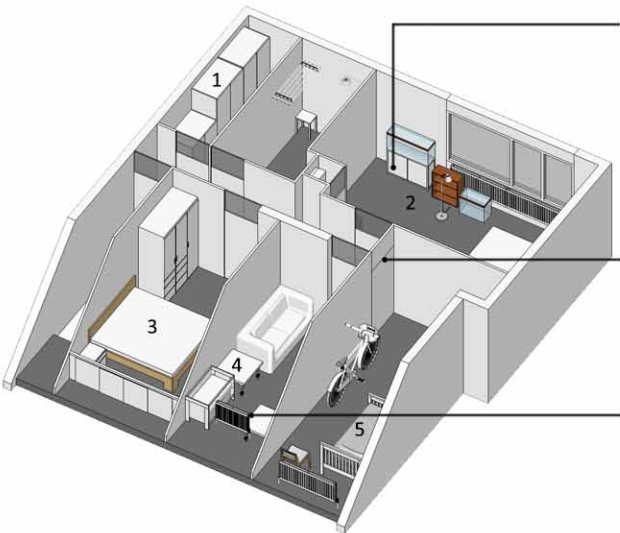
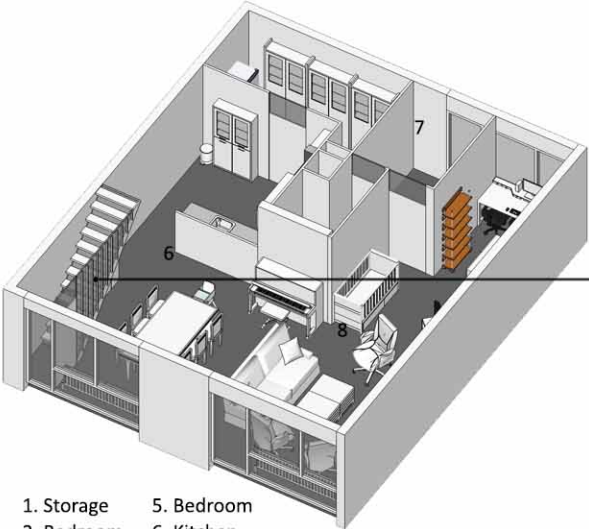
Current Living Situation

It was the four daughters' bedroom. Now the tenants plan to add a kitchen, before the man's mother comes.

The partition of the son's room was changed a little.

It was two sons' bedroom. Now it is used as a granddaughter's room.

The interior staircase was shut off, so that the heating air will not completely go to the upper floor.

- 1. Storage
- 2. Bedroom
- 3. Bedroom
- 4. Bedroom
- 5. Bedroom
- 6. Kitchen
- 7. Entrance
- 8. Living

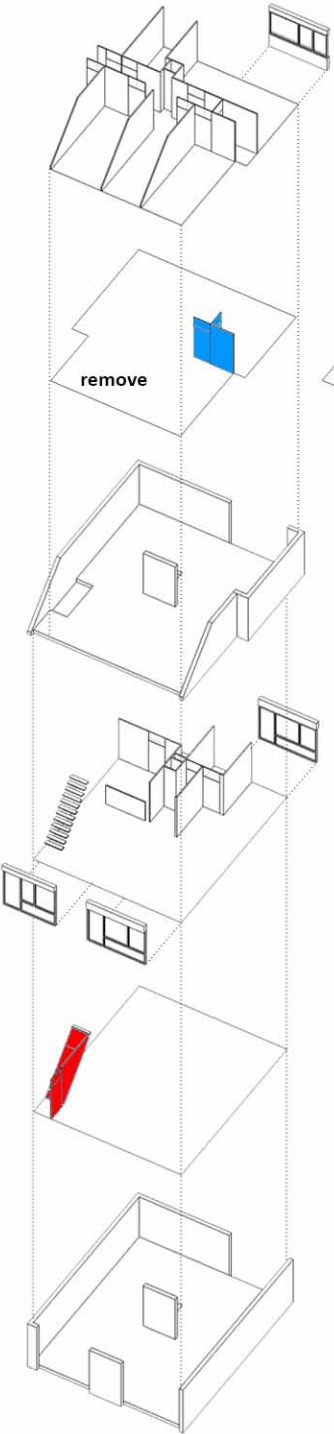
Separation  
of Support from Infill

**Infill (upper floor):** Colour and materials of the windows were selected by original users.

**Infill (upper floor):** partitions were designed according to the original user's demand.

**Change (by current user):** two bedrooms were redivided.

**Support (upper floor):** by architect

**Infill (lower floor):** Colour and materials of the windows were selected by original users.

**Infill (lower floor):** Partitions were designed according to the original user's demand.

**Add (by current user):** The interior staircase was shut off.

**Support (lower floor):** by architect

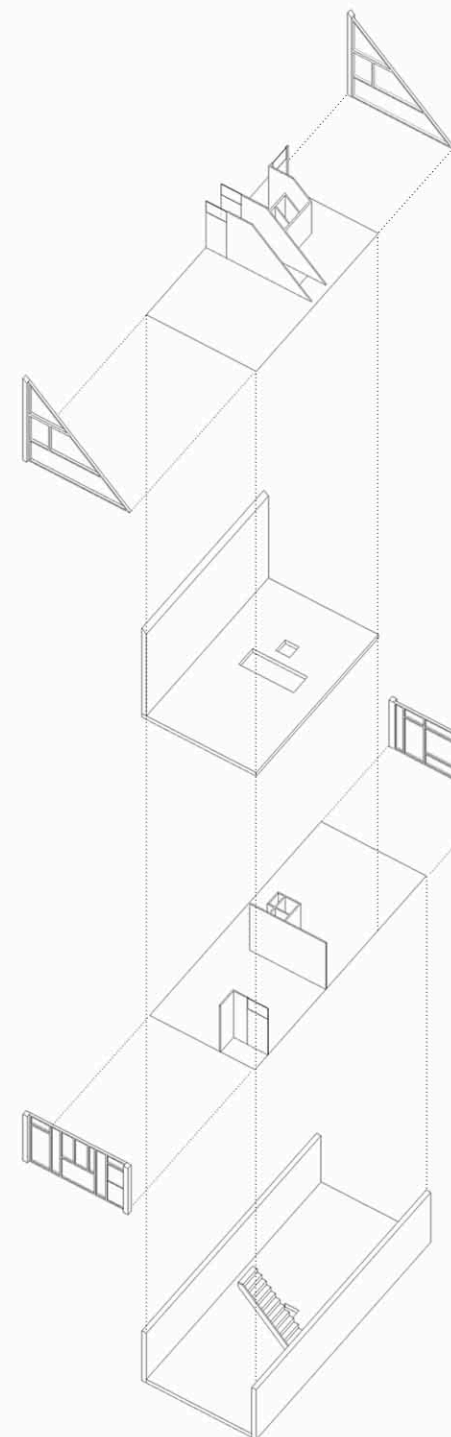
**Separation of Support from Infill**

**Infill (upper floor):**  
partitions were determined by the original users.

**Infill (upper floor):**  
the material and colours of the windows were selected by the original users.

**Support (upper floor):**  
by the architect.

**Infill (lower floor):**  
partitions were determined by the original users.

**Infill (lower floor):**  
the material and colours of the windows were selected by the original users.

**Support (lower floor):**  
by the architect.

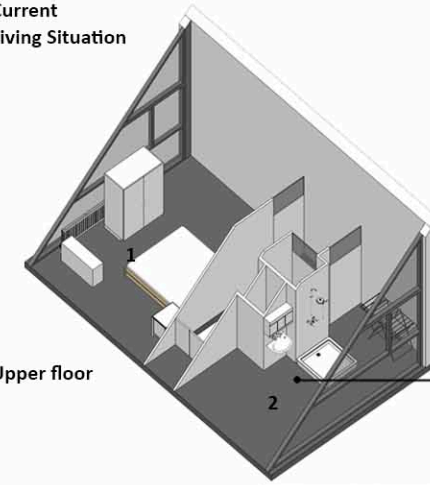
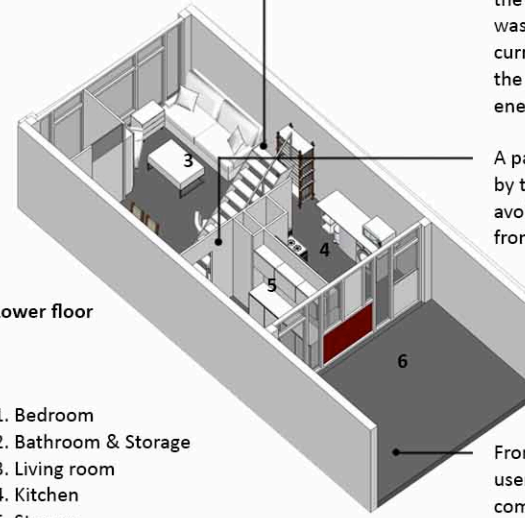
## Current Living Situation

The bathroom is used as a storage in the meantime.

The original railing of the internal staircase was removed by the current user, since she the old one was "likened a jail".

A partition was added by the current user to avoid seeing the storage from entrance.

From this terrace, the user can look down the common courtyard.

1. Bedroom
2. Bathroom & Storage
3. Living room
4. Kitchen
5. Storage
6. Terrace

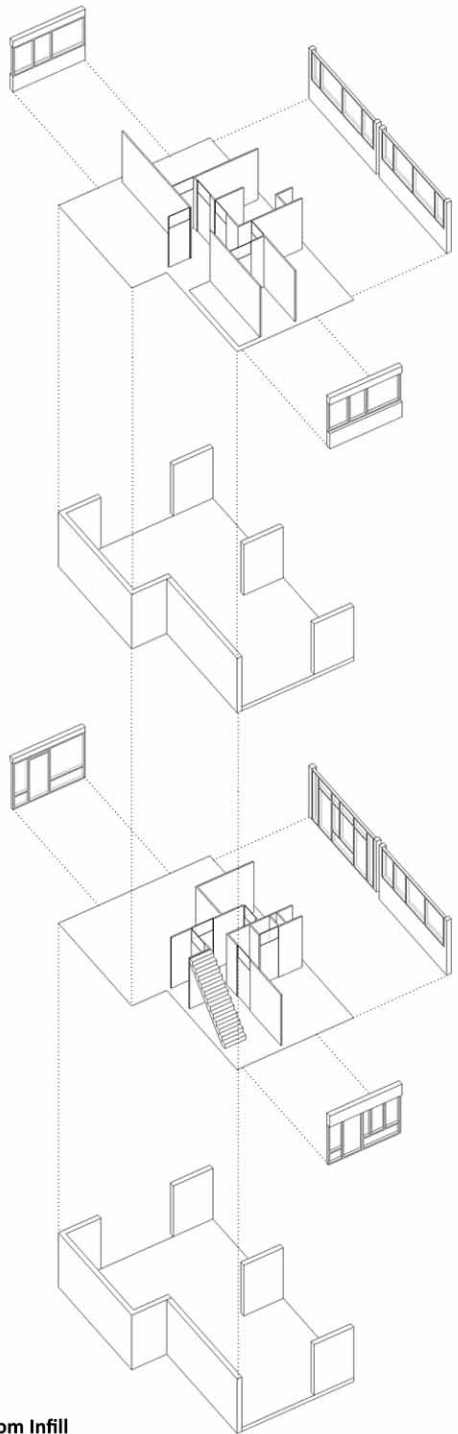
Separation of Support from Infill

**Infill (upper floor):**  
 Colour and materials of the windows were selected by original users.

**Infill (upper floor):**  
 partitions were designed according to original user's demand.

**Support (upper floor):**  
 by architect

**Infill (lower floor):**  
 Colour and materials of the windows were selected by original users.

**Support (lower floor):**  
 by architect

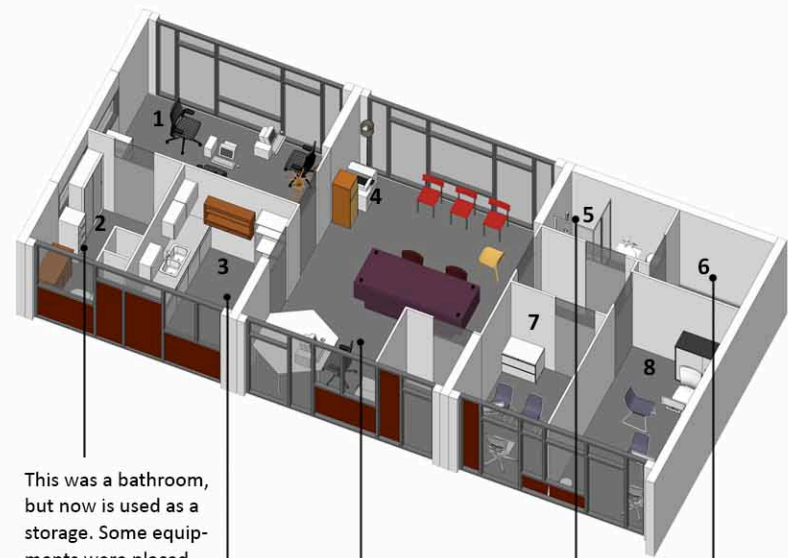
**Fig. Current Living situation**

This was a bathroom, but now is used as a storage. Some equipments were placed.

The kitchen was reserved, now the officers use it to make office and lunch.

The old living room together with dining room are now used as open office.

This was a bathroom. Now the place for bath is occupied with a few odds.

The old storage is now still used as storage, but for some valuable machines.

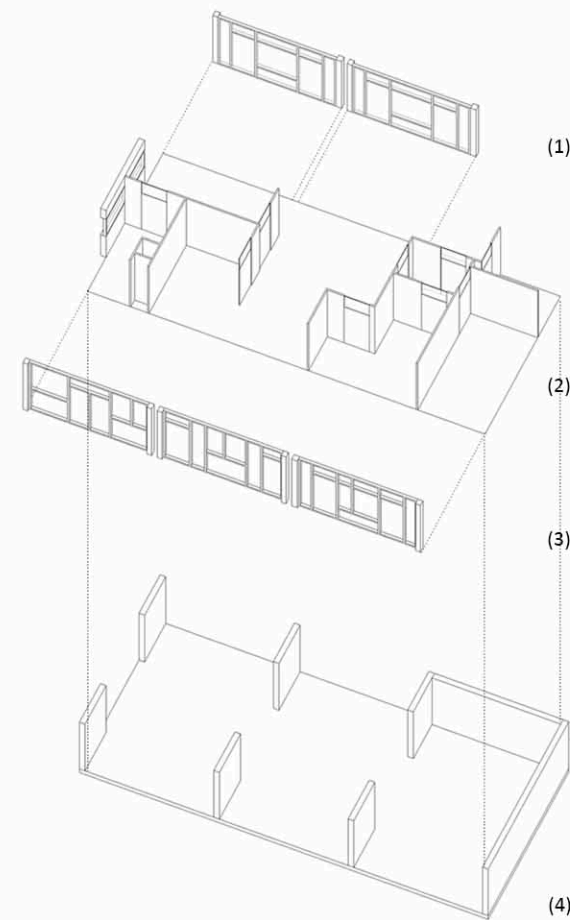
**Fig. The separation of Support from Infill**

(1) (3): Infill: the colour and materials of the windows were determined by the users.

(2) Infill: partitions designed by the original users. According to the original drawing, they were not changed in the past years.

(4) Support: designed by the architect.

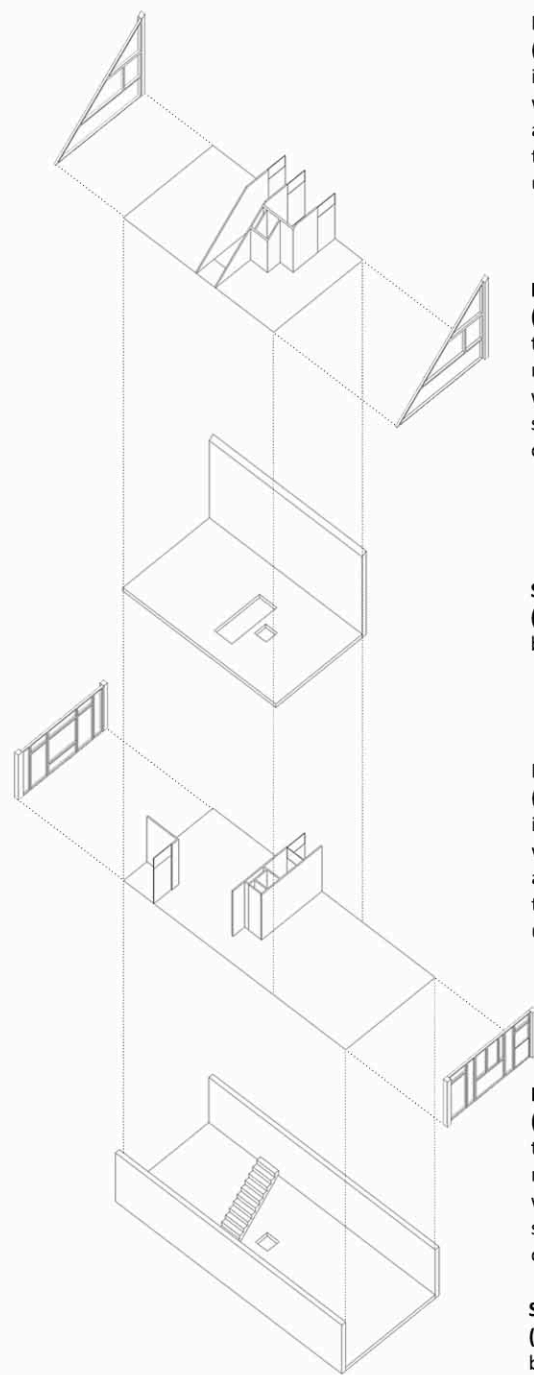
**Infill  
(upper floor)**  
interior space  
was designed  
according to  
the original  
user's demand.

**Infill  
(upper floor)**  
the colour and  
material of  
window are  
selected by  
original users.

**Support  
(upper floor)**  
by the architect

**Infill  
(lower floor)**  
interior space  
was designed  
according to  
the original  
user's demand.

**Infill  
(lower floor)**  
the colour and  
material of  
window are  
selected by  
original users.

**Support  
(lower floor)**  
by the architect

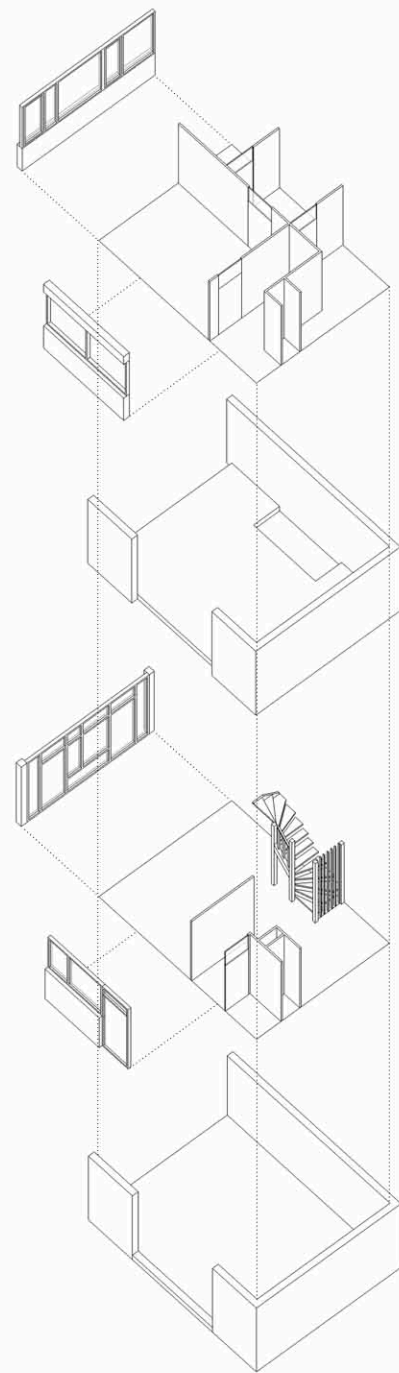
**Separation of Support from Infill**

**Infill (upper floor):**  
The colour and material of windows were selected by the original user.

**Infill (upper floor):**  
interior space was divided according to the original user's demand.

**Support (upper floor):**  
by the architect

**Infill (lower floor):**  
interior space was divided according to the original user's demand.

**Support (lower floor):**  
by the architect.

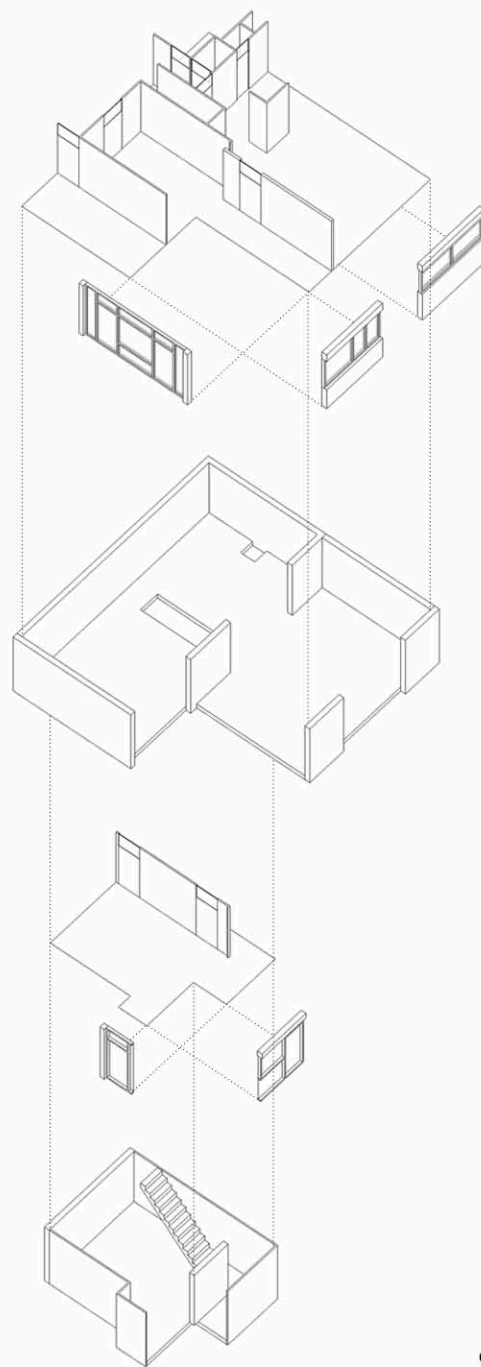
**Separation of Support from Infill**

**Infill (upper floor):**  
interior space was divided according to the original user's demand.

**Infill (upper floor):**  
The colour and material of windows were selected by the original user.

**Support (upper floor):**  
by the architect

**Infill (lower floor):**  
interior space was divided according to the original user's demand.

**Infill (lower floor):**  
The colour and material of windows were selected by original user.

**Support (lower floor):**  
by the architect.

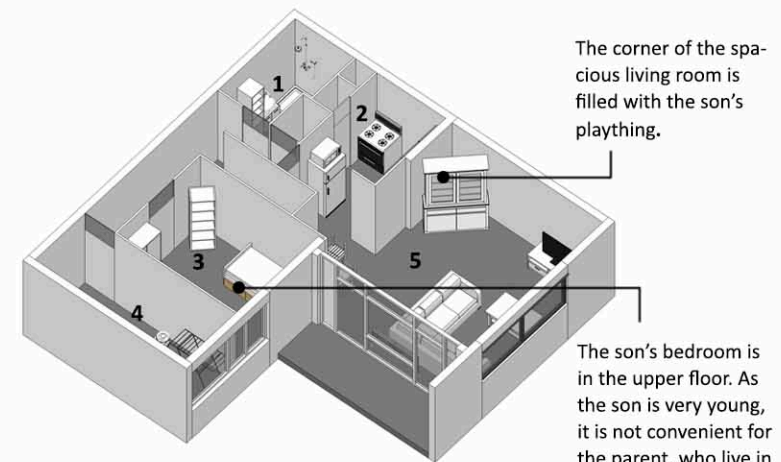
**Current Living Situation**

The corner of the spacious living room is filled with the son's plaything.

The son's bedroom is in the upper floor. As the son is very young, it is not convenient for the parent, who live in the lower floor, to take care of him.

A steel bar was installed by the current users for the young child.

The parent's bedroom is located in the lower floor.

The entrance is located in the ground floor.

- 1. Bathroom
- 2. Kitchen
- 3. Second bedroom
- 4. Storage
- 5. Living room & Dining room
- 6. Main bedroom
