Non-destructive testing on aramid fibres for the long-term assessment of interventions on heritage structures

R Ceravolo¹, A De Marchi², E Pinotti¹, C Surace¹, L Zanotti Fragonara¹

¹ Politecnico di Torino, Department of Structural, Building and Geotechnical Engineering, Corso Duca degli Abruzzi 24, Turin 10129, Italy

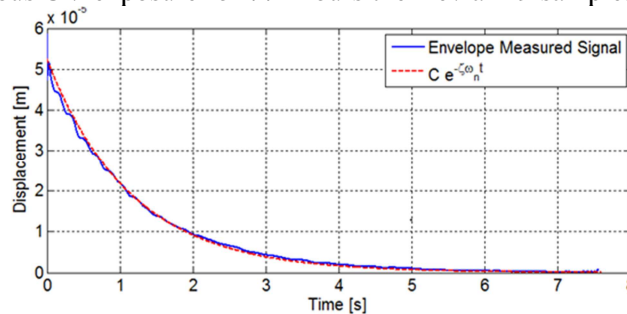
Figure 4. Kevlar-29 pristine sample: fitting of the envelope of the acquired signal.

In order to characterise the dynamic behaviour of the fibres, free-decay tests were performed. The tests allowed for the identification of natural frequencies and damping ratios of both specimens. The system identification was achieved with time domain fitting techniques applied to the Hilbert transform envelopes of the acquired signals (Figures 4 and Figure 5). Results were also validated by using standard ERA techniques [8].

The application of curve fitting techniques over free-decay signals sampled at 2500 Hz gave for the Kevlar-29 pristine samples, a resonance frequency of (20.30 ± 0.03) Hz and an experimental damping ratio of $(0.7 \pm 0.1) \%$; whilst for the Kevlar-29 damaged samples, a value for natural frequency of (19.80 ± 0.02) Hz and experimental damping ratio equal to $(0.6 \pm 0.1) \%$ were evaluated. The spread of the results was computed using 7 free-decay measurements for both samples. The high sensitivity of the measurement device allows to quantify low damping ratio and frequencies with a high level of accuracy. These damping ratios can be directly linked to the intrinsic material dissipation factor, because all other dissipation phenomena can be actually neglected. The mean value of the natural frequency was used to estimate the elastic dynamic modulus of the fibres.

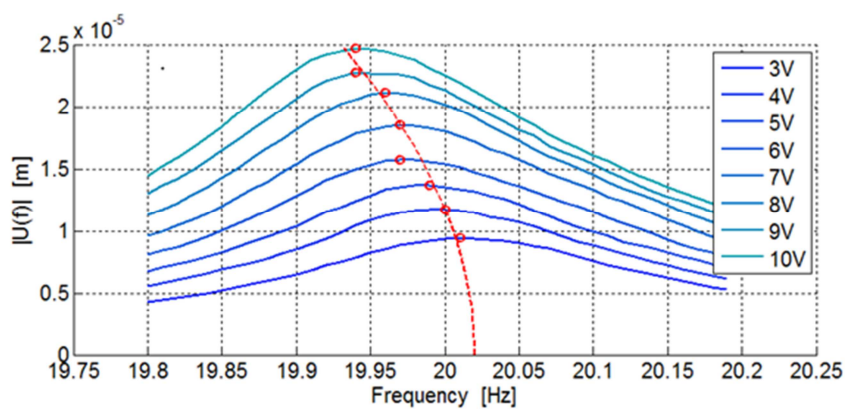
Figure 9. Back-bone nonlinear curve identification - damaged Kevlar-29 sample.

Equation (1) was used to identify the so-called back-bone non-linear curve of the response, as it is highlighted by a red line in Figure 8 and Figure 9.

For the first Kevlar-29 (not damaged sample) the non-linear stiffness χ was identified at $-3.23 \cdot 10^{11}$ N/m³, whilst for the second Kevlar-29 sample (after damage) it was ca $-3.04 \cdot 10^{11}$ N/m³.

From Figures 8 and 9, where the backbone non-linear curves were represented, no significant differences can be appreciated between the pristine and damaged samples, as regards the inclination of the back-bone curve and the value of the index of non-linearity.
