Non-destructive testing on aramid fibres for the long-term assessment of interventions on heritage structures

2015 J. Phys.: Conf. Ser. 628 012102

## Non-destructive testing on aramid fibres for the long-term assessment of interventions on heritage structures.

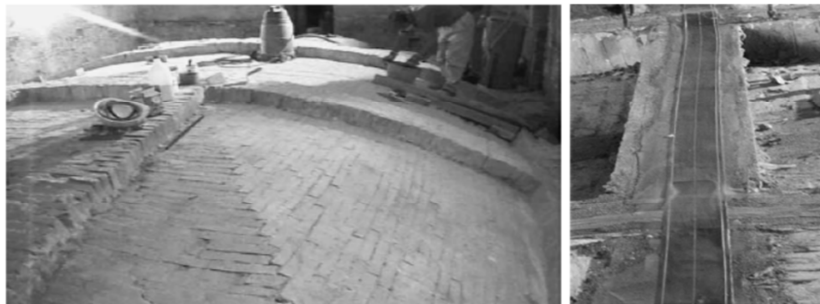
**Figure 1.** (a) The masonry vault and reinforcement arches dated 1600 during surface preparation for CFRP application. (b) Smart CFRP sheet placed on vault [3].

Interesting applications of FRP materials are typically found in the cultural heritage field, where invasiveness of interventions is a major issue. Carbon fibre reinforced polymers (FRPs) are commonly employed for the strengthening and seismic retrofitting of vaults and other masonry elements of heritage buildings (Figure 1). In any case, experimental studies are still required to better understand the durability and compatibility of interventions in polymeric materials and, in general, in other non-traditional materials. For instance, uncertainties about the long term behaviour of aramid fibres made often designers reluctant to their use in the structural engineering fields.

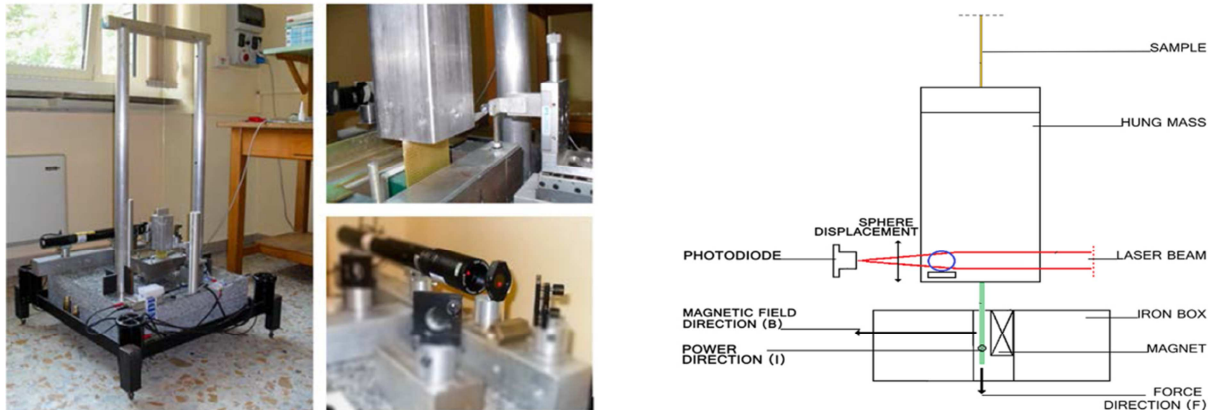
**Figure 2.** (a) The testing setup. (b) Micrometer slides, magnet for forced oscillation testing and hung mass. (c) He-Ne laser beam generator, attenuator and mirrors. (d) Schematic representation.

The testing machine frame (Figure 2.a) is composed of a rectangular crossbeam ( $L=45$  cm, cross section:  $4 \times 4$  cm) made of aluminium, transversely bounded at two cylindrical aluminium holed columns ( $h=95.4$  cm; diameter: 5 cm, thickness: 0.5 cm) on a massive square basement ( $60 \times 60$  cm) made of marble with a thickness of 14.5 cm. An isolation steel table supports the marble mass, this allowing to neutralize most of environment vibrations. The materials used for the testing system were selected in order to minimise the effect of the temperature excursion in the laboratory.

The specimen, consisting of parallel fibres, were mounted vertically, with the top fixed at the horizontal crossbeam and at an aluminium block at the lower part; a special device was inserted at the bottom in order to measure the specimen displacement during the test (Figure 2.b).

A helium-neon generator was used for the experiment (Figure 2.c) in order to produce the laser beam. The device is able to emit a coherent, monochromatic and concentrated light beam in a highly collimated beam straight, through the process of stimulated emission. The laser generator is mounted on a suitable support, so that the laser beam was emitted in the horizontal direction with respect to the anti-vibration table.

An attenuator is an electronic device that reduces the power of a signal without appreciably distorting its waveform. The attenuator was used to prevent saturation of the photodiode, attenuating the beam light (Figure 2.c).

Metal mirrors were used to adjust the direction of the laser beam. They were mounted on supports in order to be adjusted for different inclinations. The combined movement of rotation about the horizontal and vertical axes of the two mirrors allows to determine completely the direction of the light beam (Figure 2.c).

A photodiode, which converts an optical signal to an electric signal, was mounted on three precision micrometre slides. Two of these were assembled together in reference to the X-direction (parallel axis to the plane formed by the optical bench and orthogonal to the laser beam) and Z-direction (orthogonal axis to the plane formed by the optical bench and orthogonal to the laser beam direction). The third slide is positioned in a parallel direction to the bench and the laser beam (Figure 2.b).

In Figure 2.b it is also possible to notice the hung mass of 1.375 kg which was used to form a 1-DoF system with the specimen acting as spring. A copper wire coil was placed inside a magnet and aligned so that an electromagnetic force in the vertical direction could be produced and applied to the hung mass and, consequently, to the fibres (Figure 2.b).

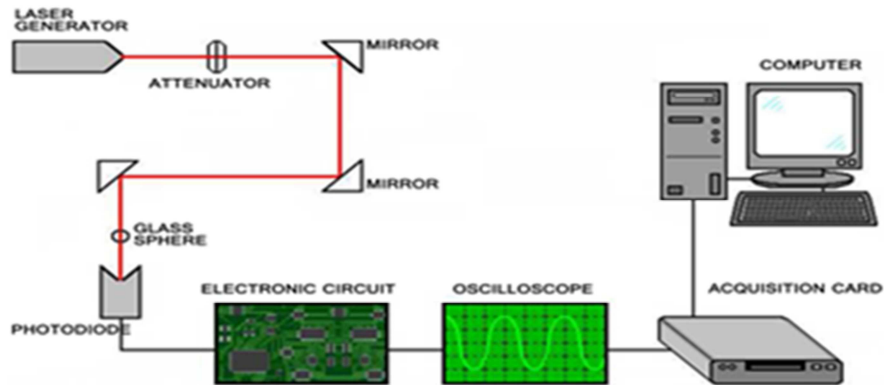
**Figure 3.** Principle of operation - schematic representation.

The principle of operation of the instrumental apparatus used in the tests (Figure 3) can be summarized in the following stages. The light source produced by the laser generator was forced to follow a predetermined path by means of a prism and two lenses. These lenses, if properly set, deflected the laser beam causing it to converge towards the instrument test, where the sample was allocated. In order to allow the photodiode to read the optical signal and, consequently, the possible displacement of the fiber, a glass sphere (connected to the hung mass) with a diameter of 8 mm was used, which, working as a convex lens, focuses the beam to a very precise point of the marker located inside the photodiode (Figure 2.b). The marker was divided into four sectors, generally square. The sensor read the movement of the glass sphere and indirectly the elongation of the fiber, in relation to the quadrant where the laser beam was focused. Therefore, it was important to make a correct positioning of the

photodiode using the micrometer slides. Indeed, for the system in a quiescent state, the read signal was set equal to zero. An electronic circuit was used to link the photodiode to an oscilloscope. An acquisition card and a Lab View application were used to record the collected data on csv files.

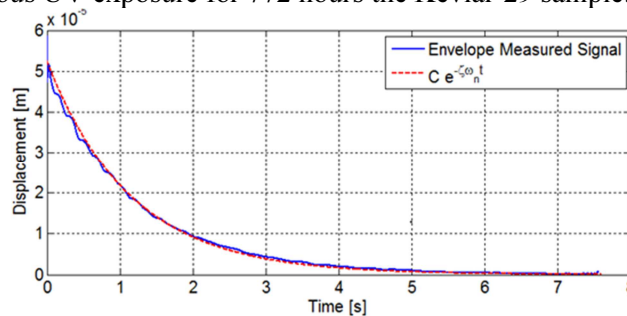
**Figure 4.** Kevlar-29 pristine sample: fitting of the envelope of the acquired signal.

In order to characterise the dynamic behaviour of the fibres, free-decay tests were performed. The tests allowed for the identification of natural frequencies and damping ratios of both specimens. The system identification was achieved with time domain fitting techniques applied to the Hilbert transform envelopes of the acquired signals (Figures 4 and Figure 5). Results were also validated by using standard ERA techniques [8].

The application of curve fitting techniques over free-decay signals sampled at 2500 Hz gave for the Kevlar-29 pristine samples, a resonance frequency of  $(20.30 \pm 0.03)$  Hz and an experimental damping ratio of  $(0.7 \pm 0.1) \%$ ; whilst for the Kevlar-29 damaged samples, a value for natural frequency of  $(19.80 \pm 0.02)$  Hz and experimental damping ratio equal to  $(0.6 \pm 0.1) \%$  were evaluated. The spread of the results was computed using 7 free-decay measurements for both samples. The high sensitivity of the measurement device allows to quantify low damping ratio and frequencies with a high level of accuracy. These damping ratios can be directly linked to the intrinsic material dissipation factor, because all other dissipation phenomena can be actually neglected. The mean value of the natural frequency was used to estimate the elastic dynamic modulus of the fibres.

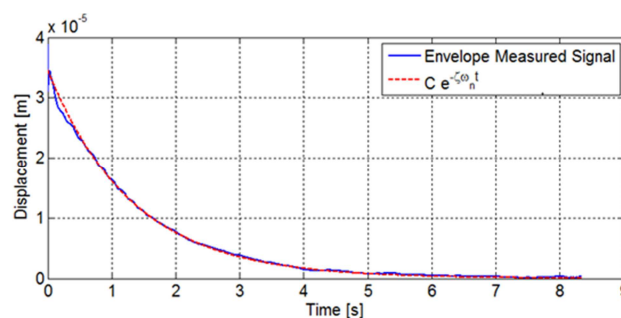
**Figure 5.** Kevlar-29 damaged sample: fitting of the envelope of the acquired signal.

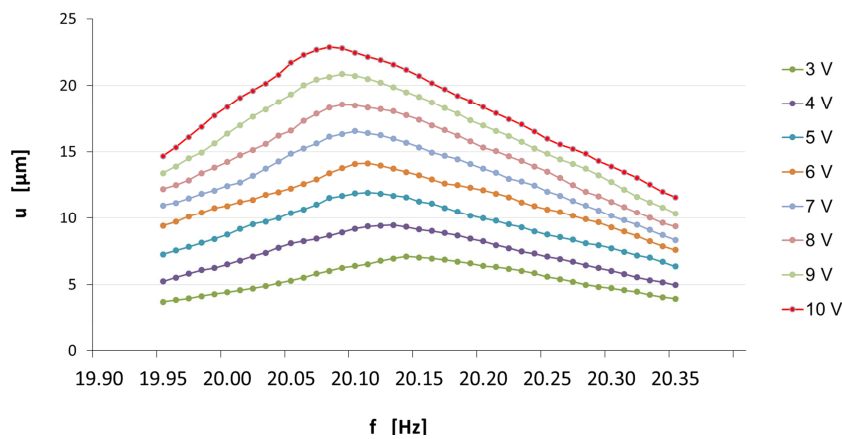
**Figure 6.** Response spectra for increasing values of the input force – pristine sample.

In order to highlight possible non-linearities, campaign with harmonic forced excitation tests was set up. The frequency range investigated was of  $\pm 0.200$  Hz with respect to the resonance frequency of the system, with a step excitation frequency chosen equal to 0.010 Hz while keeping the force constant. Then the test was repeated for different level of force, the amplitude being varied by adjusting the voltage applied through a function generator in steps from 3 V to 10 V, corresponding to forces induced by the electromagnetic field that were in the approximate range of 10-30 mN (see Figure 2.b and 2.d). The value of the amplitude of the static force at resonance was estimated at approximately 0.9 N at the lowest level applied, and 3.1 N at the highest.

Once the input voltage interval has been defined, changing the frequency of the driving force (via the function generator) it is possible to record the values of the output voltage, from which the displacement can be determined by using a conversion factor established during the photodiode calibration. The results are reported in Figure 6 and Figure 7.

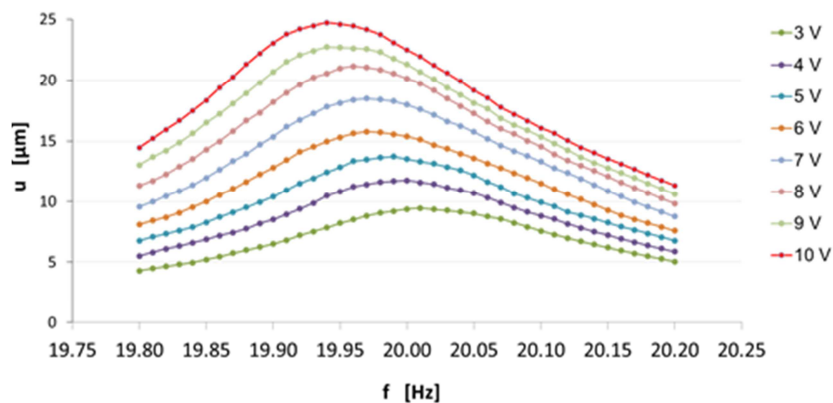
**Figure 7.** Response spectra for increasing values of the input force – damaged sample

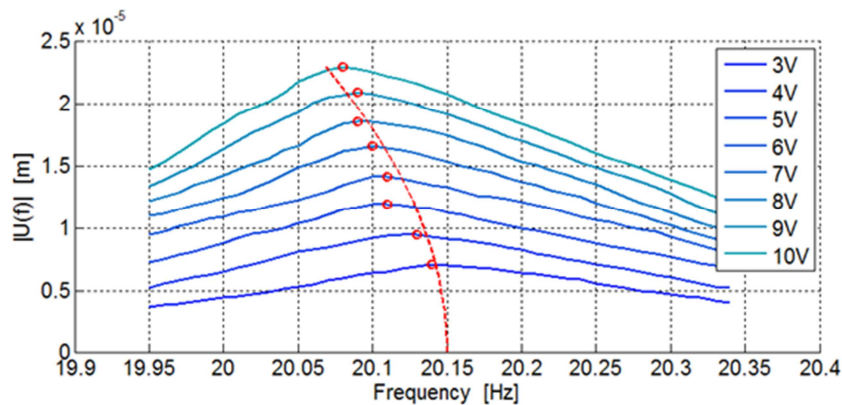
**Figure 8.** Back-bone nonlinear curve identification - undamaged Kevlar-29 sample.

Equation (1) was used to identify the so-called back-bone non-linear curve of the response, as it is highlighted by a red line in Figure 8 and Figure 9.

For the first Kevlar-29 (not damaged sample) the non-linear stiffness  $\chi$  was identified at  $-3.23 \cdot 10^{11}$  N/m<sup>3</sup>, whilst for the second Kevlar-29 sample (after damage) it was ca  $-3.04 \cdot 10^{11}$  N/m<sup>3</sup>.

From Figures 8 and 9, where the backbone non-linear curves were represented, no significant differences can be appreciated between the pristine and damaged samples, as regards the inclination of the back-bone curve and the value of the index of non-linearity.

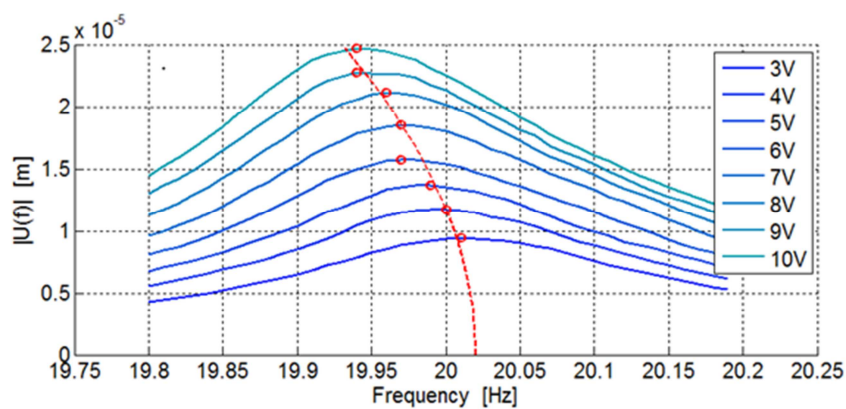
**Figure 9.** Back-bone nonlinear curve identification - damaged Kevlar-29 sample.
