Non-destructive testing on aramid fibres for the long-term assessment of interventions on heritage structures

R Ceravolo¹, A De Marchi², E Pinotti¹, C Surace¹, L Zanotti Fragonara¹

¹ Politecnico di Torino, Department of Structural, Building and Geotechnical Engineering, Corso Duca degli Abruzzi 24, Turin 10129, Italy

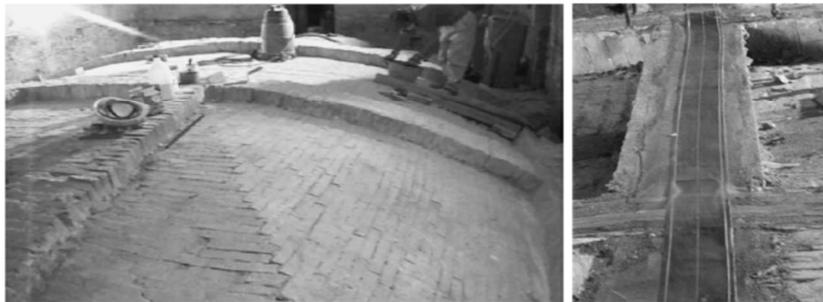
Figure 1. (a) The masonry vault and reinforcement arches dated 1600 during surface preparation for CFRP application. (b) Smart CFRP sheet placed on vault [3].

Interesting applications of FRP materials are typically found in the cultural heritage field, where invasiveness of interventions is a major issue. Carbon fibre reinforced polymers (FRPs) are commonly employed for the strengthening and seismic retrofitting of vaults and other masonry elements of heritage buildings (Figure 1). In any case, experimental studies are still required to better understand the durability and compatibility of interventions in polymeric materials and, in general, in other non-traditional materials. For instance, uncertainties about the long term behaviour of aramid fibres made often designers reluctant to their use in the structural engineering fields.

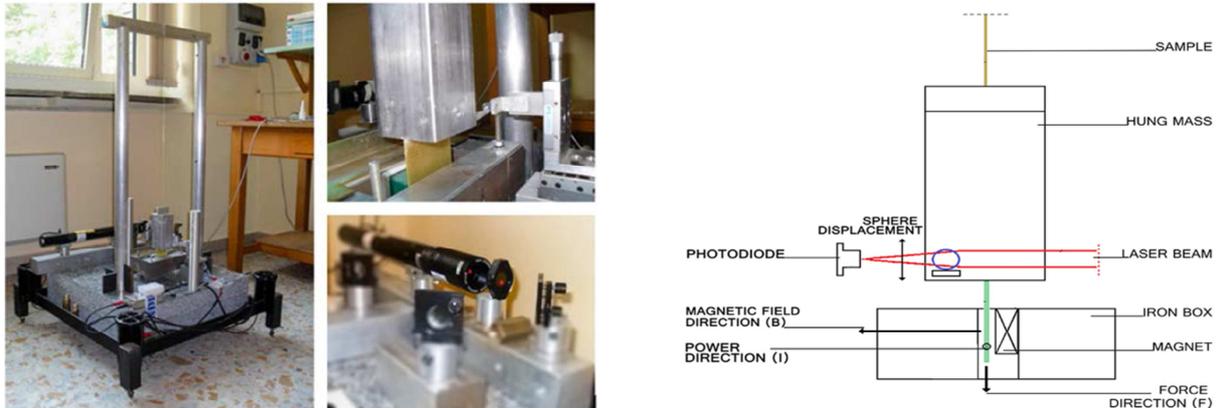
Figure 2. (a) The testing setup. (b) Micrometer slides, magnet for forced oscillation testing and hung mass. (c) He-Ne laser beam generator, attenuator and mirrors. (d) Schematic representation.

The testing machine frame (Figure 2.a) is composed of a rectangular crossbeam ($L=45$ cm, cross section: 4×4 cm) made of aluminium, transversely bounded at two cylindrical aluminium holed columns ($h=95.4$ cm; diameter: 5 cm, thickness: 0.5 cm) on a massive square basement (60×60 cm) made of marble with a thickness of 14.5 cm. An isolation steel table supports the marble mass, this allowing to neutralize most of environment vibrations. The materials used for the testing system were selected in order to minimise the effect of the temperature excursion in the laboratory.

The specimen, consisting of parallel fibres, were mounted vertically, with the top fixed at the horizontal crossbeam and at an aluminium block at the lower part; a special device was inserted at the bottom in order to measure the specimen displacement during the test (Figure 2.b).

A helium-neon generator was used for the experiment (Figure 2.c) in order to produce the laser beam. The device is able to emit a coherent, monochromatic and concentrated light beam in a highly collimated beam straight, through the process of stimulated emission. The laser generator is mounted on a suitable support, so that the laser beam was emitted in the horizontal direction with respect to the anti-vibration table.

An attenuator is an electronic device that reduces the power of a signal without appreciably distorting its waveform. The attenuator was used to prevent saturation of the photodiode, attenuating the beam light (Figure 2.c).

Metal mirrors were used to adjust the direction of the laser beam. They were mounted on supports in order to be adjusted for different inclinations. The combined movement of rotation about the horizontal and vertical axes of the two mirrors allows to determine completely the direction of the light beam (Figure 2.c).

A photodiode, which converts an optical signal to an electric signal, was mounted on three precision micrometre slides. Two of these were assembled together in reference to the X-direction (parallel axis to the plane formed by the optical bench and orthogonal to the laser beam) and Z-direction (orthogonal axis to the plane formed by the optical bench and orthogonal to the laser beam direction). The third slide is positioned in a parallel direction to the bench and the laser beam (Figure 2.b).

In Figure 2.b it is also possible to notice the hung mass of 1.375 kg which was used to form a 1-DoF system with the specimen acting as spring. A copper wire coil was placed inside a magnet and aligned so that an electromagnetic force in the vertical direction could be produced and applied to the hung mass and, consequently, to the fibres (Figure 2.b).

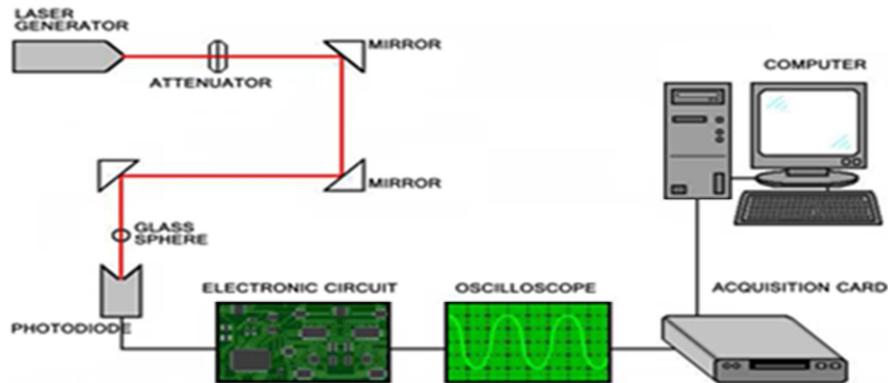
Figure 3. Principle of operation - schematic representation.

The principle of operation of the instrumental apparatus used in the tests (Figure 3) can be summarized in the following stages. The light source produced by the laser generator was forced to follow a predetermined path by means of a prism and two lenses. These lenses, if properly set, deflected the laser beam causing it to converge towards the instrument test, where the sample was allocated. In order to allow the photodiode to read the optical signal and, consequently, the possible displacement of the fiber, a glass sphere (connected to the hung mass) with a diameter of 8 mm was used, which, working as a convex lens, focuses the beam to a very precise point of the marker located inside the photodiode (Figure 2.b). The marker was divided into four sectors, generally square. The sensor read the movement of the glass sphere and indirectly the elongation of the fiber, in relation to the quadrant where the laser beam was focused. Therefore, it was important to make a correct positioning of the

photodiode using the micrometer slides. Indeed, for the system in a quiescent state, the read signal was set equal to zero. An electronic circuit was used to link the photodiode to an oscilloscope. An acquisition card and a Lab View application were used to record the collected data on csv files.

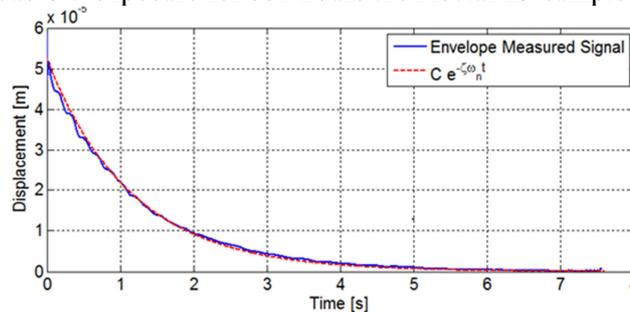
Figure 4. Kevlar-29 pristine sample: fitting of the envelope of the acquired signal.

In order to characterise the dynamic behaviour of the fibres, free-decay tests were performed. The tests allowed for the identification of natural frequencies and damping ratios of both specimens. The system identification was achieved with time domain fitting techniques applied to the Hilbert transform envelopes of the acquired signals (Figures 4 and Figure 5). Results were also validated by using standard ERA techniques [8].

The application of curve fitting techniques over free-decay signals sampled at 2500 Hz gave for the Kevlar-29 pristine samples, a resonance frequency of (20.30 ± 0.03) Hz and an experimental damping ratio of $(0.7 \pm 0.1) \%$; whilst for the Kevlar-29 damaged samples, a value for natural frequency of (19.80 ± 0.02) Hz and experimental damping ratio equal to $(0.6 \pm 0.1) \%$ were evaluated. The spread of the results was computed using 7 free-decay measurements for both samples. The high sensitivity of the measurement device allows to quantify low damping ratio and frequencies with a high level of accuracy. These damping ratios can be directly linked to the intrinsic material dissipation factor, because all other dissipation phenomena can be actually neglected. The mean value of the natural frequency was used to estimate the elastic dynamic modulus of the fibres.

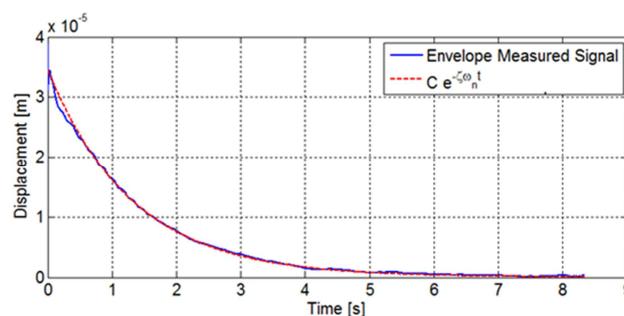
Figure 5. Kevlar-29 damaged sample: fitting of the envelope of the acquired signal.

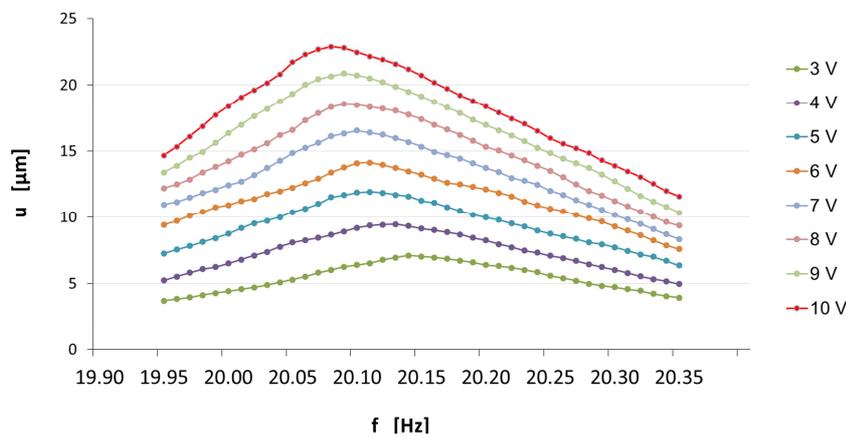
Figure 6. Response spectra for increasing values of the input force – pristine sample.

Once the input voltage interval has been defined, changing the frequency of the driving force (via the function generator) it is possible to record the values of the output voltage, from which the displacement can be determined by using a conversion factor established during the photodiode calibration. The results are reported in Figure 6 and Figure 7.

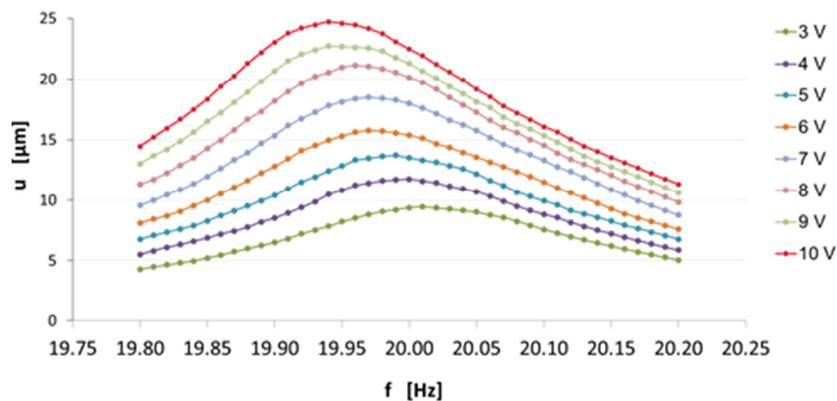
Figure 7. Response spectra for increasing values of the input force – damaged sample

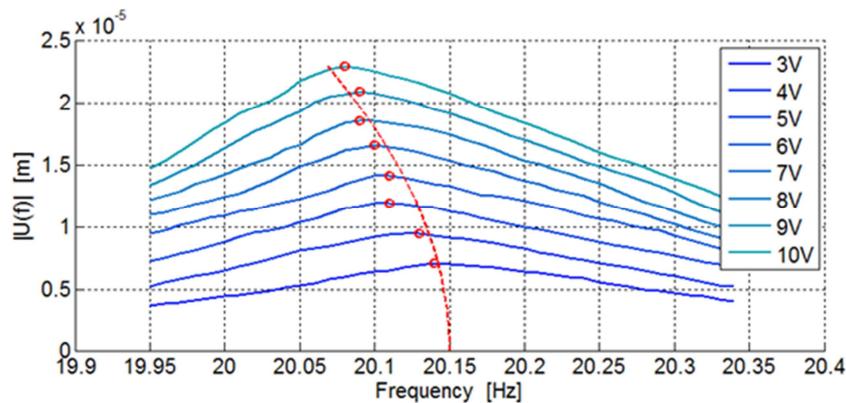
Figure 8. Back-bone nonlinear curve identification - undamaged Kevlar-29 sample.

Equation (1) was used to identify the so-called back-bone non-linear curve of the response, as it is highlighted by a red line in Figure 8 and Figure 9.

For the first Kevlar-29 (not damaged sample) the non-linear stiffness χ was identified at $-3.23 \cdot 10^{11}$ N/m³, whilst for the second Kevlar-29 sample (after damage) it was ca $-3.04 \cdot 10^{11}$ N/m³.

From Figures 8 and 9, where the backbone non-linear curves were represented, no significant differences can be appreciated between the pristine and damaged samples, as regards the inclination of the back-bone curve and the value of the index of non-linearity.

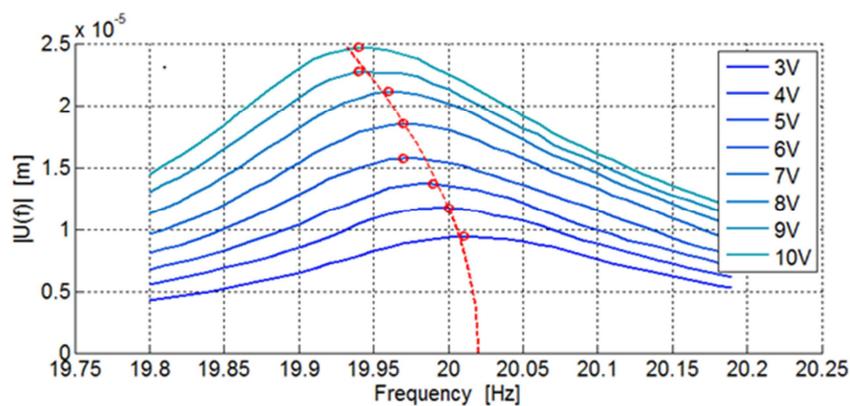
Figure 9. Back-bone nonlinear curve identification - damaged Kevlar-29 sample.
