Non-destructive testing on aramid fibres for the long-term assessment of interventions on heritage structures

R Ceravolo¹, A De Marchi², E Pinotti¹, C Surace¹, L Zanotti Fragonara¹

¹ Politecnico di Torino, Department of Structural, Building and Geotechnical Engineering, Corso Duca degli Abruzzi 24, Turin 10129, Italy

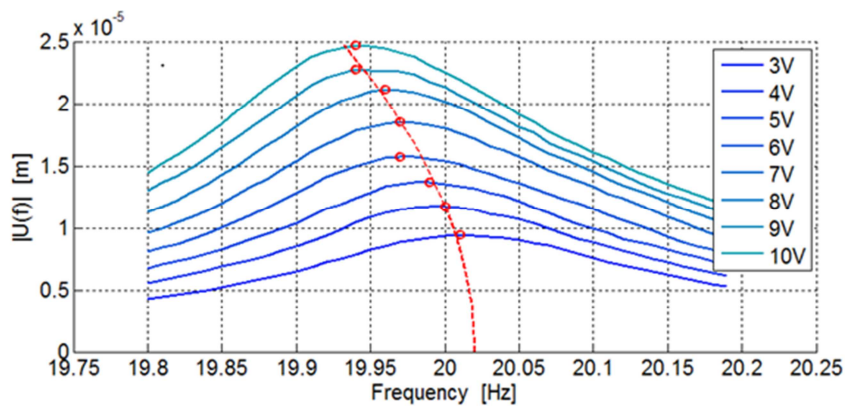
Figure 9. Back-bone nonlinear curve identification - damaged Kevlar-29 sample.

Equation (1) was used to identify the so-called back-bone non-linear curve of the response, as it is highlighted by a red line in Figure 8 and Figure 9.

For the first Kevlar-29 (not damaged sample) the non-linear stiffness χ was identified at $-3.23 \cdot 10^{11}$ N/m³, whilst for the second Kevlar-29 sample (after damage) it was ca $-3.04 \cdot 10^{11}$ N/m³.

From Figures 8 and 9, where the backbone non-linear curves were represented, no significant differences can be appreciated between the pristine and damaged samples, as regards the inclination of the back-bone curve and the value of the index of non-linearity.
