DIAMOND WIRE – STONE INTERACTION DURING CUTTING PROCESS: MECHANICAL, PHYSICAL AND CHEMICAL INVESTIGATIONS

S. Spriano¹, S. Ferraris¹, R. Bellopede², P. Marini², L. Zichella², A. Tori³

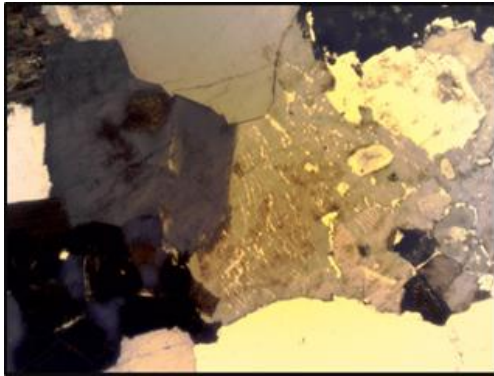
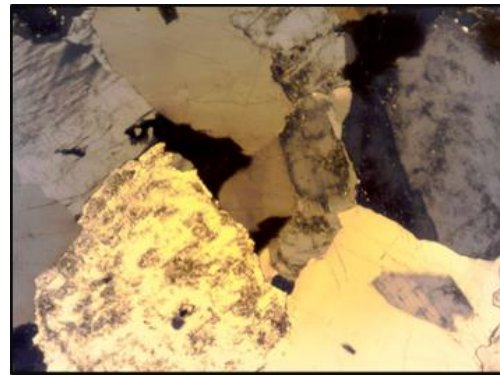
A. RG granite

B. GP granite

Figure 1: Thin sections of RG and GP granite (long side 4.3mm): microscopy crossed nicols, in black the ferrous components (biotite).

Petrographic analysis and mineralogical investigation have been performed on the stones and on the muds derived from their cutting. Both have been analyzed by means of the optical microscope Leitz Wetzlar. Image analyzer software IMAGE J (an open source image processing program designed for scientific multidimensional image), in order to define size, dimension and ratio between quartz and feldspar. In

Figure 1 the thin sections of two different kind of Sardinian granite (RG and GP) are reported.

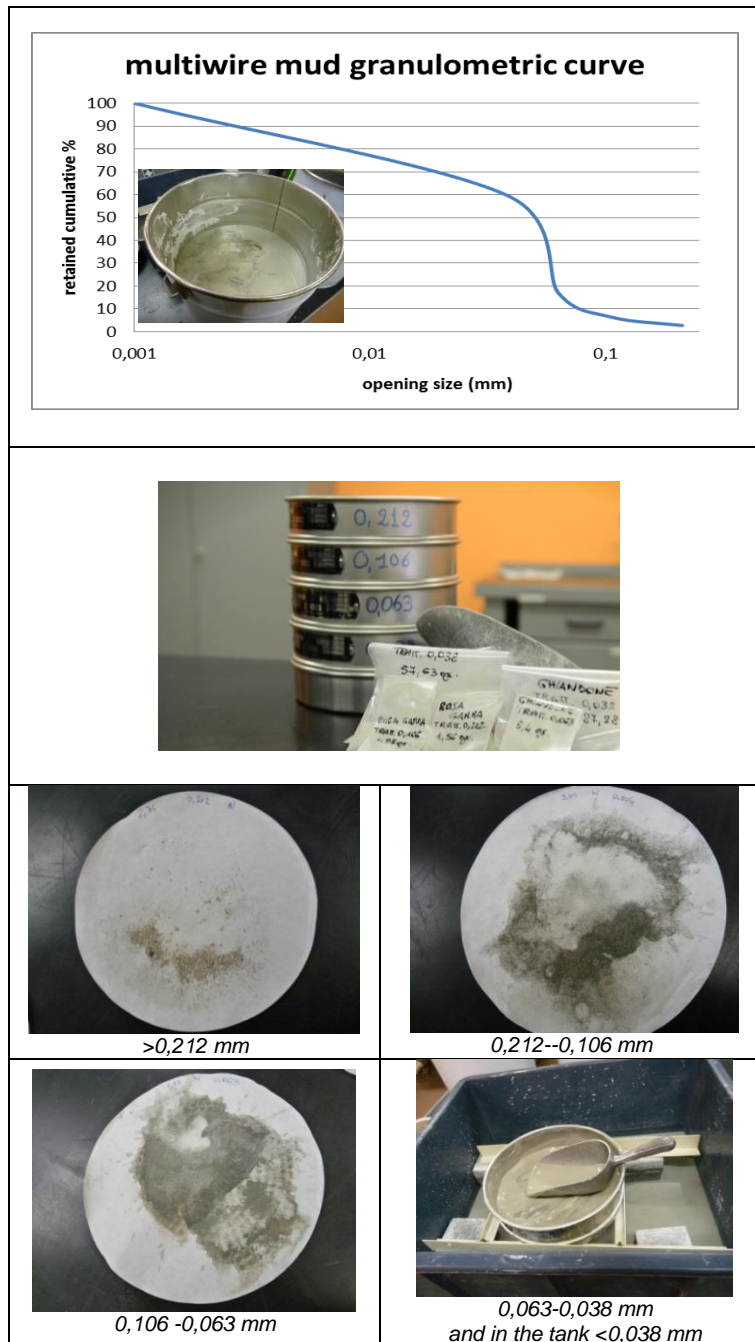
The granulometric curve of multiwire muds is shown in Figure 2; it is characterized by a high percentage (40.2%) of particles minor than 0,038mm.

Figure 2: size distribution process and characterization of multiwire muds

Each one of the classes obtained through the granulometric separation has been processed with a wet magnetic separation (Co-Al – Ni magnet). On the size classes minor than 0,063mm a further analysis by means of X – Ray Diffraction (XRD) have been performed.

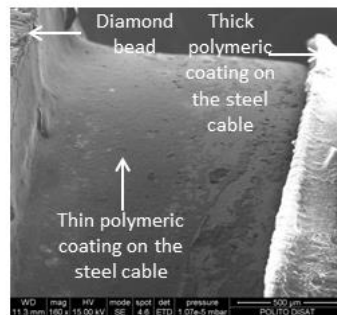
In the case of diamond wires used in cutting of Fe containing stones, we observed by SEM that the junction between the diamond beads and the steel rope is good and no wear was observed in this area (Figure 3). The steel rope is well covered by a thin or thick polymeric coating (polyurethane) at the junction between the rope and the diamond bead, without any erosion, detachment or wear of the coating (Figure 4).

Figure 3: SEM image at low magnification of the junction between the diamond beads and the steel rope

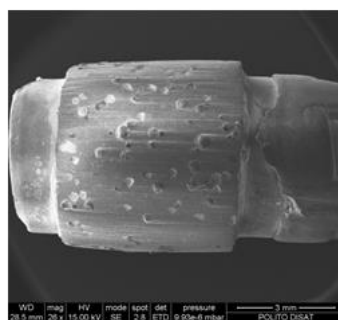
As first, we observed at low magnification that the beads almost maintain their shape after stone cutting and they are almost uniformly worn (see Figure 4) on all their length. The direction of cutting and rotation of the diamond wire can be derived by observing the presence of “comet tails” behind the diamond grits and the slight lower diameter of the bead on the left of the image: the first impact of the bead with the stone during cutting was on the left side, in this case.

Figure 4: SEM image at low magnification of a worn diamond bead

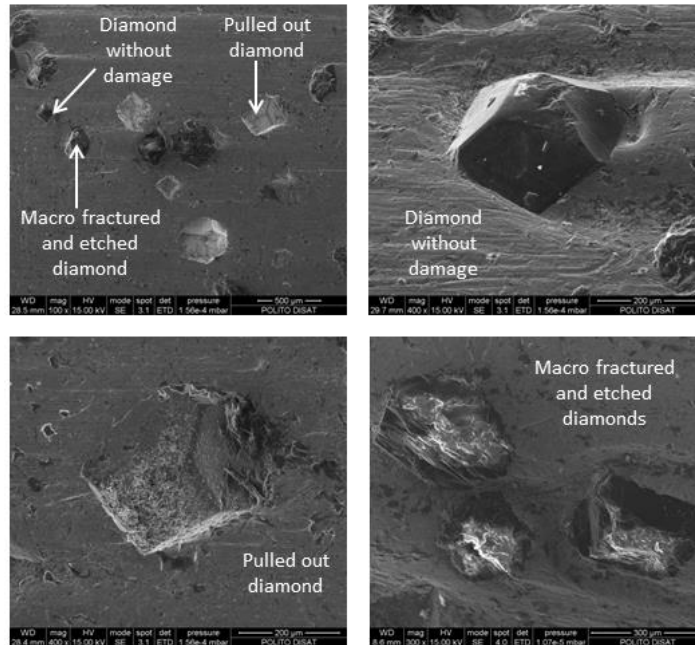
In this case, we observed diamonds arising from the surface without any damage, macro fractured, pulled out and etched (Figure 5).

Figure 5: Image of the surface of a worn diamond bead with diamond bits differently damaged

Diamonds without any damage are diamonds still able to cut stones and a “comet tail” is clearly visible behind them, because their presence prevent erosion of the metal matrix behind them by stone debris, during cutting. [8] The interface between the un-damaged diamond bits and the metal matrix is continuous and without any cracks, showing a high retention ability of the metal matrix and good sintering of the beads. [9] EDS analysis performed on the smooth surface of the un-damaged diamonds only shows the presence of carbon.

Some diamonds were pulled out during cutting and some voids are observable on the surface; the voids are often quite deep, showing that in these cases diamonds were pulled out before they were highly worn. The EDS analysis performed inside the voids deriving from pulled out diamonds shows the presence of Co and WC, which are the main components of the matrix. No porosity can be seen inside the voids of the pulled out diamonds, confirming a good sintering of the metal matrix.

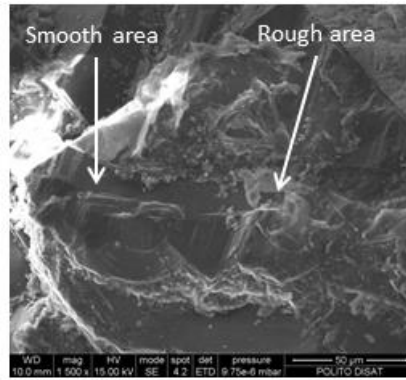
The most interesting diamonds grits are the macro fractured and etched ones. These diamonds are no longer able to cut stones and they do not show any “comet tail” behind them. Macro fractured diamonds do not highly protrude from the surface level and they still show a good interface with the metal matrix, showing that in some cases the retention ability of the metal matrix is too high: un-efficient diamonds without cutting ability are still maintained on the surface by the strong interface with the metal matrix. [10] The surface of the macro fractured diamonds shows both some smooth cleavage planes, deriving from a brittle fracture mechanism, and some rough areas probably deriving from etching (Figure 6). On the rough areas of the etched diamonds, EDS analysis shows the presence of an adherent layer of stone containing Fe, Ca Na, K, Mg and Si, suggesting that Fe containing stones are able to react with the diamonds causing a high degree of damage and macro fractures follow this etching.

Figure 6: Macro fractured and etched diamond

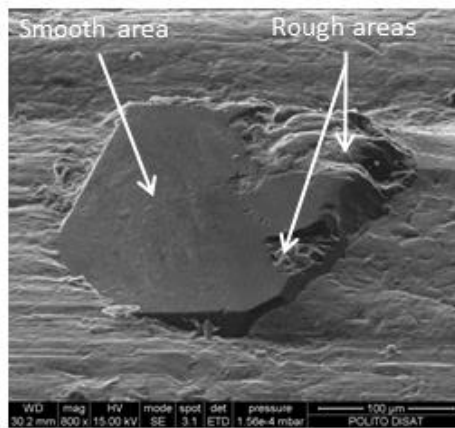
On one diamond grain, arising from the surface with an almost un-damaged and smooth surface, it was interesting to see the damage, probably due to etching and reaction with iron, in a first stage (Figure 7), limited to small areas: in this case macro fractures did not occur because of the limited etching.

Figure 7: An almost un-damaged diamond bit showing etching in a first stage

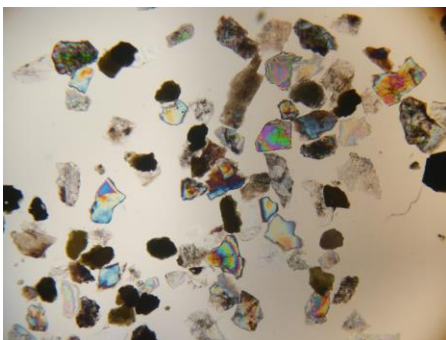
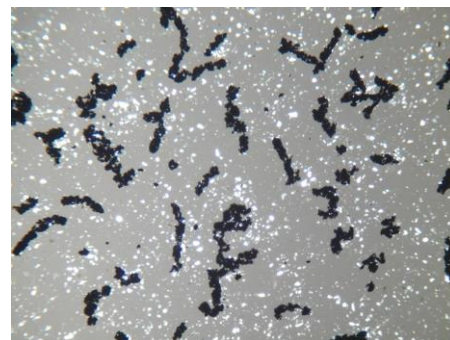
Figure 8: On the left micro-photo (6.9x5,19mm) with crossed nicols of mud particles >0.212mm and on the right micro photo (10.6 x 8mm)with parallel nicols of mud particles between 0.038-0.063mm.

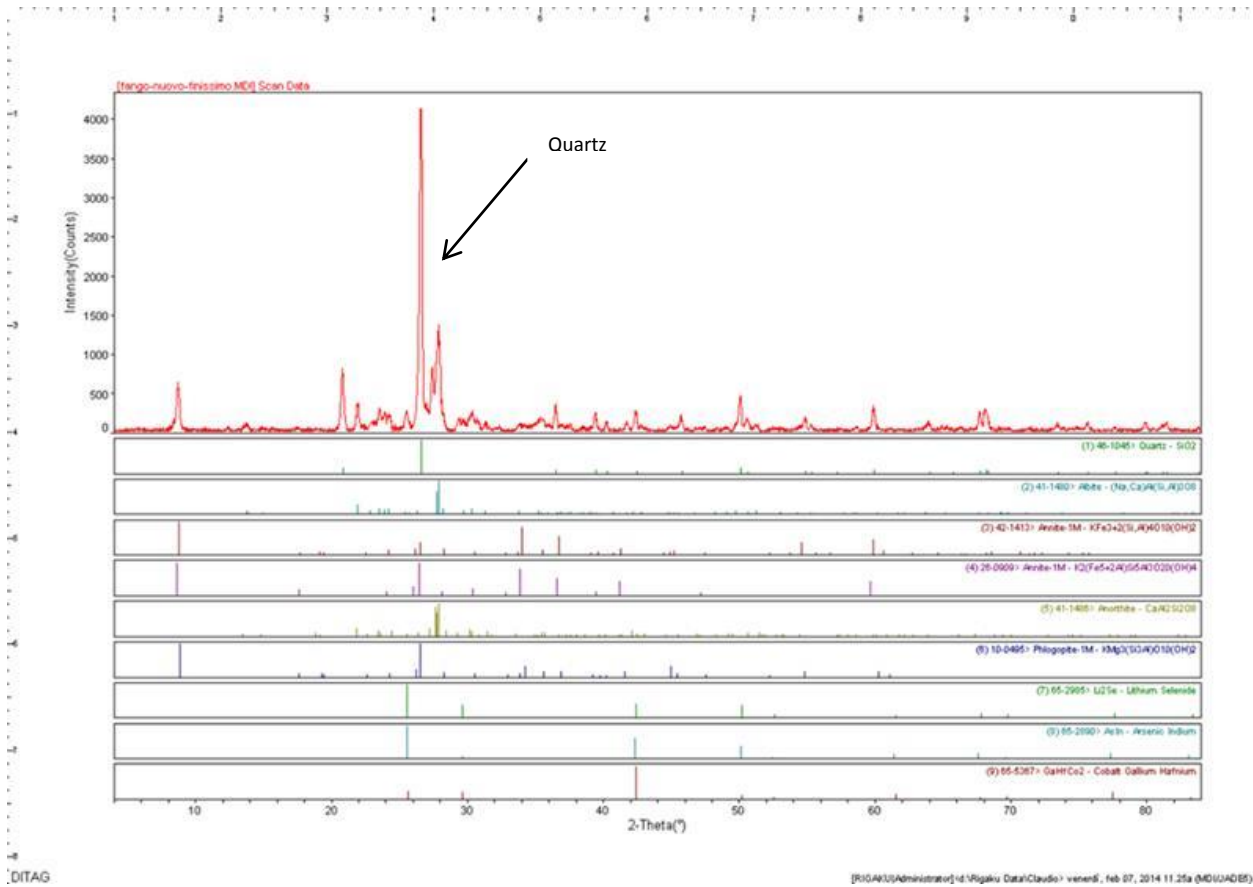
Figure 9: X- Ray Diffraction of muds <0,038 mm
