The Dynamic Behavior of the Basilica of San Francesco in Assisi Using Simplified Analytical Models

The Dynamic Behavior of the Basilica of San Francesco in Assisi Using Simplified Analytical Models / Arcidiacono, V.; Cimellaro, GIAN PAOLO; Piermarini, E.; Ochsendorf, J.. - In: INTERNATIONAL JOURNAL OF ARCHITECTURAL HERITAGE. - ISSN 1558-3058. - ELETTRONICO. - 10:7(2016), pp. 938-953. [10.1080/15583058.2016.1158333]

V. Arcidiacono, G.P. Cimellaro, E. Piermarini & J. Ochsendorf

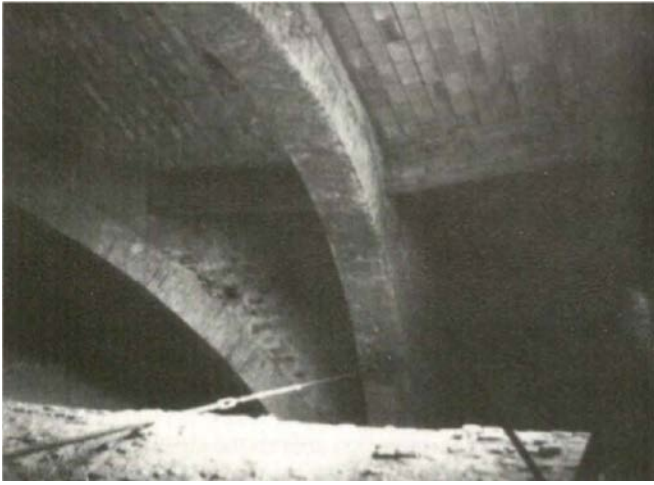
Figure 7- Tie installed during the 1958 (Rocchi, 2002).

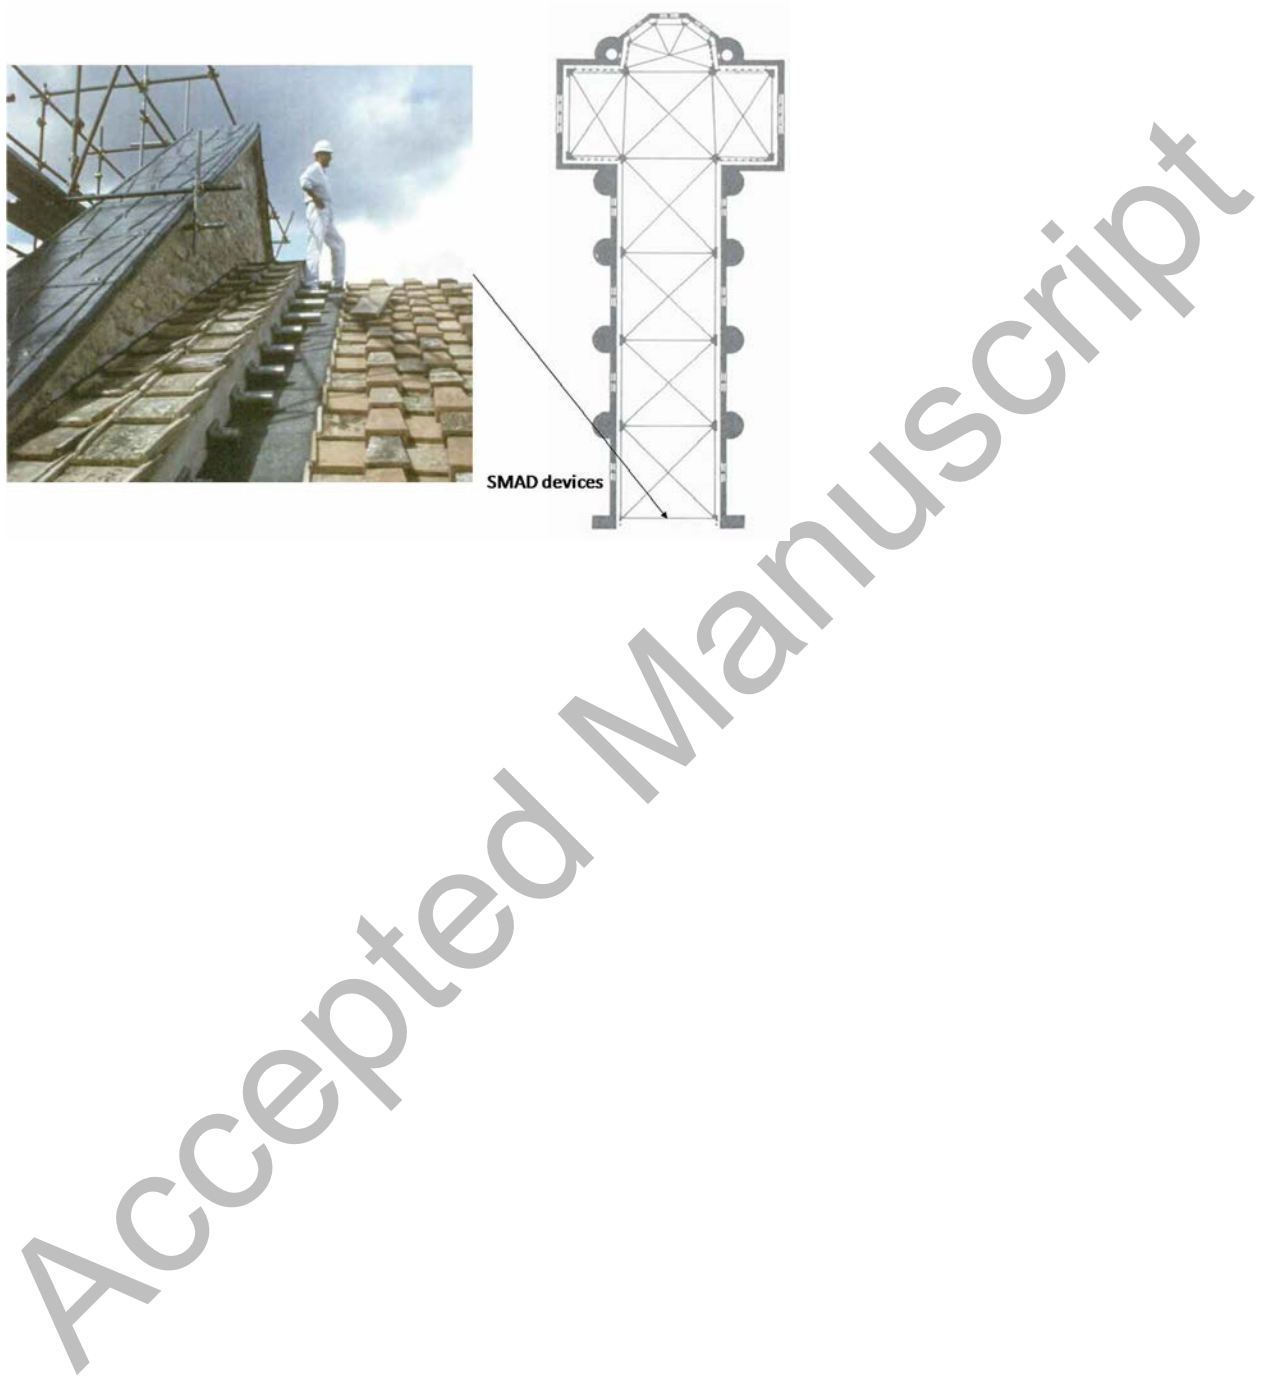
Figure 9- Installation of SMADs at the Tympanum-roof interface (Croci et al., 2007).

from a rigid connection by inserting shape memory alloy devices (SMAD) to reduce the out of plane seismic loadings on the tympanum (Figure 9). The Gothic vaults were strengthened putting aramid fibers to the extrados of the ribs of the vaults using an epoxy. These ribs were then connected to the reinforced concrete roof purlins via a system of tie rods, springs, and steel beams as shown in Figure 10. These were connected to steel beams installed between diagonal arches. Finally, the vaults themselves, which had been severely cracked during the earthquake, were strengthened using a special type of mortar. The masonry walls were strengthened with a steel truss that runs around the perimeter of the nave and transept (Figure 11) at about 7 m above the floor, i.e. where the flying arch buttresses intersect the cylindrical buttresses.

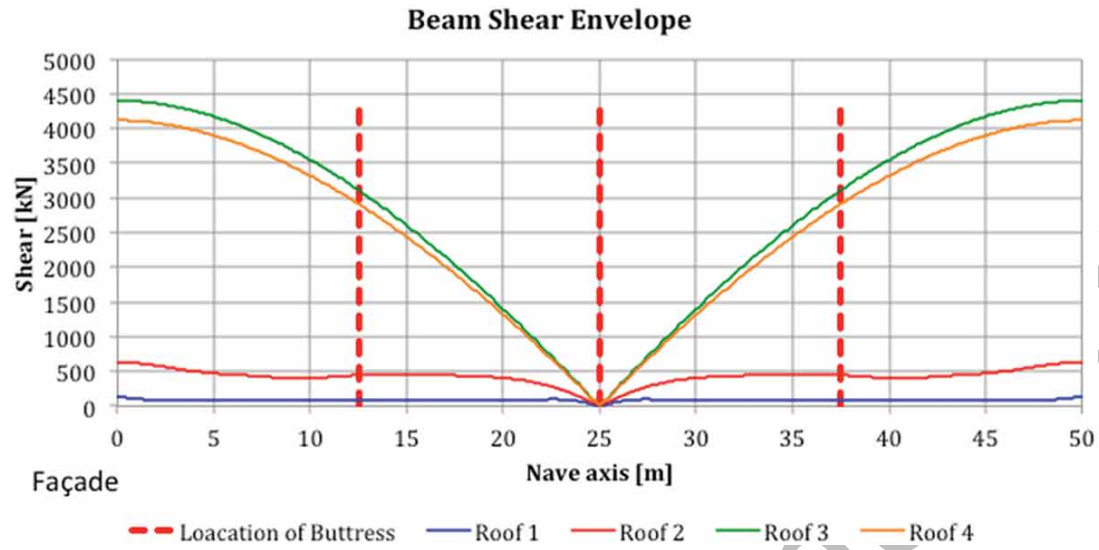
Figure 17- Results of the response spectrum analyses: shear acting on the beam.

The 1997 Umbria Marche 2nd shock seismic record related to the R.A.N. (Rete Accelerometrica Nazionale) station “ASS” has been used in the response spectrum analyses. Horizontal response spectra in the North-South and East-West directions and the worst-case combination, which considers the inclination (36°) of the Basilica with respect to the North-South direction, are shown in Figure 14. Response spectrum analyses were performed using the first 19 modes and applying the worst-case response spectrum. The analyses (Figure 15) predict that the maximum absolute displacement of the nave is at the middle point of the beam. This is 0.4 and 0.6 lower, respectively with *roof 3* and *roof 4*, with respect to that predicted with *roof 1* or *roof 2*. The shear envelope of the beam and the horizontal seismic loads applied on the nave section defined in Equation 7 are shown in Figure 16 and Figure 17. The analyses indicate that the maximum nave load is located at the middle point of the beam, while the maximum shear is located at the rigid supports (i.e., transept and façade). In Table 4 are listed the normalized results of the worst-case response spectrum analyses. The increase in the element stiffness and the participant mass explains the massive increase of 35 and 25 times, respectively, in the maximum beam shear and in the ratio between the maximum shear and the maximum nave load from *roof 1* to *roof 3*. The spectral acceleration of the analytical model with roof 4 model is lower with respect to that with

roof 3 model. This justifies the reduction of the maximum shear from roof 3 to roof 4. The response spectrum analysis gives an approximation of the initial load distribution, but it does not provide any information about the dynamic nonlinearities.
