The Dynamic Behavior of the Basilica of San Francesco in Assisi Using Simplified Analytical Models

V. Arcidiacono, G.P. Cimellaro, E. Piermarini & J. Ochsendorf

KEYWORDS: Basilica of San Francesco in Assisi, Historic Masonry Structures, Monumental Structures, Seismic Vulnerability, Seismic Retrofitting

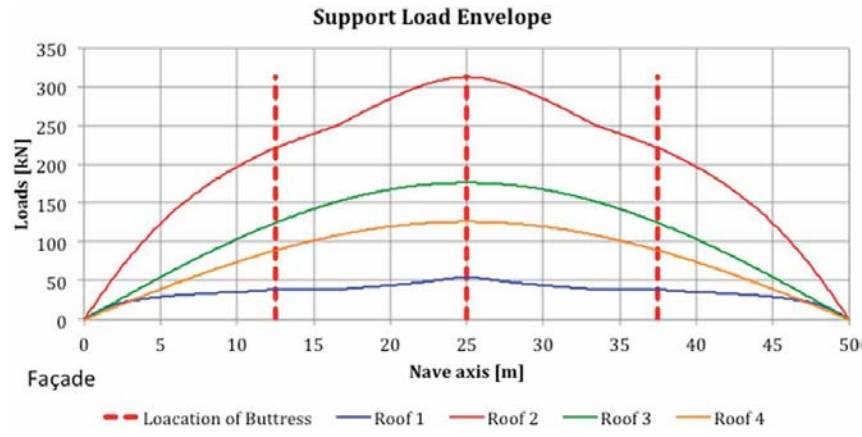
Figure 16- Results of the response spectrum analyses: load acting on the supports.
