Stabilization of earthen plasters: Exchange of knowledge and experiences between Italy and Morocco

M. Mattone^{1,3}, M. Ibnoussina², S. Rescic³, F. Fratini³, D. Magrini³, A. M. Mecchi³,
M. Nocairi²

Abstract

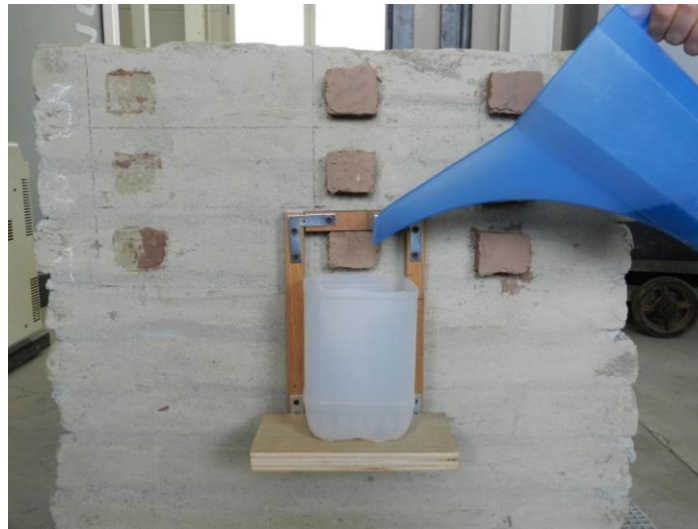
In order to evaluate the bond of the plasters to the wall, shear tests were conducted according to what suggested in recent researches (Hamard et al., 2013). Three specimens (size 40x50x20 mm) of each kind of plaster were prepared. The shear test measures the load necessary to make the specimen fail. Each specimen was loaded with little lead balls until fail, using a special device (Figure 2). The load at which the sample fails was recorded. It was possible to evaluate the average shear stress (τ , N/mm²) of each plaster considering the failure load (m_f , Kg) and the surface (S , mm²) of the samples since $\tau = m_f \times g / S$, where $g = 9.81 \text{ m/s}^2$.

Figure 2: The shear test device (Manuela Mattone).

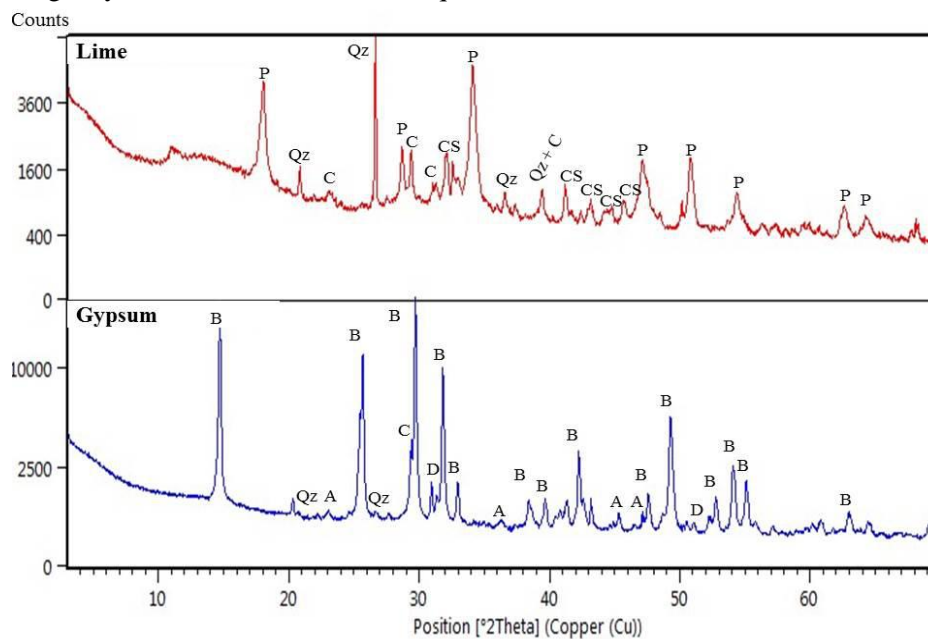
The composition of the Moroccan starting materials carried out by XRD analysis is described in Table 3 and Figure 3.

Figure 3: XRD spectra of Moroccan lime and gypsum. Calcium silicate (larnite) is a typical compound of hydraulic lime (P=portlandite; CS=calcium silicate; B= bassanite; A= anhydrite; Q=quartz, C=calcite, D=dolomite).

The mineralogical investigation made it possible to verify that the gypsum can be ascribed to a “soluble anidrite” while the lime is a natural hydraulic lime due to the presence of β -calcium silicate (larnite). After 28 days of curing, as new mineralogical phases, we have evidenced the presence of calcite in earthen plaster stabilized with lime and presence of calcite in earthen plaster stabilized with gypsum (Fig.4). Hydraulic phases due to hydration of larnite (CS) or pozzolanic reaction between calcium hydroxide (portlandite) with clay minerals have not been identified (may be due to amorphous state or low crystallinity).

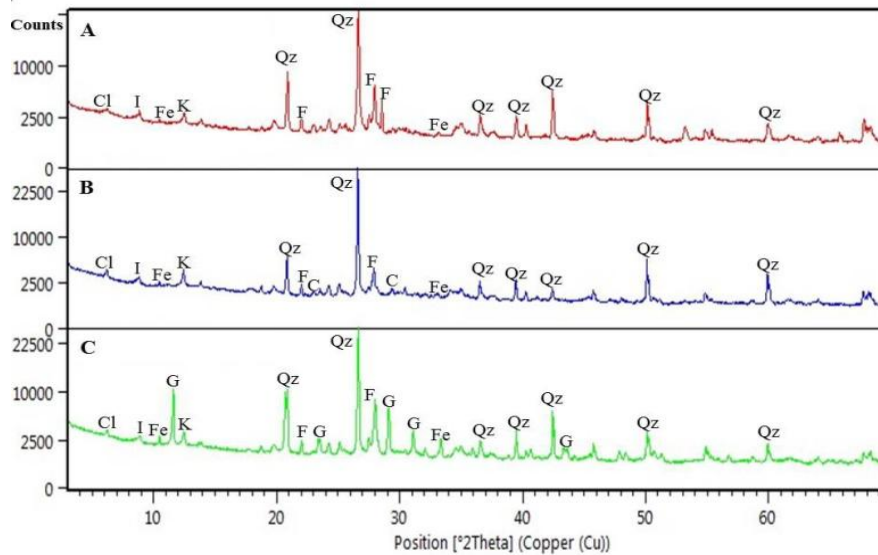
Figure 4: Comparison among XRD spectra of earthen plaster made with only earth (A) earth + lime (B) and earth + gypsum (C). Qz=quartz, F=feldspars, C=calcite, D=dolomite, P=portlandite, I=illite, K=kaolinite, Cl=chlorite; G= gypsum, Fe= iron oxides.

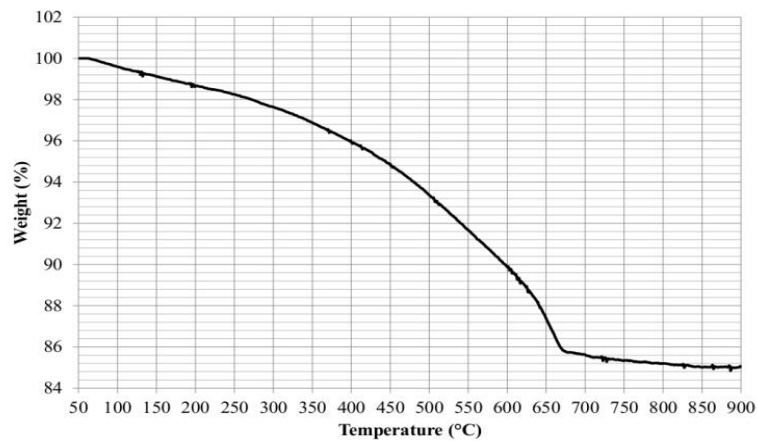
The result of the thermal analysis carried out on the sample of earth - lime plaster (B) is shown in Figure 6.

Figure 6: Thermogravimetric curve of sample of earth with lime (plaster B).

The thermogravimetric curve (Figure 6) indicates that the dehydration of the earth + lime sample occurs in more stages: $60\text{--}110^\circ\text{C}$ loss of absorbed water; $130\text{--}190^\circ\text{C}$ loss of water from calcium silicate hydrates (CSH) (Eskander et al, 2012); $250\text{--}450^\circ\text{C}$ loss of water from different stages of dehydration of C-S-H and calcium aluminate hydrates, and loss of water from dehydration of interlayer water of clay minerals (Eskander et al, 2012; ěě et al, 2013; Plante et al., 2009); $450\text{--}600^\circ\text{C}$ expulsion of OH-ion from the clay mineral lattice (dehydroxylation) (Plante et al., 2009); $600\text{--}680^\circ\text{C}$ dehydroxylation of clay mineral and initial stage of decomposition of carbonates ion associated with calcite (Eskander et al, 2012); $680\text{--}900^\circ\text{C}$ decomposition of carbonate ions of calcite (Eskander et al, 2012). It should be noted that this analysis is the only one that allows to evidence the presence, as expected, of products of larnite's hydration.

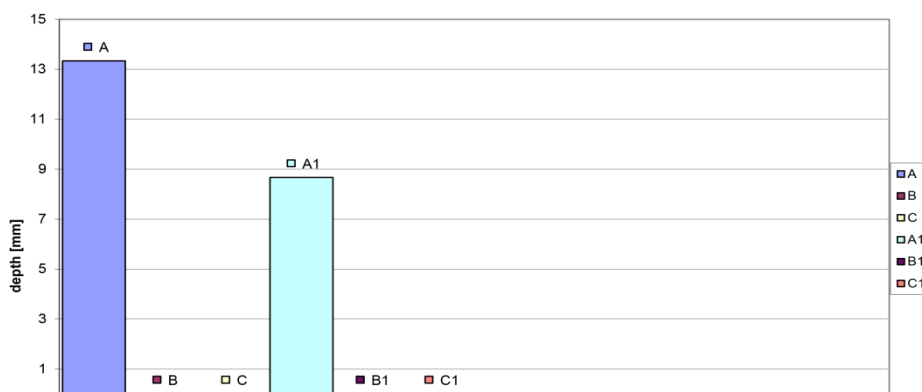
The Geelong test shows that, except for the earthen plasters (A and A1) which failed, all the other tested samples were not eroded at all (Figure 7). Concerning the Spray test as well (Figure 8) higher erosion resistance is evidenced for the stabilized earths. In particular, the erosion is none for the plasters stabilized with lime (B and B1).

Figure 7: Diagram showing Geelong test results (in ordinates is the depth of erosion)

The performance tests carried out in laboratory show that, with regard to water resistance (determined with the Geelong test and spray test), the addition of lime gives the best results. To be noted however that the plaster with no additives has not withstood the test.

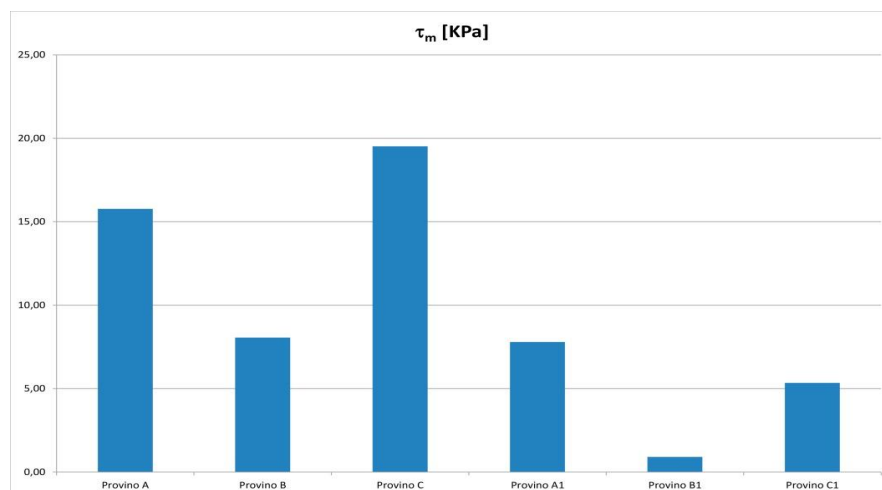
The shear test point out that all the plasters made with straw (A1, B1, C1) are characterized by a lower shear strength compared to the others (Figure 10). The higher shear strength was obtained for the plaster stabilized with gypsum (C). However the results are quite scattered, which could be due both to heterogeneities of the wall and to the dimensions of the samples that makes it difficult to guarantee a good application of the coating. Therefore, the shear strength should be evaluated preparing more samples and increasing their size.

Figure 10: Shear test to evaluate the bond of the plasters to the wall (τ_m [KPa]).
