Stabilization of earthen plasters: Exchange of knowledge and experiences between Italy and Morocco

M. Mattone^{1,3}, M. Ibnoussina², S. Rescic³, F. Fratini³, D. Magrini³, A. M. Mecchi³,
M. Nocairi²

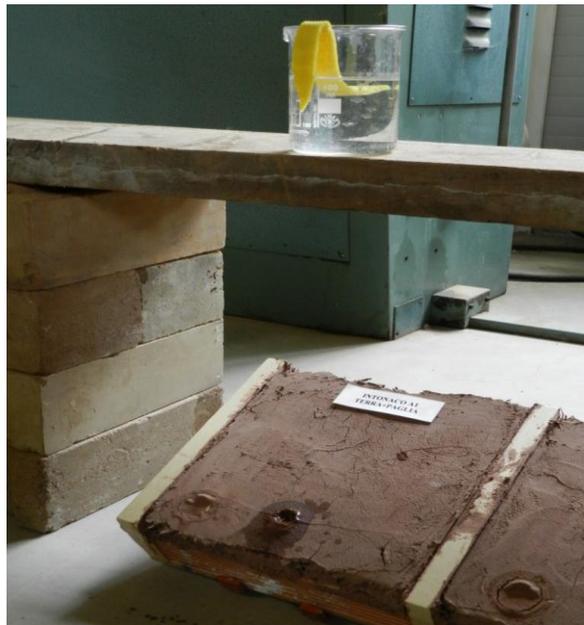
The Geelong test is based on the measurement of the samples' erosion caused by the repeated impact of a water drop (from an height of 400 mm and for a total of 100 ml) on the tested surface which is placed at an angle of nearly 30° to the horizontal (Figure 1). The evaluation is done by measuring the cavity depth due to the impact of the water drop on the surface.

Figure 1: The Geelong test (Manuela Mattone).

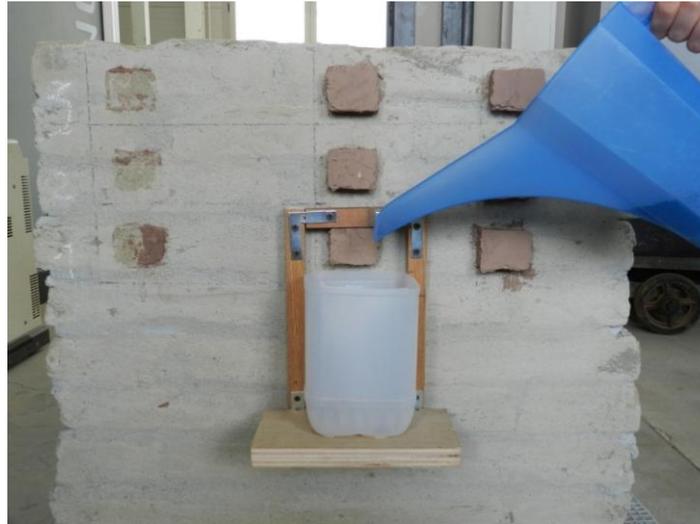
In order to evaluate the bond of the plasters to the wall, shear tests were conducted according to what suggested in recent researches (Hamard et al., 2013). Three specimens (size 40x50x20 mm) of each kind of plaster were prepared. The shear test measures the load necessary to make the specimen fail. Each specimen was loaded with little lead balls until fail, using a special device (Figure 2). The load at which the sample fails was recorded. It was possible to evaluate the average shear stress (τ , N/mm²) of each plaster considering the failure load (m_f , Kg) and the surface (S , mm²) of the samples since $\tau = m_f \times g / S$, where $g = 9.81 \text{ m/s}^2$.

Figure 2: The shear test device (Manuela Mattone).

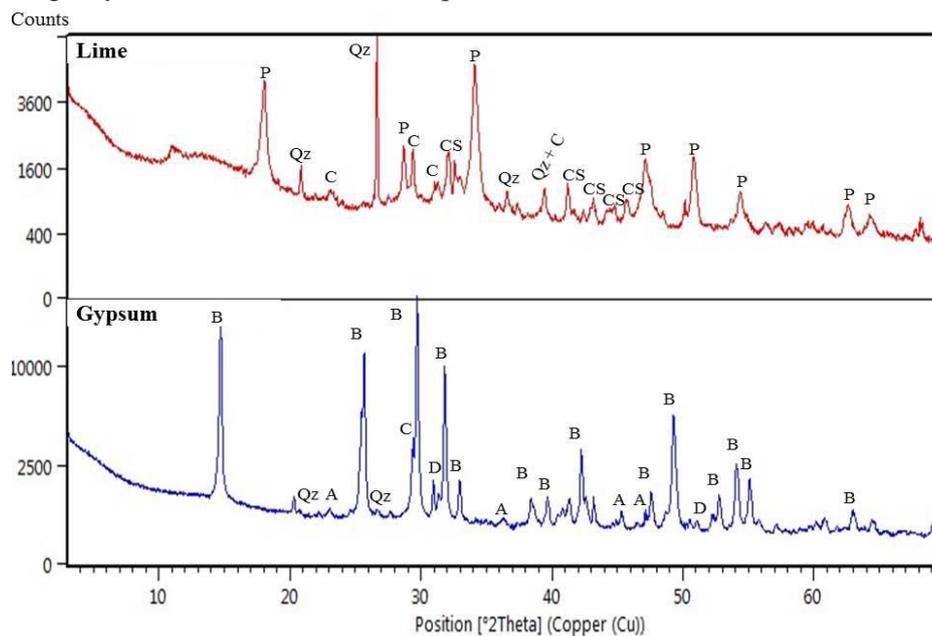
Figure 3: XRD spectra of Moroccan lime and gypsum. Calcium silicate (larnite) is a typical compound of hydraulic lime (P=portlandite; CS=calcium silicate; B= bassanite; A= anhydrite; Q=quartz, C=calcite, D=dolomite).

The composition of the Moroccan starting materials carried out by XRD analysis is described in Table 3 and Figure 3.

The mineralogical investigation made it possible to verify that the gypsum can be ascribed to a “soluble anidrite” while the lime is a natural hydraulic lime due to the presence of β -calcium silicate (larnite). After 28 days of curing, as new mineralogical phases, we have evidenced the presence of calcite in earthen plaster stabilized with lime and presence of calcite in earthen plaster stabilized with gypsum (Fig.4). Hydraulic phases due to hydration of larnite (CS) or pozzolanic reaction between calcium hydroxide (portlandite) with clay minerals have not been identified (may be due to amorphous state or low crystallinity).

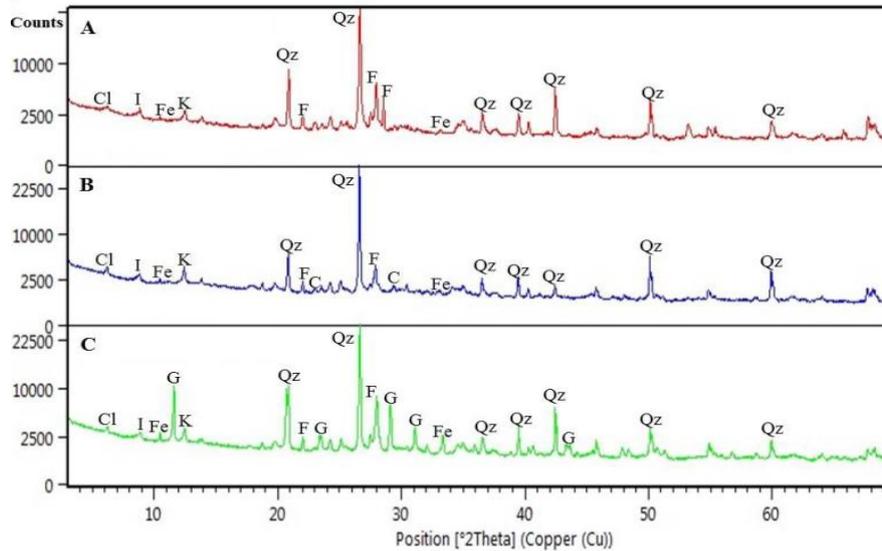
Figure 4: Comparison among XRD spectra of earthen plaster made with only earth (A) earth + lime (B) and earth + gypsum (C). Qz=quartz, F=feldspars, C=calcite, D=dolomite, P=portlandite, I=illite, K=kaolinite, Cl=chlorite; G= gypsum, Fe= iron oxides.

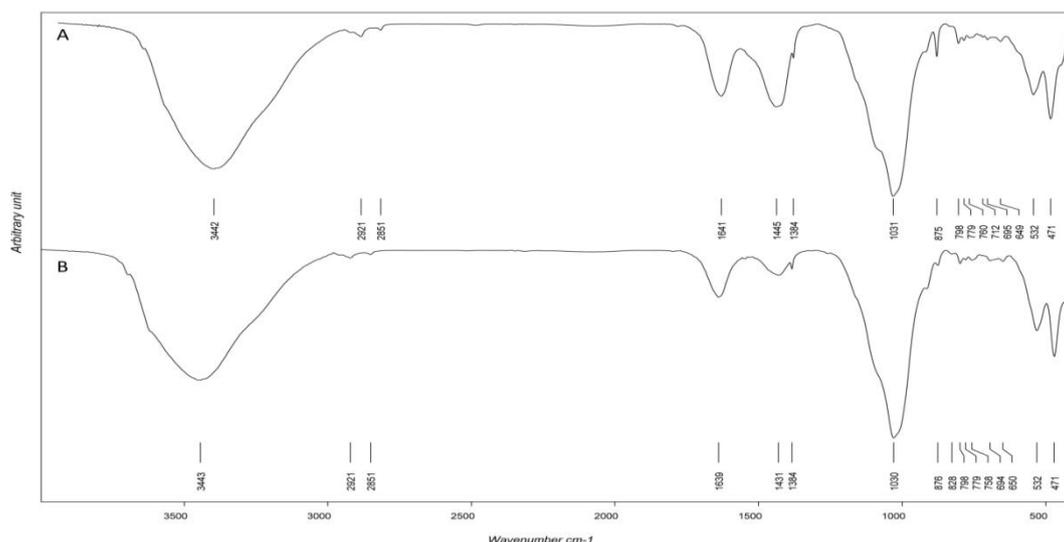
In Figure 5 the results of mid -IR investigation carried out on earth - lime samples (graph A) compared to those obtained from the earth ones (graph B), are shown.

Figure 5: Mid -IR spectra: comparison between sample of earth with lime (graph A) and sample of only earth (graph B).

The spectra are very similar and IR bands are comparable. In particular, in both spectra, the following peaks are present: symmetric and asymmetric stretching of Si-O ($800-1000\text{cm}^{-1}$, silicates) and, specifically, a high peak at 1030cm^{-1} attributable to stretching of Si-Al-O (aluminosilicates); deformation of SiO_4 tetrahedron ($400-500\text{cm}^{-1}$, silicates) (Hanke, 1986); asymmetric stretching of CO_3^{2-} ($1400-1500\text{cm}^{-1}$, carbonates) and a shoulder

of bending out-of-plane of CO_3^{2-} ion (875cm^{-1} , carbonates) (Hunt 1971); bending H-O-H of molecular H_2O (1640cm^{-1}) and $-\text{OH}$ stretching vibration of H_2O ($2800\text{--}3700\text{cm}^{-1}$) (Williams, 1966). It should be noted that, the main vibrations characteristics of C-S-H compounds (peak at $\sim 970\text{cm}^{-1}$ and two shoulders at $\sim 1060\text{cm}^{-1}$ and 900cm^{-1}), related to Si-O stretching vibrations of the Q2 tetrahedra (Trezza, 2007, Yu, 1999), are not visible (probably they are hidden by the broad band of silicates at $800\text{--}1000\text{cm}^{-1}$).

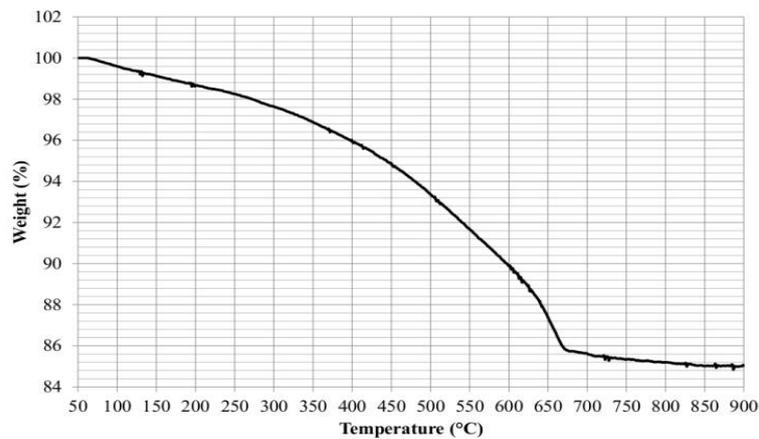
The result of the thermal analysis carried out on the sample of earth - lime plaster (B) is shown in Figure 6.

Figure 6: Thermogravimetric curve of sample of earth with lime (plaster B).

The thermogravimetric curve (Figure 6) indicates that the dehydration of the earth + lime sample occurs in more stages: $60\text{--}110^\circ\text{C}$ loss of absorbed water; $130\text{--}190^\circ\text{C}$ loss of water from calcium silicate hydrates (CSH) (Eskander et al, 2012); $250\text{--}450^\circ\text{C}$ loss of water from different stages of dehydration of C-S-H and calcium aluminate hydrates, and loss of water from dehydration of interlayer water of clay minerals (Eskander et al, 2012; ěč et al, 2013; Plante et al., 2009); $450\text{--}600^\circ\text{C}$ expulsion of OH-ion from the clay mineral lattice (dehydroxylation) (Plante et al., 2009); $600\text{--}680^\circ\text{C}$ dehydroxylation of clay mineral and initial stage of decomposition of carbonates ion associated with calcite (Eskander et al, 2012); $680\text{--}900^\circ\text{C}$ decomposition of carbonate ions of calcite (Eskander et al, 2012). It should be noted that this analysis is the only one that allows to evidence the presence, as expected, of products of larnite's hydration.

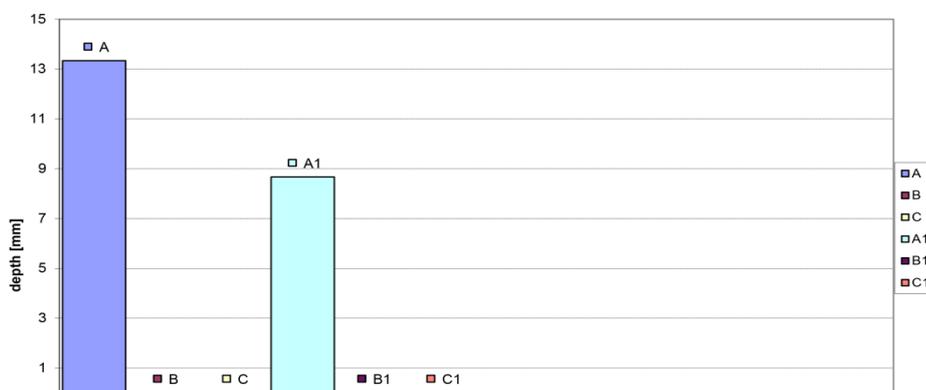
The Geelong test shows that, except for the earthen plasters (A and A1) which failed, all the other tested samples were not eroded at all (Figure 7). Concerning the Spray test as well (Figure 8) higher erosion resistance is evidenced for the stabilized earths. In particular, the erosion is none for the plasters stabilized with lime (B and B1).

Figure 7: Diagram showing Geelong test results (in ordinates is the depth of erosion)

The performance tests carried out in laboratory show that, with regard to water resistance (determined with the Geelong test and spray test), the addition of lime gives the best results. To be noted however that the plaster with no additives has not withstood the test.

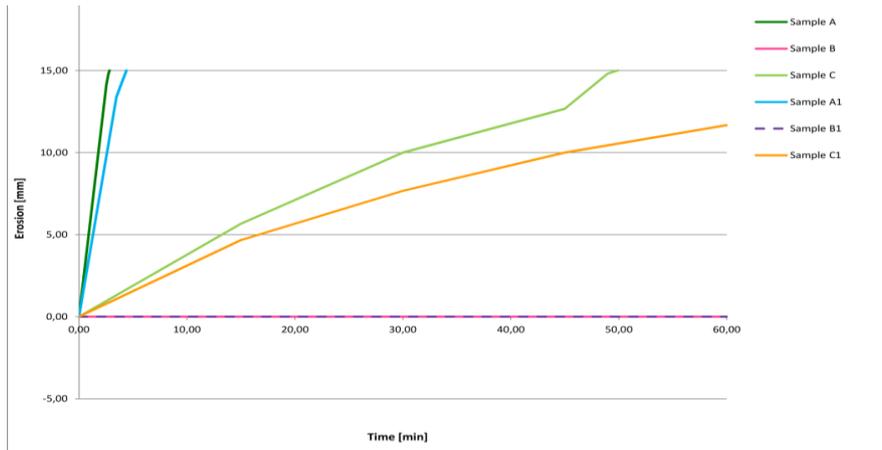
Figure 8: Diagram showing the erosion spray test results

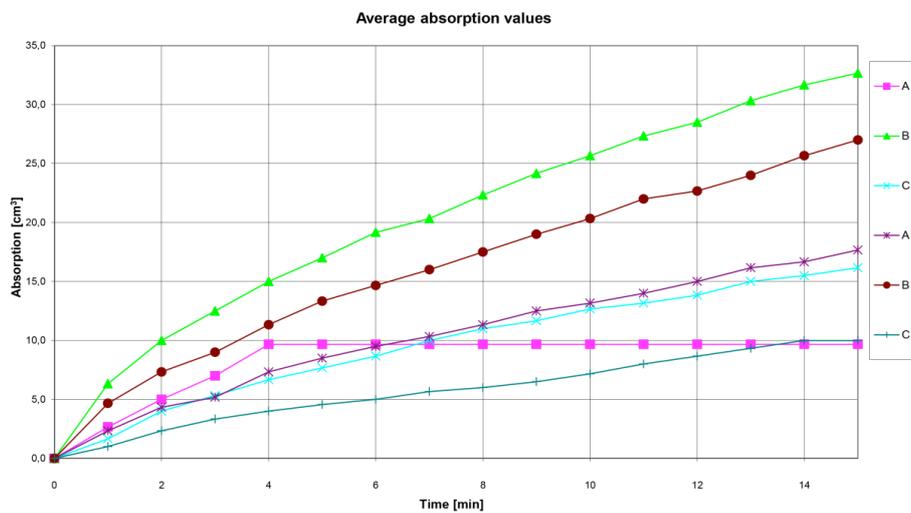
The water absorption test shows that, while gypsum (C and C1) reduces the rate of water absorption, the lime (B and B1) determines an increase of absorption with respect to the earth plaster (A) and the earth + straw (A1) (Figure 9).

Figure 9: Diagram showing the water absorption test results.

With regard to the capillary absorption capacity, the values obtained show that gypsum has reduced it while the addition of lime has made the plaster more absorbent. With regard to shear tests, the presence of straw generally worsens the behaviour, while for gypsum and lime, the best performance has been obtained by the first one. Regarding the permeability to water vapour, it keeps almost unchanged in all the plasters.

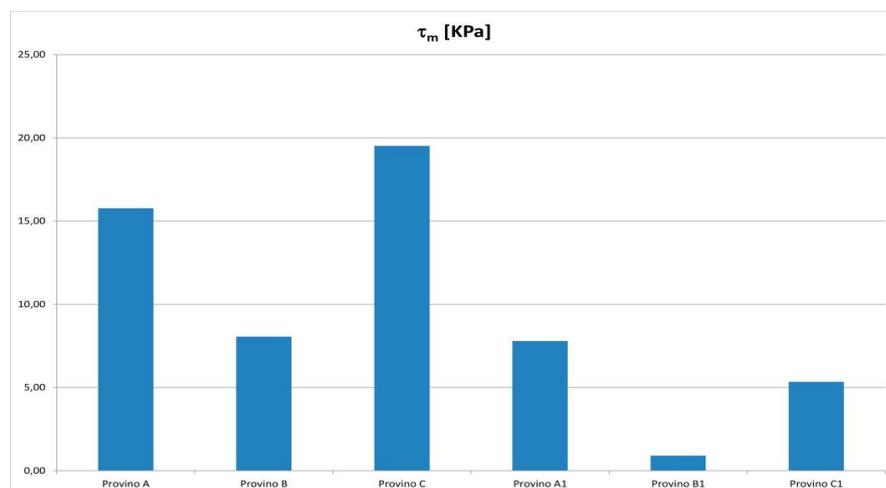
The shear test point out that all the plasters made with straw (A1, B1, C1) are characterized by a lower shear strength compared to the others (Figure 10). The higher shear strength was obtained for the plaster stabilized with gypsum (C). However the results are quite scattered, which could be due both to heterogeneities of the wall and to the dimensions of the samples that makes it difficult to guarantee a good application of the coating. Therefore, the shear strength should be evaluated preparing more samples and increasing their size.

Figure 10: Shear test to evaluate the bond of the plasters to the wall (τ_m [KPa]).
