Stabilization of earthen plasters: Exchange of knowledge and experiences between Italy and Morocco

Keywords: Earthen plasters, Stabilization, Traditional products, Lime, Gypsum

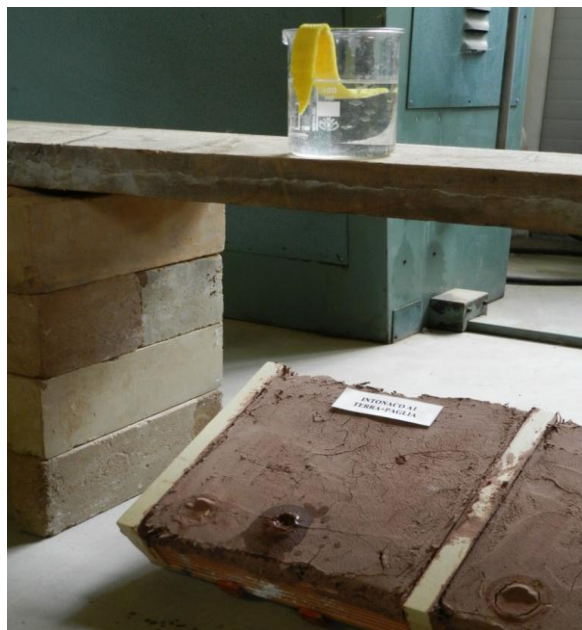
The Geelong test is based on the measurement of the samples' erosion caused by the repeated impact of a water drop (from an height of 400 mm and for a total of 100 ml) on the tested surface which is placed at an angle of nearly 30° to the horizontal (Figure 1). The evaluation is done by measuring the cavity depth due to the impact of the water drop on the surface.

Figure 1: The Geelong test (Manuela Mattone).

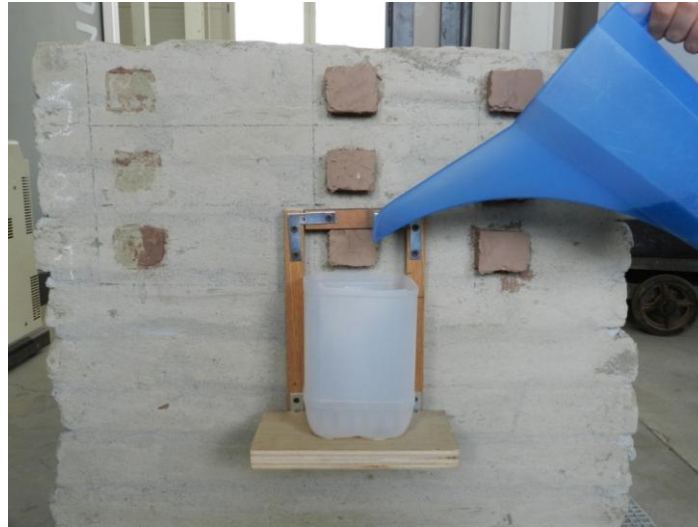
In order to evaluate the bond of the plasters to the wall, shear tests were conducted according to what suggested in recent researches (Hamard et al., 2013). Three specimens (size 40x50x20 mm) of each kind of plaster were prepared. The shear test measures the load necessary to make the specimen fail. Each specimen was loaded with little lead balls until fail, using a special device (Figure 2). The load at which the sample fails was recorded. It was possible to evaluate the average shear stress (τ , N/mm²) of each plaster considering the failure load (m_f , Kg) and the surface (S , mm²) of the samples since $\tau = m_f \times g / S$, where $g = 9.81 \text{ m/s}^2$.

Figure 2: The shear test device (Manuela Mattone).
