Stabilization of earthen plasters: Exchange of knowledge and experiences between Italy and Morocco

## Stabilization of earthen plasters: Exchange of knowledge and experiences between Italy and Morocco

### Abstract

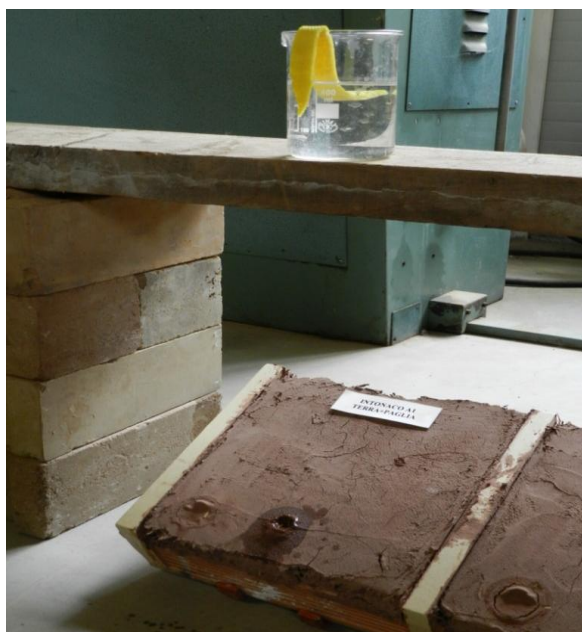
The Geelong test is based on the measurement of the samples' erosion caused by the repeated impact of a water drop (from an height of 400 mm and for a total of 100 ml) on the tested surface which is placed at an angle of nearly 30° to the horizontal (Figure 1). The evaluation is done by measuring the cavity depth due to the impact of the water drop on the surface.

**Figure 1:** The Geelong test (Manuela Mattone).

The erosion tests were conducted, according to New Zealand Standards NZS 4298, in two different ways: Geelong test (NZS 4298E, 1998) and spray test (NZS 4298D, 1998).

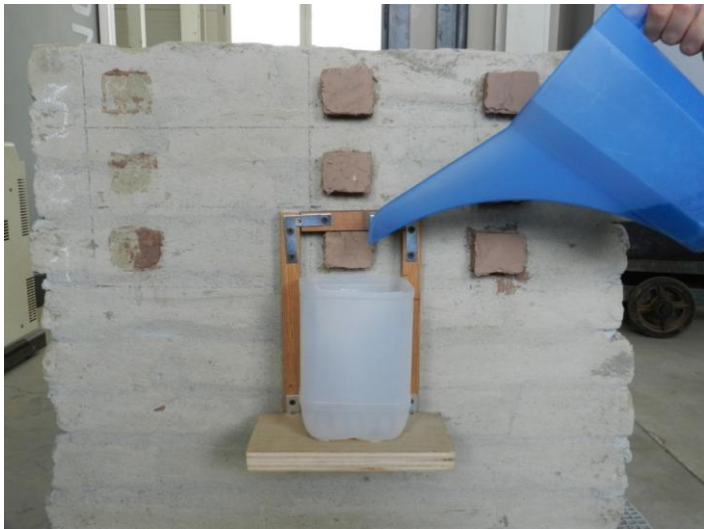
Figure 2: The shear test device (Manuela Mattone).

In order to evaluate the bond of the plasters to the wall, shear tests were conducted according to what suggested in recent researches (Hamard et al., 2013). Three specimens (size 40x50x20 mm) of each kind of plaster were prepared. The shear test measures the load necessary to make the specimen fail. Each specimen was loaded with little lead balls until fail, using a special device (Figure 2). The load at which the sample fails was recorded. It was possible to evaluate the average shear stress ( $\tau$ , N/mm<sup>2</sup>) of each plaster considering the failure load ( $m_f$ , Kg) and the surface ( $S$ , mm<sup>2</sup>) of the samples since  $\tau = m_f \times g / S$ , where  $g = 9.81 \text{ m/s}^2$ .

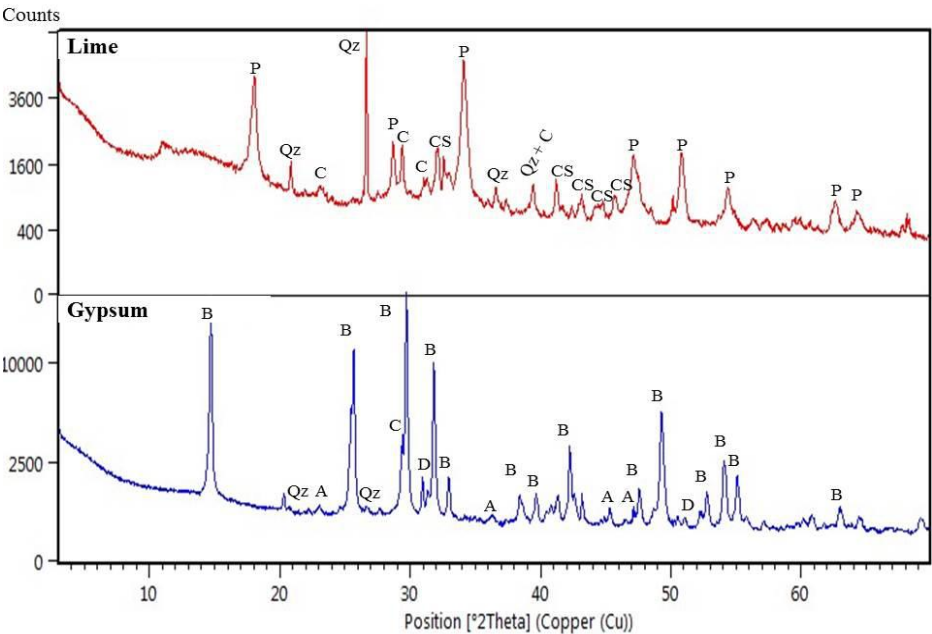
Figure 3: XRD spectra of Moroccan lime and gypsum. Calcium silicate (larnite) is a typical compound of hydraulic lime (P=portlandite; CS=calcium silicate; B= bassanite; A= anhydrite; Q=quartz, C=calcite, D=dolomite).

The composition of the Moroccan starting materials carried out by XRD analysis is described in Table 3 and Figure 3.

The mineralogical investigation made it possible to verify that the gypsum can be ascribed to a “soluble anidrite” while the lime is a natural hydraulic lime due to the presence of  $\beta$ -calcium silicate (larnite). After 28 days of curing, as new mineralogical phases, we have evidenced the presence of calcite in earthen plaster stabilized with lime and presence of gypsum in earthen plaster stabilized with gypsum (Fig.4). Hydraulic phases due to hydration of larnite (CS) or pozzolanic reaction between calcium hydroxide (portlandite) with clay minerals have not been identified (may be due to amorphous state or low crystallinity).

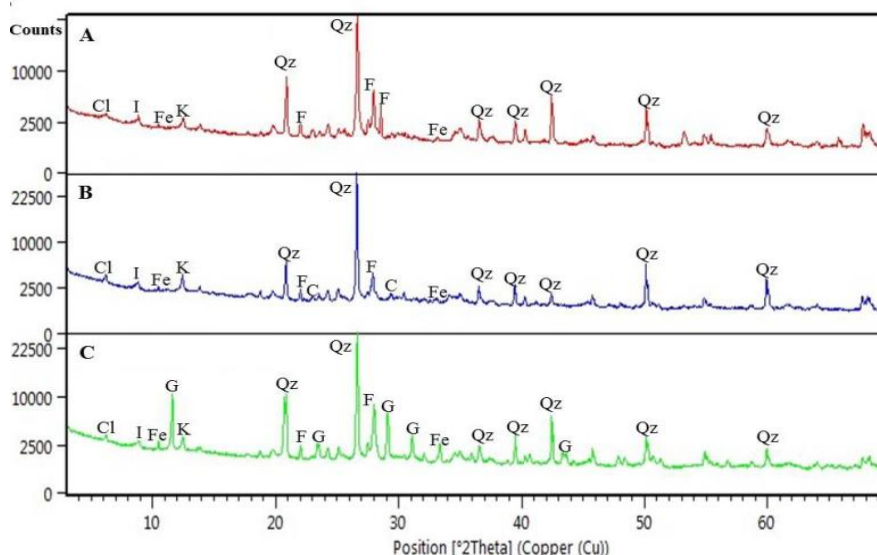
**Figure 4:** Comparison among XRD spectra of earthen plaster made with only earth (A) earth + lime (B) and earth + gypsum (C). Qz=quartz, F=feldspars, C=calcite, D=dolomite, P=portlandite, I=illite, K=kaolinite, Cl=chlorite; G= gypsum, Fe= iron oxides.

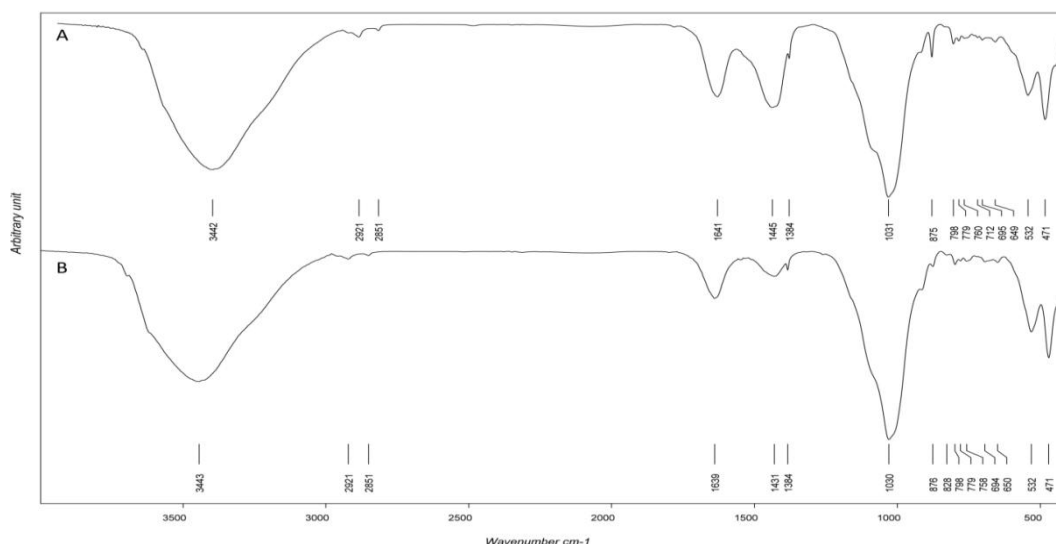
In Figure 5 the results of mid -IR investigation carried out on earth - lime samples (graph A) compared to those obtained from the earth ones (graph B), are shown.

**Figure 5:** Mid -IR spectra: comparison between sample of earth with lime (graph A) and sample of only earth (graph B).

The spectra are very similar and IR bands are comparable. In particular, in both spectra, the following peaks are present: symmetric and asymmetric stretching of Si-O ( $800\text{--}1000\text{cm}^{-1}$ , silicates) and, specifically, a high peak at  $1030\text{cm}^{-1}$  attributable to stretching of Si-Al-O (aluminosilicates); deformation of  $\text{SiO}_4$  tetrahedron ( $400\text{--}500\text{cm}^{-1}$ , silicates) (Hanke, 1986); asymmetric stretching of  $\text{CO}_3^{2-}$  ( $1400\text{--}1500\text{cm}^{-1}$ , carbonates) and a shoulder

of bending out-of-plane of  $\text{CO}_3^{2-}$  ion ( $875\text{cm}^{-1}$ , carbonates) (Hunt 1971); bending H-O-H of molecular  $\text{H}_2\text{O}$  ( $1640\text{cm}^{-1}$ ) and -OH stretching vibration of  $\text{H}_2\text{O}$  ( $2800\text{--}3700\text{cm}^{-1}$ ) (Williams, 1966). It should be noted that, the main vibrations characteristics of C-S-H compounds (peak at  $\sim 970\text{cm}^{-1}$  and two shoulders at  $\sim 1060\text{cm}^{-1}$  and  $900\text{cm}^{-1}$ ), related to Si-O stretching vibrations of the Q2 tetrahedra (Trezza, 2007, Yu, 1999), are not visible (probably they are hidden by the broad band of silicates at  $800\text{--}1000\text{cm}^{-1}$ ).

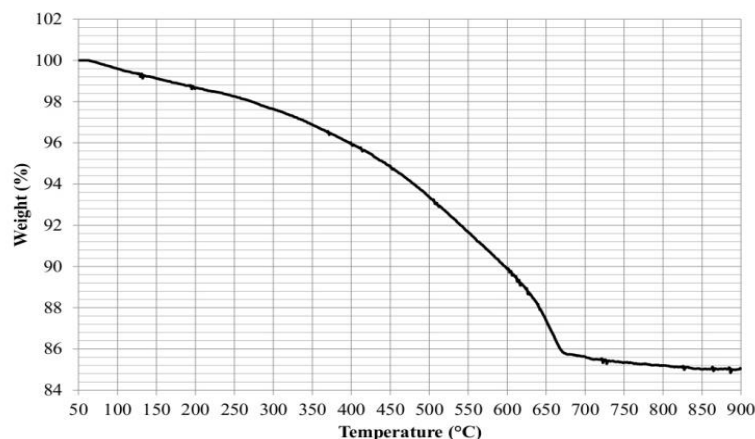
The result of the thermal analysis carried out on the sample of earth - lime plaster (B) is shown in Figure 6.

**Figure 6:** Thermogravimetric curve of sample of earth with lime (plaster B).

The thermogravimetric curve (Figure 6) indicates that the dehydration of the earth + lime sample occurs in more stages:  $60\text{--}110^\circ\text{C}$  loss of absorbed water;  $130\text{--}190^\circ\text{C}$  loss of water from calcium silicate hydrates (CSH) (Eskander et al, 2012);  $250\text{--}450^\circ\text{C}$  loss of water from different stages of dehydration of C-S-H and calcium aluminate hydrates, and loss of water from dehydration of interlayer water of clay minerals (Eskander et al, 2012; Ćć et al, 2013; Plante et al., 2009);  $450\text{--}600^\circ\text{C}$  expulsion of OH-ion from the clay mineral lattice (dehydroxylation) (Plante et al., 2009);  $600\text{--}680^\circ\text{C}$  dehydroxylation of clay mineral and initial stage of decomposition of carbonates ion associated with calcite (Eskander et al, 2012);  $680\text{--}900^\circ\text{C}$  decomposition of carbonate ions of calcite (Eskander et al, 2012). It should be noted that this analysis is the only one that allows to evidence the presence, as expected, of products of larnite's hydration.

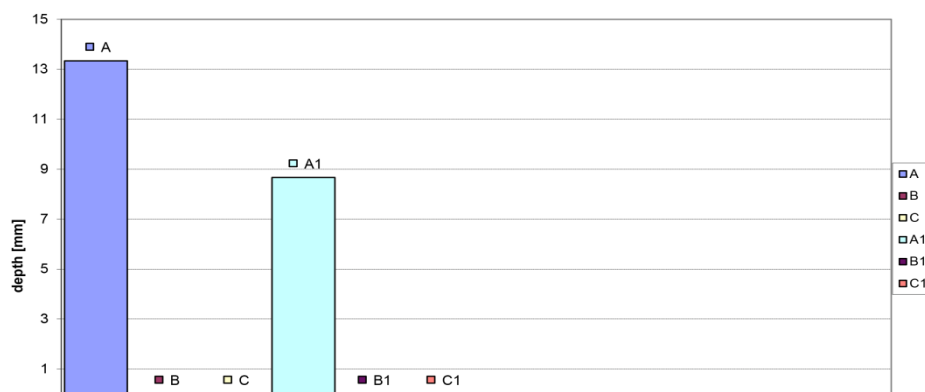
The Geelong test shows that, except for the earthen plasters (A and A1) which failed, all the other tested samples were not eroded at all (Figure 7). Concerning the Spray test as well (Figure 8) higher erosion resistance is evidenced for the stabilized earths. In particular, the erosion is none for the plasters stabilized with lime (B and B1).

**Figure 7:** Diagram showing Geelong test results (in ordinates is the depth of erosion)

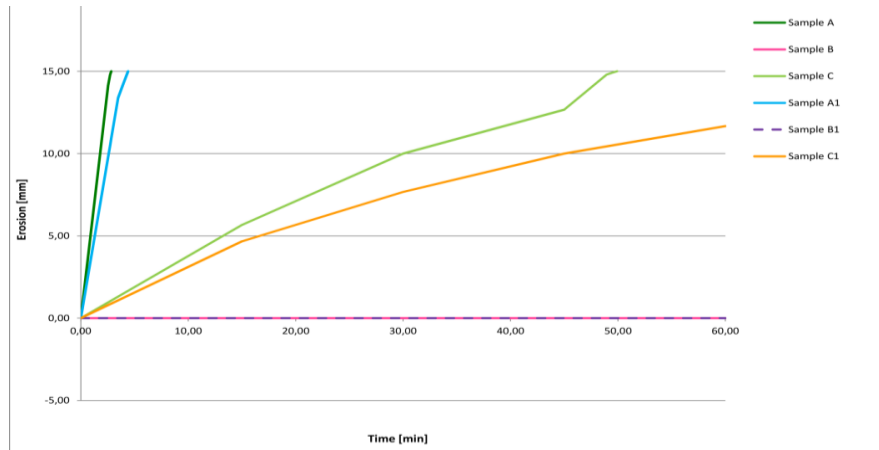
**Figure 8:** Diagram showing the erosion spray test results

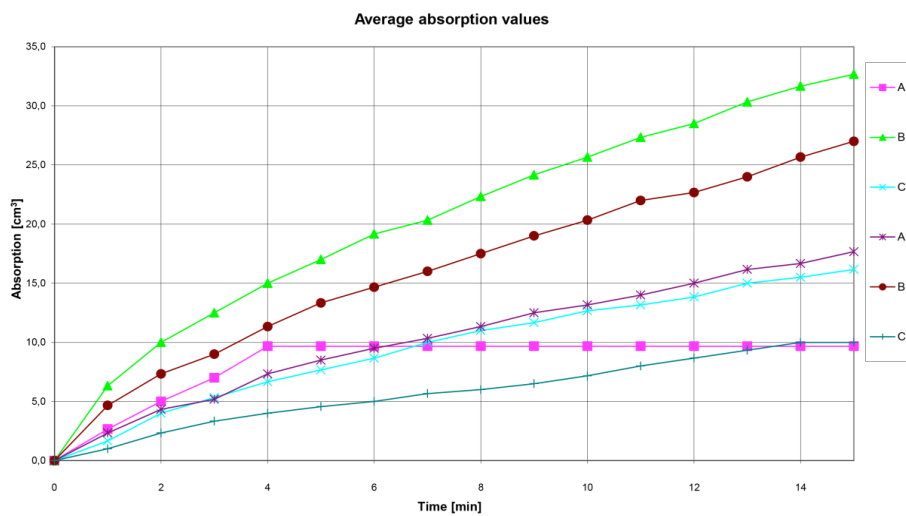
**Figure 9:** Diagram showing the water absorption test results.

The water absorption test shows that, while gypsum (C and C1) reduces the rate of water absorption, the lime (B and B1) determines an increase of absorption with respect to the earth plaster (A) and the earth + straw (A1) (Figure 9).
