## MULTITEMPORAL 3D MODELLING FOR CULTURAL HERITAGE EMERGENCY DURING SEISMIC EVENTS: DAMAGE ASSESMENT OF S. AGOSTINO CHURCH IN AMATRICE (RI)

**KEY WORDS:** UAV photogrammetry, multi-temporal model, structural assessment, seismic emergency, Cultural Heritage

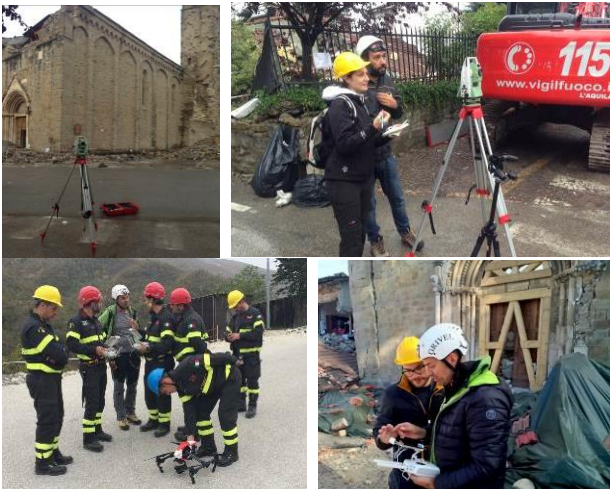
Figure 4. Survey operation in the area of Sant'Agostino; The RPAS group of the Firefighters with the INSPIRE 1; Remote control of the UAV during the image acquisition phase.

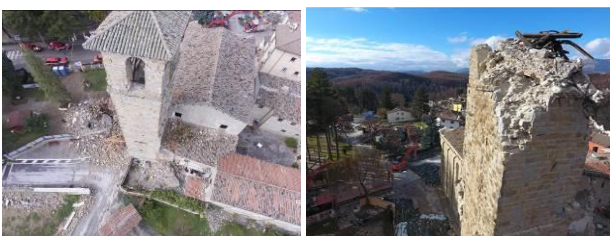
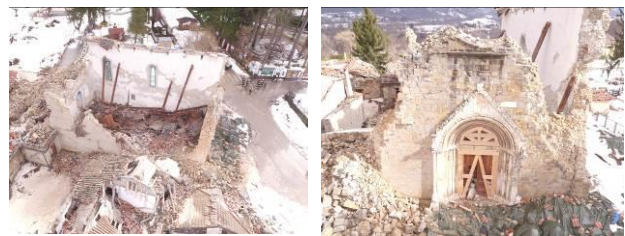
Figure 5. Oblique image of the Sant'Agostino Church; the top of the bell tower and the collapse after the Norcia earthquake; the structure after the January seismic events

As one can clearly deduce from the previous paragraph, the extremely poor balance situation was definitively exceeded after the sequence of three earthquakes occurred at 9:25 (M5.1), 10:14 (M5.5) and 10:25 (M5.4) on the 18<sup>th</sup> of January 2017. This new seismic swarm produced the collapse of the belt tower, the east and south façades and an important increasing of the damages on the main façade. The west part of the church is still preserve although very important damages are clearly recognizable on the structure.

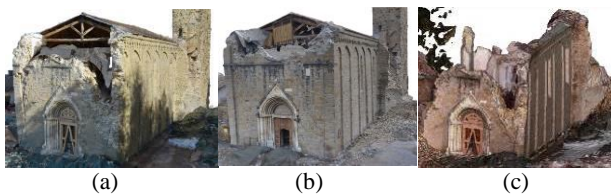
Figure 6. A view of the achieved models: September (a), December (b), January (c)

The achieved accuracy (Table1) allow considering the products suitable for a representation at a scale 1:100. In Figure 6 the achieved 3D models according to the different acquired dataset are reported.

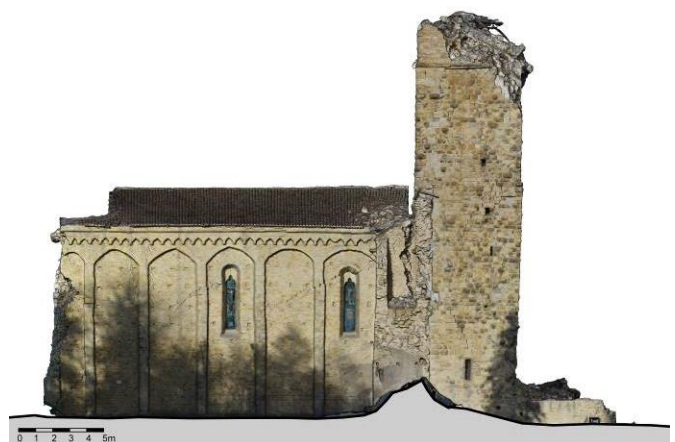
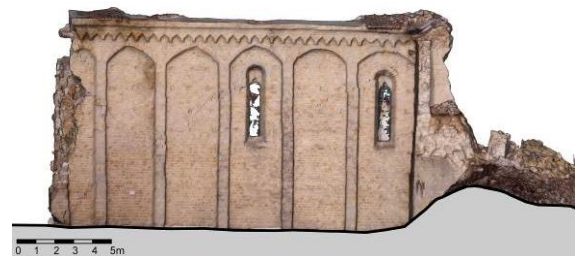
Figure 7. Orthophoto of East wall. Top: September (t1); centre: December (t2); down: January (t3)

As is possible to deduce from the orthophotos of the west façade realized according to the three employed dataset (t1, t2 and t3) showed in the next Figure 7, the influence of the sunlight seriously affect the radiometry of the final output. Despite an image pre-processing that as usual was performed for the acquired images, especially in the DJI sensor is very difficult to correct those effects. Some analysis are ongoing in the research group according to the national and international research on this topic (He et al., 2013; Milanfar, 2013; González-Aguilera et al., 2016) in order to define the better strategy for image pre-processing.

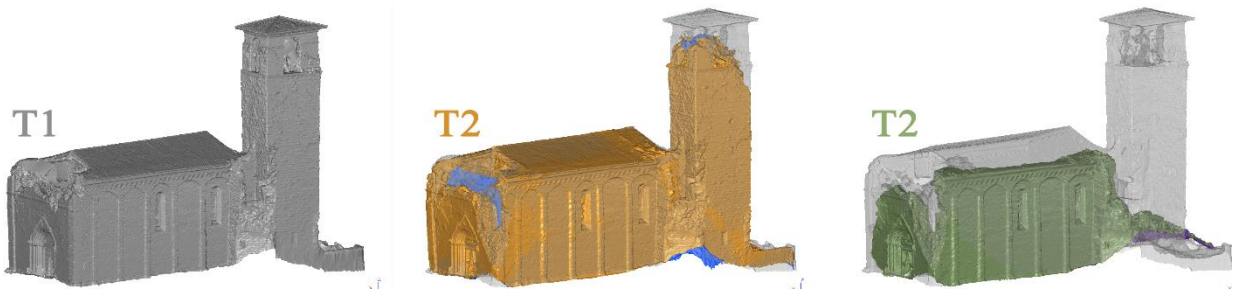
In Figure 8 a volumetric evaluation on collapsed structures; t1 model, alone (left) and compared to t2 and t3. The collapses caused by seismic shock and consequent loss of structural stability have led to significant loss of volume, up to -68,4% in comparison with the time 1, September 2016.

Figure 8. Multi-temporal model compared with t1

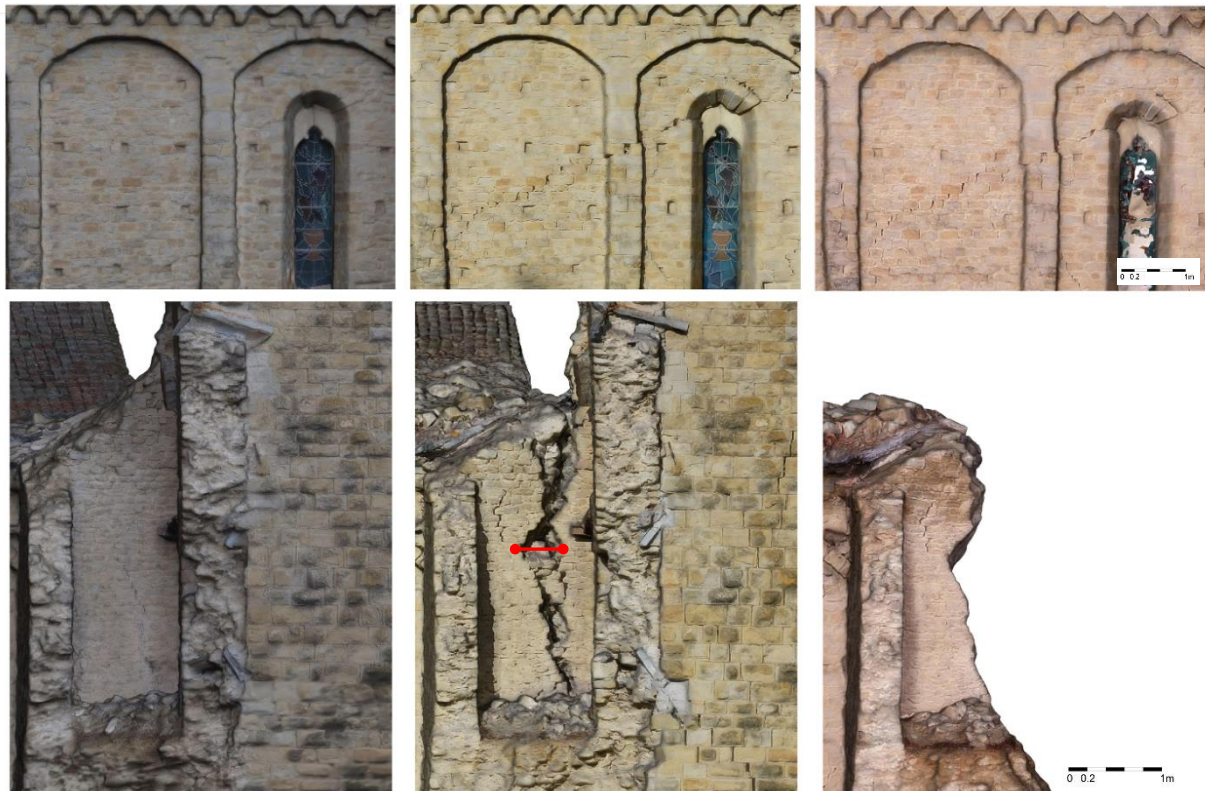
Figure 9. Multi-temporal models and orthoimages excerpts on East wall: (left) t1; (centre) t2; (right) t3

The connection in the South-East corner is maybe one of the most significant enough to be deeply analysed in the global structural behaviour of this ancient masonry. Thanks to the possibility of multi-temporal 3D models comparison (Figure 8) an interesting analysis by orthoimages (Figure 9) and point clouds comparison expressed in range colours classification (Figure 10) can be processed. The orthoimages display great displacements on the masonries connection deformed by shear stress (up to 60cm); here the surface assessment was shown, together with the variation from t1 represented in range scale colours between blue and green. The scale values with the order of magnitude of some centimetres distributed over a mean height of 12m, confirms the serious structural damage that hit the building. Nevertheless, this wall is the only one to be still standing together with a part of the main façade.

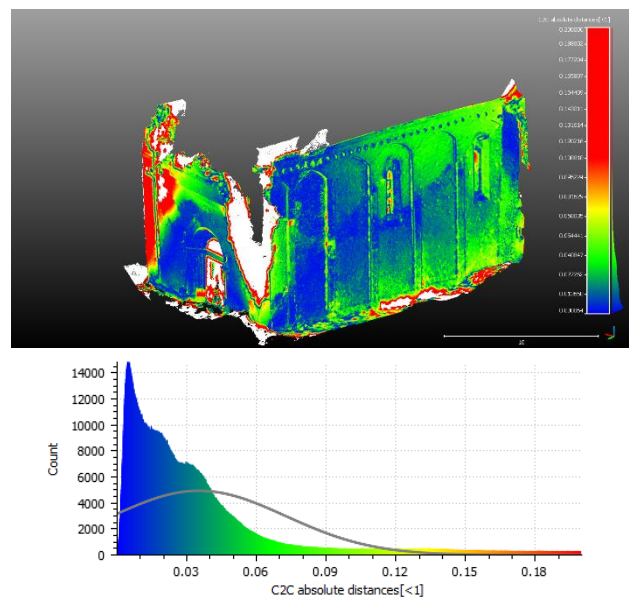
Figure 10. Comparison of t2 on t1 point clouds and associated histogram of values distribution included in  $0 < v < 0.2m$ . In grey colours values associated to areas in  $T2 > 0.20m$  respect to T1.

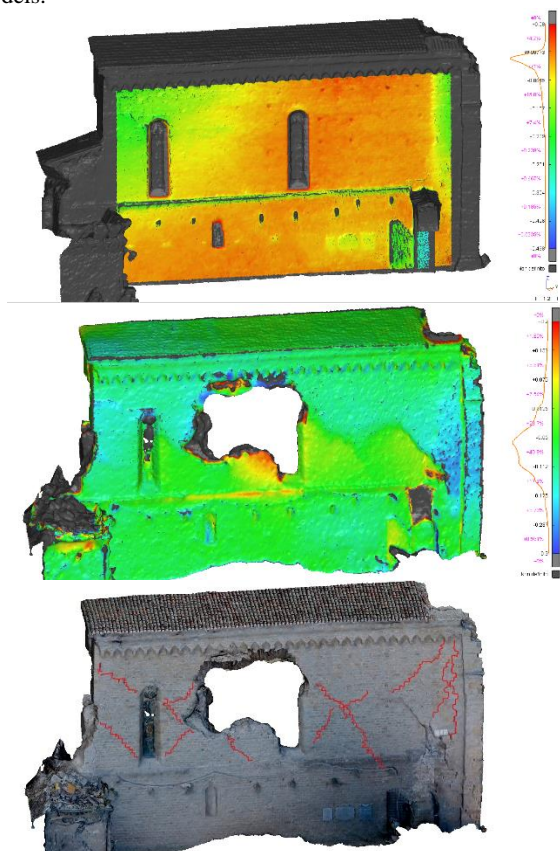
Figure 11. 3D analysis on West wall. a) Fitting plane analysis. b) t1-t2 comparison and mapping c) cracks mapping.

Another focus on the geometric evaluation by multi-temporal comparison that we chose to explore to support masonries stability assessment and contribute to the metric basis for structural diagnosis, is the West wall that, despite the East one, in T3 is not left standing after the subsequent seismic events. On the t1 model it can be traced a widespread lack of planarity of masonry surface (Figure 11a) on the basis of a mean plane fit at the basis on wall. 75% of the surface differs from the vertical plan of about  $-0.06m < v < +0.08m$ . In Figure 11b comparison of t2 on t1 after another seismic event and the collapse of the central area of the wall, in correspondence with the window opening. A series of shear stress traces can be observed, identified and measured with high scale detail on the 3D mesh. A preliminary evaluation of the collapsed volume can be performed too on these kind of models.

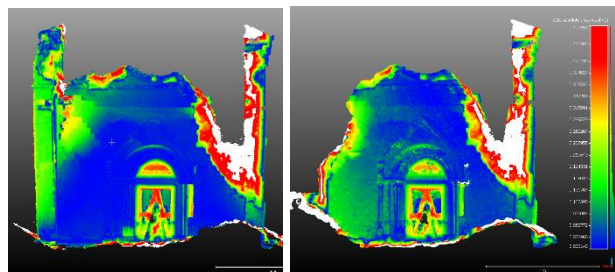
Figure 13. The main façade collapse comparison in 2 steps: a) t1-t2; b) t1-t3. The represented range values are  $0 < v < 0.2m$  (white values  $> 0.2m$ ).

Damages are consistent on the main façade and are well easy to read, detectable, and quantifiable too on multi-temporal 3D models. With t2 model the collapses occurred in t3 were easily maybe predictable and can be located and measured in relation to the global structural assessment. The key point of the dynamic behavior of the façade can be clearly identified in the lateral connection with transversal walls surrounding the church nave.

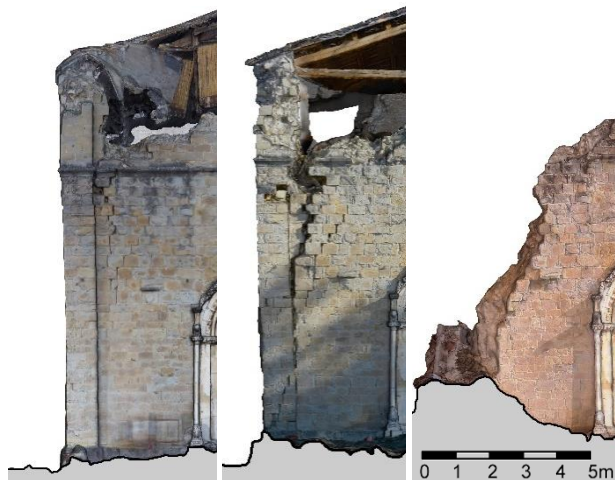
Figure 14. Orthoimages of the main façade in t1, t2, t3.

In this specific focus on the left connection with the West wall (Figure 14) the progressive evolution of collapse a series of break lines traces were detected in t1 in relation to the ones identified in t2 before the decisive collapse.

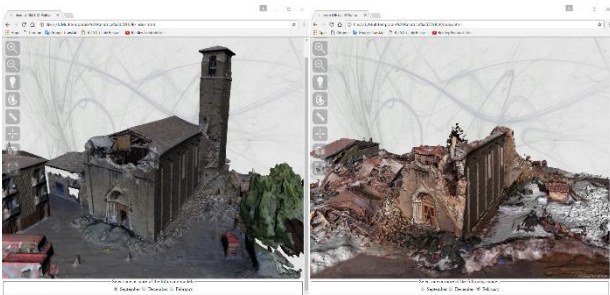
Figure 18. The online 3D HOP visualizer of the multi-temporal model (left, September; right, February)

The models of the three states of evolution were prepared to be shared on a web visualizer through the 3D HOP package. The online visualizer, showed in Figure 18, was customized thanks to the library of available JavaScript functions. The first customization was the addition of a selection tool that allows the users to choose which model or models visualize. In our case we decided to use some tools that allows to perform measurements on the model (distances and coordinates), some tools for the activation of different modalities of visualizations and a tool that enable the creation and management of section planes on different directions.
