MULTITEMPORAL 3D MODELLING FOR CULTURAL HERITAGE EMERGENCY DURING SEISMIC EVENTS: DAMAGE ASSESMENT OF S. AGOSTINO CHURCH IN AMATRICE (RI)

F. Chiabrando^a, A. Di Lolli^b, G. Patrucco^a, A. Spanò^a, G. Sammartano^{a*}, L. Teppati Losè^a

KEY WORDS: UAV photogrammetry, multi-temporal model, structural assessment, seismic emergency, Cultural Heritage

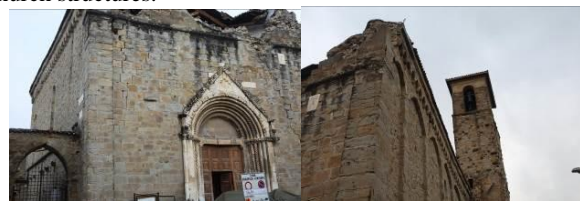
Figure 3. Two terrestrial images acquired in the first campaign

The first reconnaissance (5th- 9th of September) performed after the earthquake of Amatrice (24th of August) allowed to acquire a terrain dataset of the S. Agostino church with some topographic measurements as well. The images were acquired by a Nikon D800E reflex digital camera equipped with a 24x36mm frame. The camera has a 36 Mpx full-frame CMOS sensor with a pixel size of 4.89µm. The images (7360 x 4912 pixel) have been acquired from almost 8 m, then were post processed for balancing light and colours and masked for the next processing steps. The access to the area was, during this first campaign, very short since the area was in the red zone. Only images of the main façade (south), west and bell tower were recorded since in the other parts the entrance was forbidden according to the instability of the church structures.

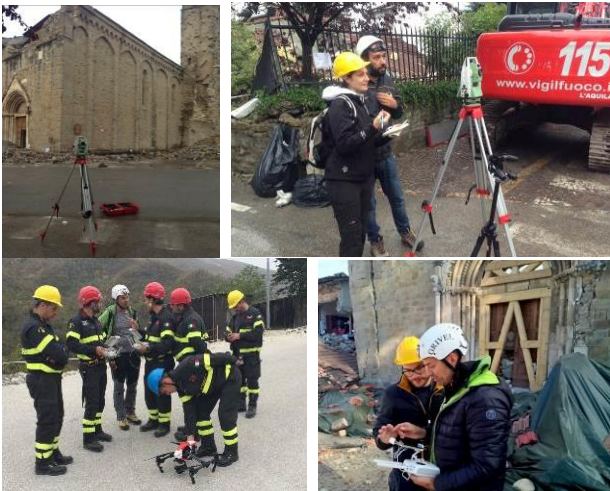
Figure 4. Survey operation in the area of Sant'Agostino; The RPAS group of the Firefighters with the INSPIRE 1; Remote control of the UAV during the image acquisition phase.

Furthermore, according to the usual data acquisition workflow several Ground Control Points were measured. The survey was performed with a traditional total station (Figure 4) in a local reference system, n°16 natural GCPs were measured in the two visible façades (it was not possible to use artificial marker, due to the structural problems of the church).

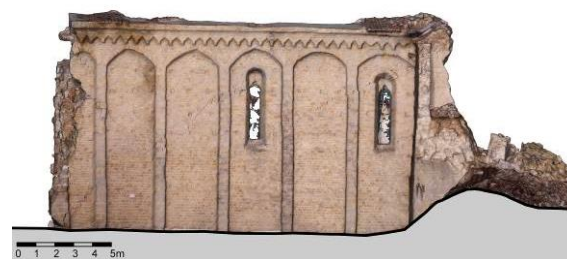
Figure 7. Orthophoto of East wall. Top: September (t1); centre: December (t2); down: January (t3)

As is possible to deduce from the orthophotos of the west façade realized according to the three employed dataset (t1, t2 and t3) showed in the next Figure 7, the influence of the sunlight seriously affect the radiometry of the final output. Despite an image pre-processing that as usual was performed for the acquired images, especially in the DJI sensor is very difficult to correct those effects. Some analysis are ongoing in the research group according to the national and international research on this topic (He et al., 2013; Milanfar, 2013; González-Aguilera et al., 2016) in order to define the better strategy for image pre-processing.

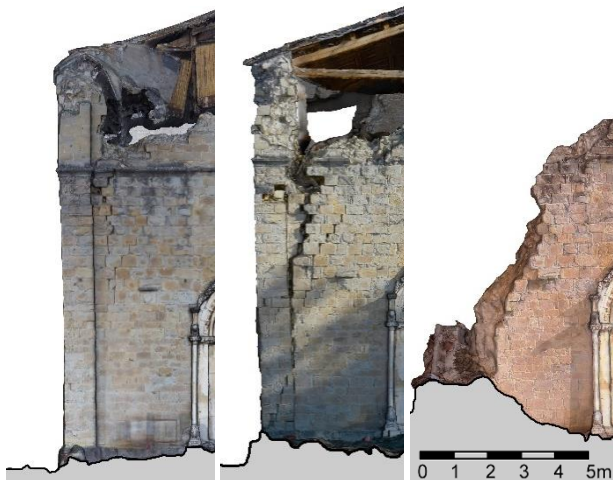
Figure 14. Orthoimages of the main façade in t1, t2, t3.

In this specific focus on the left connection with the West wall (Figure 14) the progressive evolution of collapse a series of break lines traces were detected in t1 in relation to the ones identified in t2 before the decisive collapse.
