MULTITEMPORAL 3D MODELLING FOR CULTURAL HERITAGE EMERGENCY DURING SEISMIC EVENTS: DAMAGE ASSESMENT OF S. AGOSTINO CHURCH IN AMATRICE (RI)

F. Chiabrando^a, A. Di Lolli^b, G. Patrucco^a, A. Spanò^a, G. Sammartano^{a*}, L. Teppati Losè^a

KEY WORDS: UAV photogrammetry, multi-temporal model, structural assessment, seismic emergency, Cultural Heritage

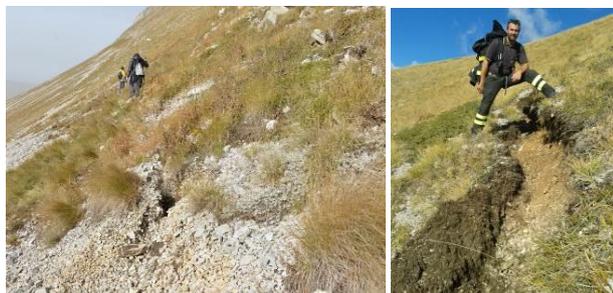
Figure 1. The Fault of Mt. Vettore before the earthquake of Norcia (Left) and after (right)

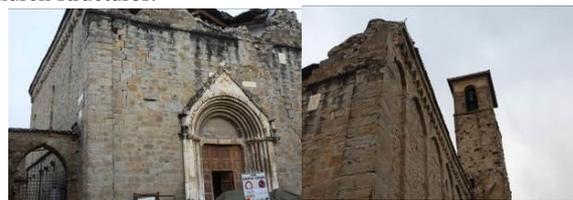
Figure 3. Two terrestrial images acquired in the first campaign

The first reconnaissance (5th- 9th of September) performed after the earthquake of Amatrice (24th of August) allowed to acquire a terrain dataset of the S. Agostino church with some topographic measurements as well. The images were acquired by a Nikon D800E reflex digital camera equipped with a 24x36mm frame. The camera has a 36 Mpx full-frame CMOS sensor with a pixel size of 4.89µm. The images (7360 x 4912 pixel) have been acquired from almost 8 m, then were post processed for balancing light and colours and masked for the next processing steps. The access to the area was, during this first campaign, very short since the area was in the red zone. Only images of the main façade (south), west and bell tower were recorded since in the other parts the entrance was forbidden according to the instability of the church structures.

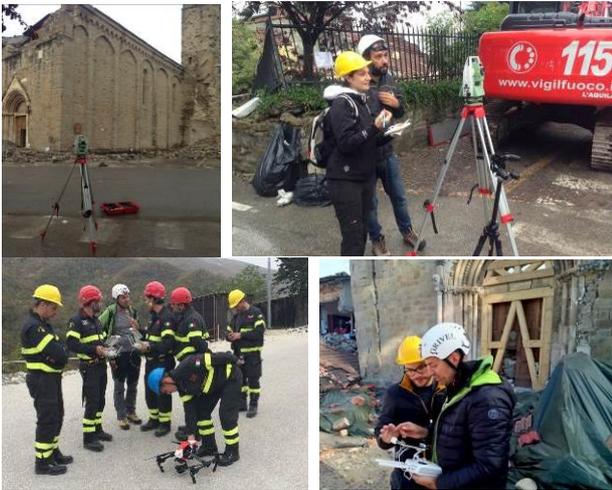
Figure 4. Survey operation in the area of Sant'Agostino; The RPAS group of the Firefighters with the INSPIRE 1; Remote control of the UAV during the image acquisition phase.

Furthermore, according to the usual data acquisition workflow several Ground Control Points were measured. The survey was performed with a traditional total station (Figure 4) in a local reference system, n°16 natural GCPs were measured in the two visible façades (it was not possible to use artificial marker, due to the structural problems of the church).

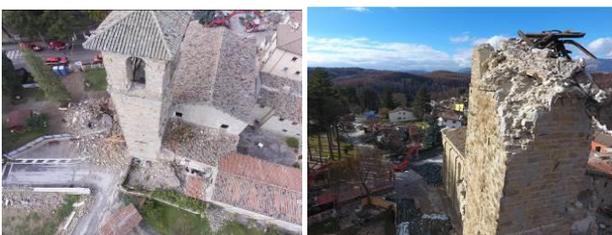
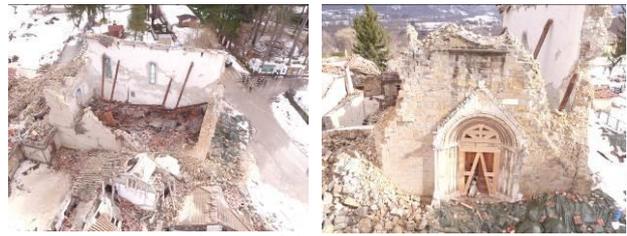
Figure 5. Oblique image of the Sant'Agostino Church; the top of the bell tower and the collapse after the Norcia earthquake; the structure after the January seismic events

As one can clearly deduce from the previous paragraph, the extremely poor balance situation was definitively exceeded after the sequence of three earthquakes occurred at 9:25 (M5.1), 10:14 (M5.5) and 10:25 (M5.4) on the 18th of January 2017. This new seismic swarm produced the collapse of the belt tower, the east and south façades and an important increasing of the damages on the main façade. The west part of the church is still preserve although very important damages are clearly recognizable on the structure.

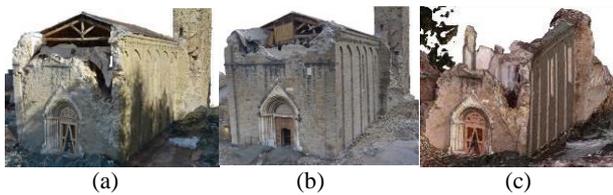
Figure 6. A view of the achieved models: September (a), December (b), January (c)

The achieved accuracy (Table1) allow considering the products suitable for a representation at a scale 1:100. In Figure 6 the achieved 3D models according to the different acquired dataset are reported.

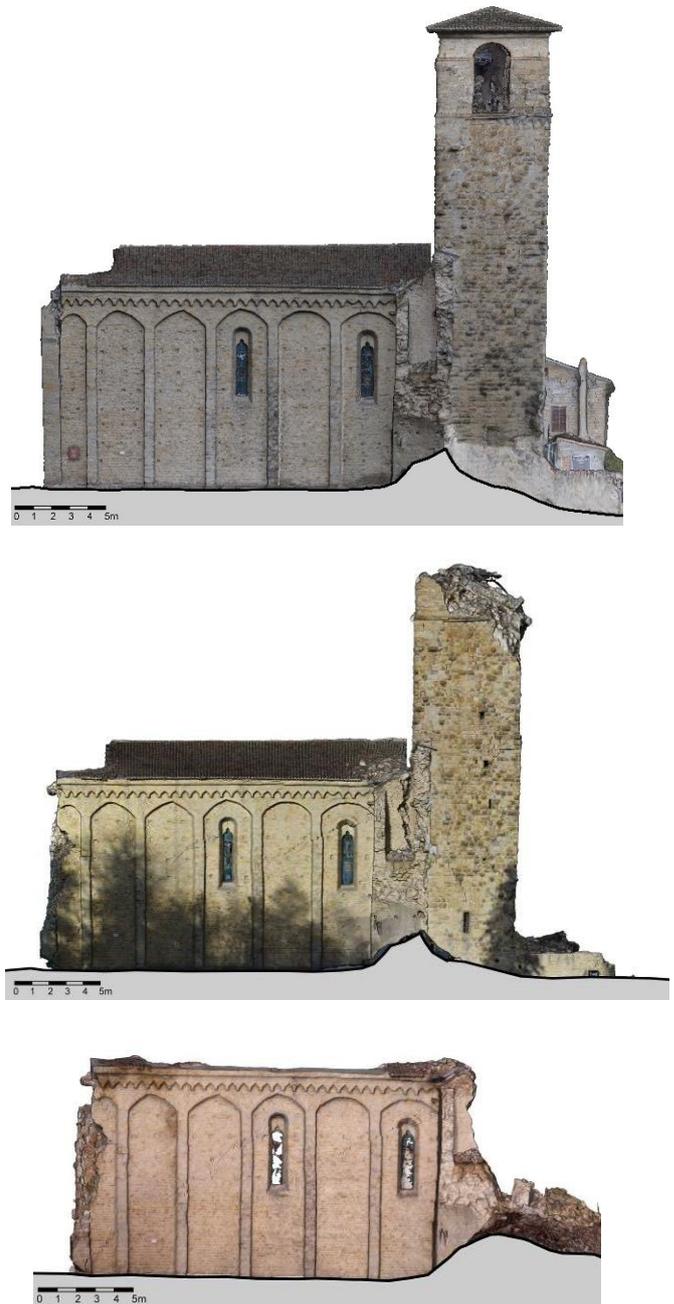
Figure 7. Orthophoto of East wall. Top: September (t1); centre: December (t2); down: January (t3)

As is possible to deduce from the orthophotos of the west façade realized according to the three employed dataset (t1, t2 and t3) showed in the next Figure 7, the influence of the sunlight seriously affect the radiometry of the final output. Despite an image pre-processing that as usual was performed for the acquired images, especially in the DJI sensor is very difficult to correct those effects. Some analysis are ongoing in the research group according to the national and international research on this topic (He et al., 2013; Milanfar, 2013; González-Aguilera et al., 2016) in order to define the better strategy for image pre-processing.

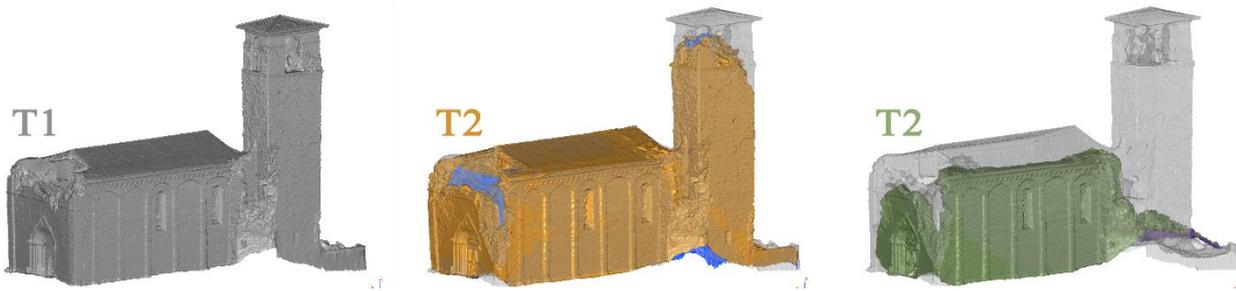
In Figure 8 a volumetric evaluation on collapsed structures; t1 model, alone (left) and compared to t2 and t3. The collapses caused by seismic shock and consequent loss of structural stability have led to significant loss of volume, up to -68,4% in comparison with the time 1, September 2016.

Figure 8. Multi-temporal model compared with t1

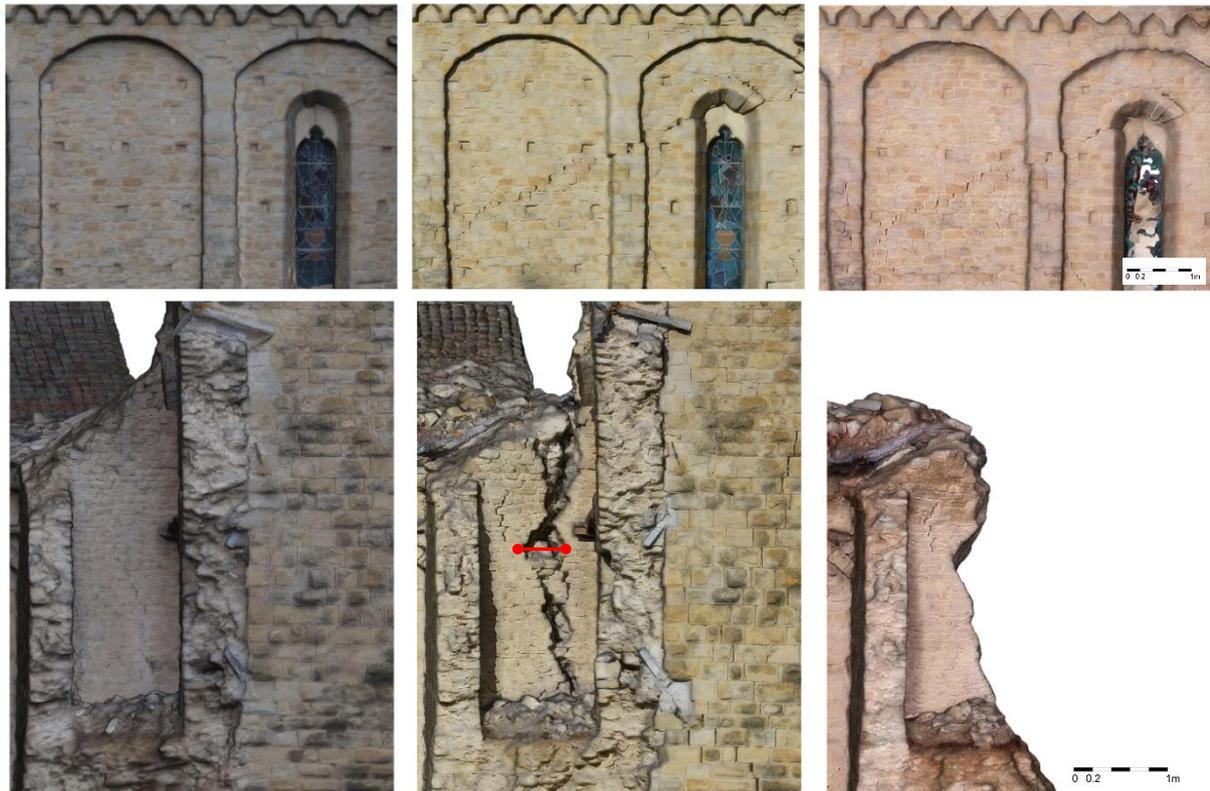
Figure 9. Multi-temporal models and orthoimages excerpts on East wall: (left) t1; (centre) t2; (right) t3

The connection in the South-East corner is maybe one of the most significant enough to be deeply analysed in the global structural behaviour of this ancient masonry. Thanks to the possibility of multi-temporal 3D models comparison (Figure 8) an interesting analysis by orthoimages (Figure 9) and point clouds comparison expressed in range colours classification (Figure 10) can be processed. The orthoimages display great displacements on the masonries connection deformed by shear stress (up to 60cm); here the surface assessment was shown, together with the variation from t1 represented in range scale colours between blue and green. The scale values with the order of magnitude of some centimetres distributed over a mean height of 12m, confirms the serious structural damage that hit the building. Nevertheless, this wall is the only one to be still standing together with a part of the main façade.

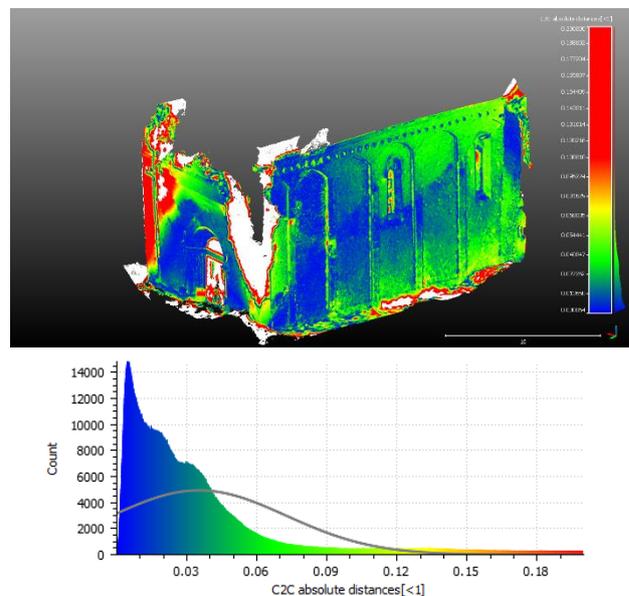
Figure 10. Comparison of t2 on t1 point clouds and associated histogram of values distribution included in $0 < v < 0.2m$. In grey colours values associated to areas in $T2 > 0.20m$ respect to T1.

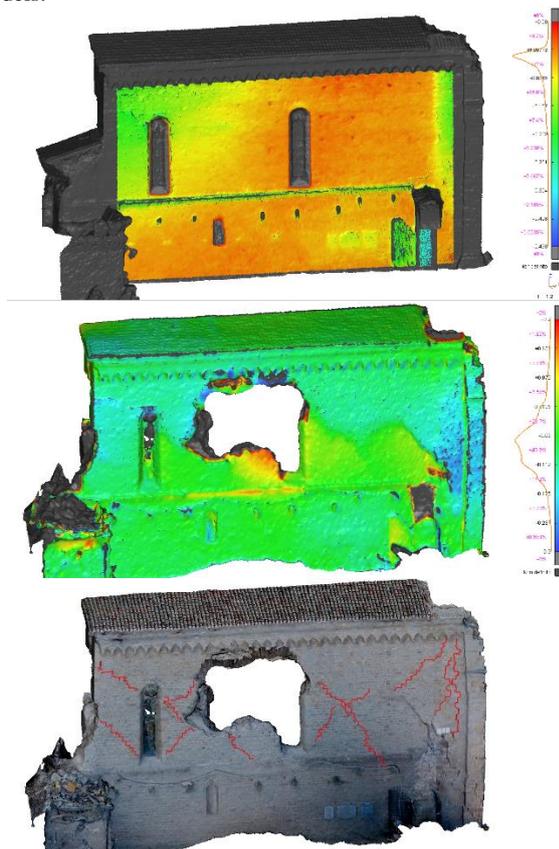
Another focus on the geometric evaluation by multi-temporal comparison that we chose to explore to support masonries stability assessment and contribute to the metric basis for structural diagnosis, is the West wall that, despite the East one, in T3 is not left standing after the subsequent seismic events. On the t1 model it can be traced a widespread lack of planarity of masonry surface (Figure 11a) on the basis of a mean plane fit at the basis on wall. 75% of the surface differs from the vertical plan of about $-0.06m < v < +0.08m$. In Figure 11b comparison of t2 on t1 after another seismic event and the collapse of the central area of the wall, in correspondence with the window opening. A series of shear stress traces can be observed, identified and measured with high scale detail on the 3D mesh. A preliminary evaluation of the collapsed volume can be performed too on these kind of models.

Figure 11. 3D analysis on West wall. a) Fitting plane analysis. b) t1-t2 comparison and mapping c) cracks mapping.

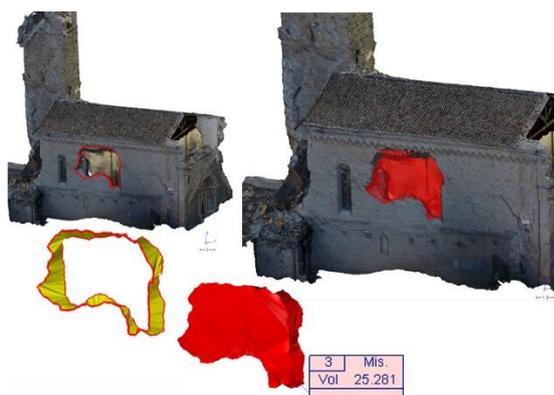
Figure 12. Analysis on West wall where the damage mechanisms caused the collapse of the central part of the masonry by shear failures.

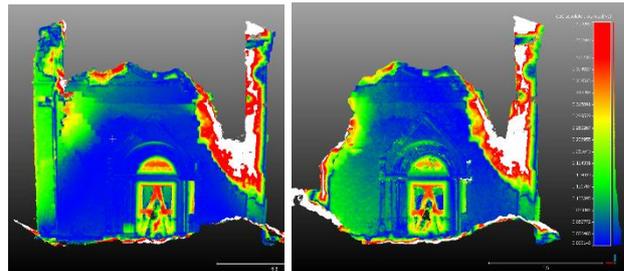
Damages are consistent on the main façade and are well easy to read, detectable, and quantifiable too on multi-temporal 3D models. With t2 model the collapses occurred in t3 were easily maybe predictable and can be located and measured in relation to the global structural assessment. The key point of the dynamic behavior of the façade can be clearly identified in the lateral connection with transversal walls surrounding the church nave.

Figure 13. The main façade collapse comparison in 2 steps: a) t1-t2; b) t1-t3. The represented range values are $0 < v < 0.2m$ (white values $> 0.2m$).

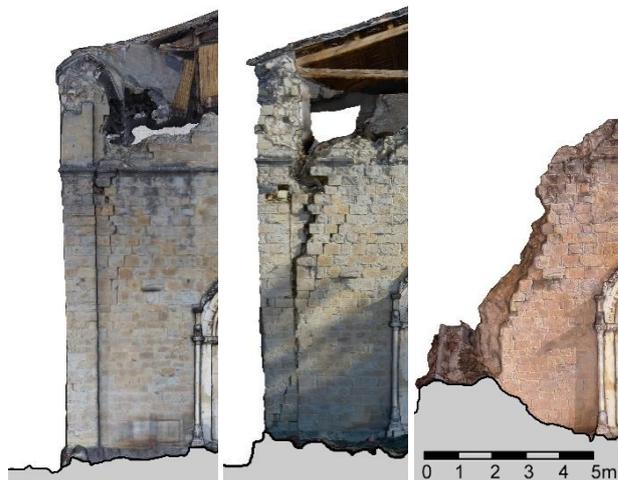
In this specific focus on the left connection with the West wall (Figure 14) the progressive evolution of collapse a series of break lines traces were detected in t1 in relation to the ones identified in t2 before the decisive collapse.

Figure 14. Orthoimages of the main façade in t1, t2, t3.

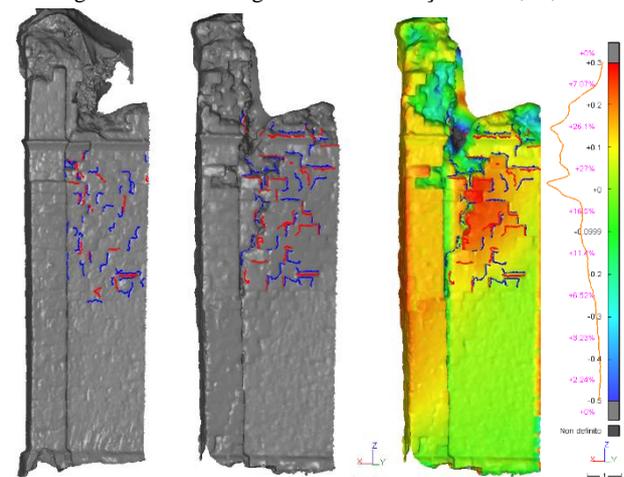
Figure 15. 3D model breaklines detection on t1 and t2; the surface comparison between t1-t2 with appreciable differences of about 0.1-0.3m (more or less 55% on the surface)

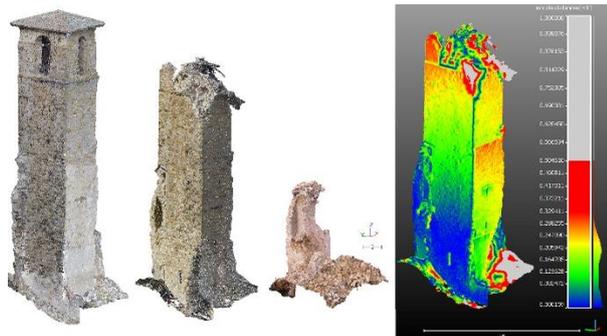
In the 3D metric model of the bell tower, a significant displacement of the north side can be identified, quantifiable in a mean range value of 0.2-0.3m, clearly pinpointed from the slight sliding of bricks layers, in the masonry texture.

Figure 16. Belfry temporal transformation after reiterated seismic shocks: t1, t2, t3. In range colors comparison between t1-t2 with values $0 < v < 0.50m$ (grey for values $> 0.5m$)

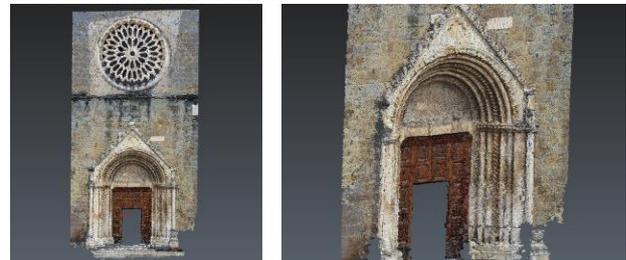
Figure 17. First test of point cloud generation of the portal before the earthquakes

In March 2017, we started a new project to evaluate if it would be possible to create a 3D model of the church of S. Agostino through an online campaign of crowdsourcing. In the first phase of the project we wanted to evaluate the type of images that were online available for the church and the quality of the results we can expect. We performed some researches on the major online platforms for the storage and sharing of images and we selected a set of around 20 images. The images were selected depending on size, quality and presence of metadata and were all focussed on the decorated portal of the church. The same solution for SfM (Agisoft Photoscan) was used in this first phase and some encouraging results have been reached (Figure 17).

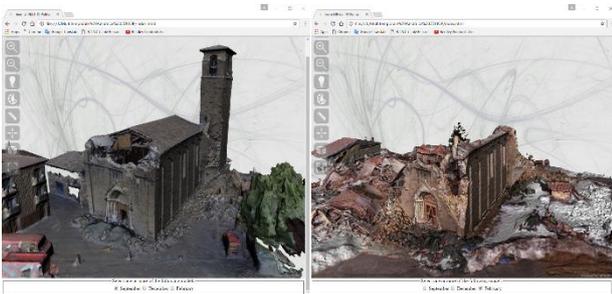
The models of the three states of evolution were prepared to be shared on a web visualizer through the 3D HOP package. The online visualizer, showed in Figure 18, was customized thanks to the library of available JavaScript functions. The first customization was the addition of a selection tool that allows the users to choose which model or models visualize. In our case we decided to use some tools that allows to perform measurements on the model (distances and coordinates), some tools for the activation of different modalities of visualizations and a tool that enable the creation and management of section planes on different directions.

Figure 18. The online 3D HOP visualizer of the multi-temporal model (left, September; right, February)
