MULTITEMPORAL 3D MODELLING FOR CULTURAL HERITAGE EMERGENCY DURING SEISMIC EVENTS: DAMAGE ASSESMENT OF S. AGOSTINO CHURCH IN AMATRICE (RI)

KEY WORDS: UAV photogrammetry, multi-temporal model, structural assessment, seismic emergency, Cultural Heritage

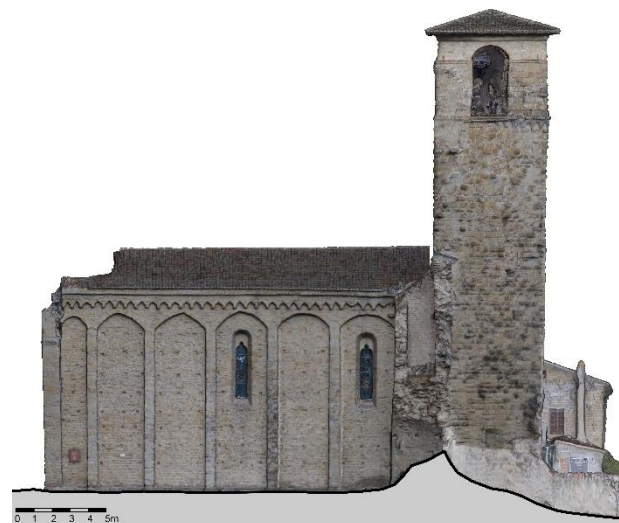
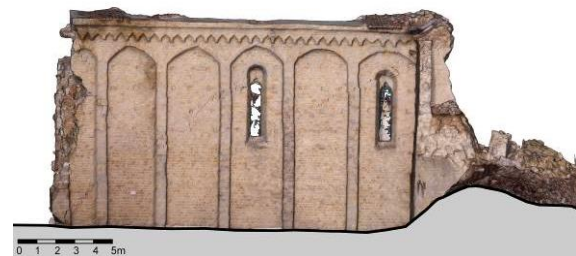
As is possible to deduce from the orthophotos of the west façade realized according to the three employed dataset (t1, t2 and t3) showed in the next Figure 7, the influence of the sunlight seriously affect the radiometry of the final output. Despite an image pre-processing that as usual was performed for the acquired images, especially in the DJI sensor is very difficult to correct those effects. Some analysis are ongoing in the research group according to the national and international research on this topic (He et al., 2013; Milanfar, 2013; González-Aguilera et al., 2016) in order to define the better strategy for image pre-processing.

Figure 7. Orthophoto of East wall. Top: September (t1); centre: December (t2); down: January (t3)
