MAINTENANCE OF ROCKFALL NET FENCES

Andrea Luciani¹, Daniele Peila²

The efficiency of rockfall protection net fences is affected during their lifetime by damages and ageing phenomena. To identify the main issues that can affect the durability of rockfall protection net fences a site survey campaign has been performed in the North-west of Italy. This campaign aims to point out to the main aspects to focus on for maintenance management.

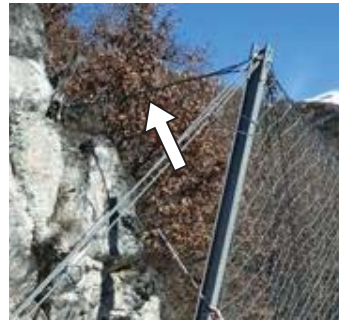
Fig. 2 - Short upstream rope

Furthermore, ETAG 027 [2] prescribes to indicate, in the installation manual, the tolerances and imposes to the designer to perform specific evaluation reports in the case the barrier is installed disregarding those tolerances. Nevertheless, during the survey campaign several barriers have shown a configuration not compliant with the available installation manual. For example, in Fig. 2 one of the upstream ropes is installed sub-horizontal and shorter than all the other due to the presence of a rock slope immediately behind the post. On the contrary, in Fig. 3, the upstream ropes are much longer than what required by the installation manual due to the slope conformation.

| Problem simulated | Residual efficiency [%] |
|--|---|
| Short and horizontal upstream ropes | 80 |

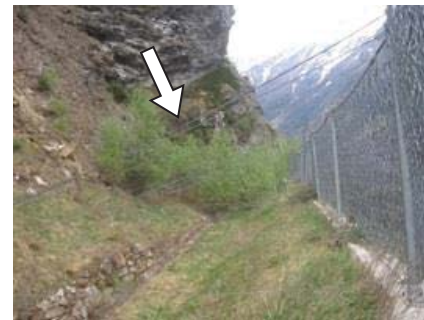
Fig. 3 - Long upstream ropes

| Problem simulated | Residual efficiency [%] |
|--|---|
| Long upstream ropes | 87 |
