MAINTENANCE OF ROCKFALL NET FENCES

## MAINTENANCE OF ROCKFALL NET FENCES

Andrea Luciani<sup>1</sup>, Daniele Peila<sup>2</sup>

The efficiency of rockfall protection net fences is affected during their lifetime by damages and ageing phenomena. To identify the main issues that can affect the durability of rockfall protection net fences a site survey campaign has been performed in the North-west of Italy. This campaign aims to point out to the main aspects to focus on for maintenance management.

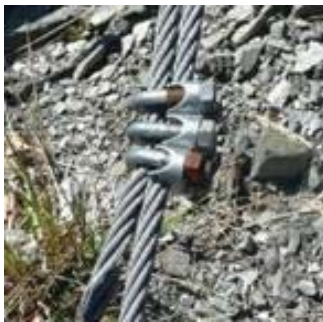
Fig. 1 - Slid clamps

Moreover, problems related to the quality of the connections using clamps. During the survey campaign the clamps were often found not installed in accordance with the regulations in force [5] in terms of number, distance and closure. The clamp connection shown in Fig. 1 has not worked and the clamps have get close to each other letting the rope slide during the impact. This phenomenon may be connected to an incorrect torque applied to the fastener. Therefore, during the campaign, the torque applied to the clamps was recorded using a torque wrench. These measures show a different behavior of clamps installed on tensioned ropes and on loose ropes. The first ones maintain the prescribed torque in the 95% of the recorded samples while the latter ones have only the 80% of the prescribed torque, even in clamps installed in the last 5 years. This seems to be a key aspect to focus on in order to guarantee the correct behavior of the connection structures during all the life span of a rockfall protection barrier and more studies are needed to analyze the behavior of clamps on net fences.

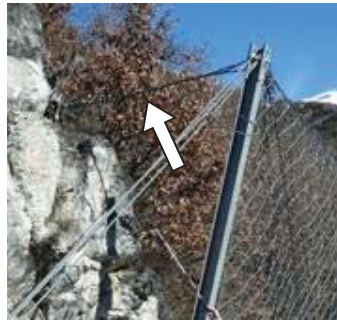
Fig. 2 - Short upstream rope

Furthermore, ETAG 027 [2] prescribes to indicate, in the installation manual, the tolerances and imposes to the designer to perform specific evaluation reports in the case the barrier is installed disregarding those tolerances. Nevertheless, during the survey campaign several barriers have shown a configuration not compliant with the available installation manual. For example, in Fig. 2 one of the upstream ropes is installed sub-horizontal and shorter than all the other due to the presence of a rock slope immediately behind the post. On the contrary, in Fig. 3, the upstream ropes are much longer than what required by the installation manual due to the slope conformation.

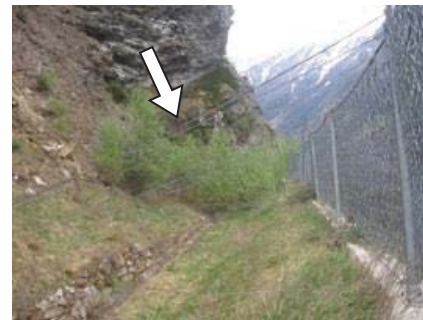
Fig. 3 - Long upstream ropes
