Structural health monitoring of historical heritage in Italy: some relevant experiences

Structural health monitoring of historical heritage in Italy: some relevant experiences / DE STEFANO, A., Matta, E., Clemente, P.. - In: JOURNAL OF CIVIL STRUCTURAL HEALTH MONITORING. - ISSN 2190-5452. - STAMPA. - 6:1(2016), pp. 83-106. [10.1007/s13349-016-0154-y]

Alessandro De Stefano¹, Emiliano Matta¹, Paolo Clemente²

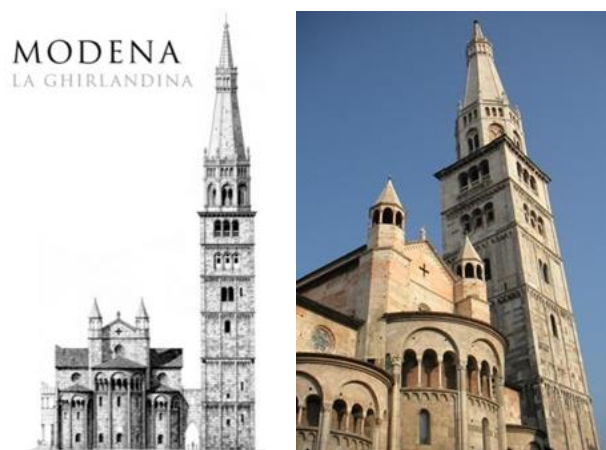
Fig. 6 The Ghirlandina Tower in Modena

The case study of the Ghirlandina bell-tower is important for its general implications [39]. The wonderful Cathedral of Modena (central-northern Italy) and its bell-tower Ghirlandina are part of the UNESCO site Piazza Grande (Fig. 6). The construction of the tower began in 1099 together with the cathedral and ended in 1319. The arches connecting the southern side of the tower to the cathedral were set in place in 1338, because there was evidence that a tilt, later corrected, occurred during the construction. Measurements of the tilt and studies on the foundation depth and consistency started at the end of the nineteenth century. In 2007 a scientific committee found that the brick-made foundation had a thickness of 3 m and was conceived as a spread foundation without supporting piles. It was possible to define the settlement suffered by the tower (~ 2 m) and the compressibility of the foundation soil. Over the last decade, there has been a growing interest in the potential seismic vulnerability of the tower and its interaction with the cathedral. This interest was further increased by the recent earthquake in the Emilia Romagna region in May 2012 because many historical masonry bell towers collapsed despite the moderate magnitude ($M = 5.9$) of the seismic event.

Strain-hardening plasticity models, the so-called macro-element models of the overall soil-footing systems, are accepted as providing reliable simulations [40]. Ambient vibration tests and identification supplied significant contributions [41]. A model updating procedure is needed to build a reliable predictive tool [42]. Models of ancient towers founded on soft soil must include soil-structure interaction, otherwise no updating leads to reasonable results. The soil profile down to the investigated depth of 80 m is a sequence of recently deposited alluvial horizons; medium- to high-plasticity inorganic clays are surmounted by 5-7 m of alluvium linked to flooding events (of post-Roman era) produced by minor streams. Cross-hole tests revealed a shear wave velocity (VS) ranging from 100 to 200 m/s in the upper 20 m, more dispersed values, up to 500 m/s, from 20 to 35 m deep, about 200 m/s below 34 m.
