Structural health monitoring of historical heritage in Italy: some relevant experiences

Alessandro De Stefano¹, Emiliano Matta¹, Paolo Clemente²

Abstract. The architectural heritage in the world represents a fundamental resource and a sign of the national cultural background. Its maintenance and preservation require a balance between the structural safety needs and the respect for their architectural and cultural value. Structural health monitoring (SHM) is increasingly emerging as a unique tool to achieve such a balance, through a proper combination of traditional and innovative techniques. This paper presents some recent experiences of SHM applied to the historical heritage in Italy, discussing relevant tools and reporting some of the most significant case studies.

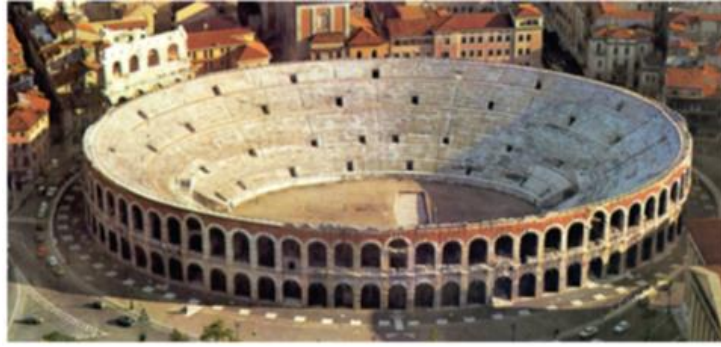
Fig. 1 The Roman Arena in Verona

The Roman Arena in Verona, Italy, built in the first century A.D., is still standing in the historical city center (Fig. 1). It is open to public use for visits but also for operas, concerts and relevant shows (audience of 20.000 people). It suffered damages due to aging as well as natural and man-induced events, such as earthquakes, floods, wars and sieges and, for centuries, continuative stealing of stones and material for reuse in other constructions. Past seismic events are the cause of the almost complete collapse of the third (external) ring of the monument, today only remaining in the so-called “ala” (wing) of the Arena, an isolated portion of stone blocks curved wall characterized by arches and massive pillars. Post-tensioned tendons were placed vertically along the entire height of the massive pillars in 1956.
