Structural health monitoring of historical heritage in Italy: some relevant experiences

Alessandro De Stefano¹, Emiliano Matta¹, Paolo Clemente²

Keywords: architectural heritage; historical constructions; structural health monitoring; masonry buildings; real case studies; damage symptoms.

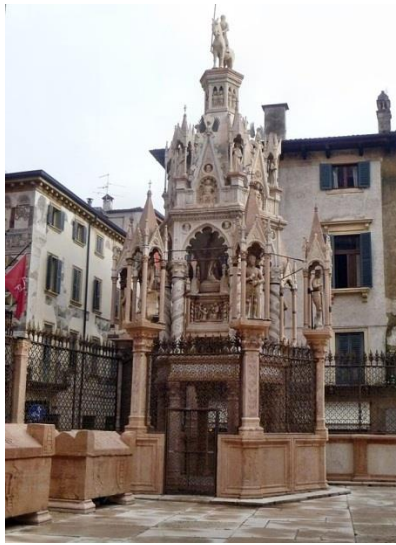
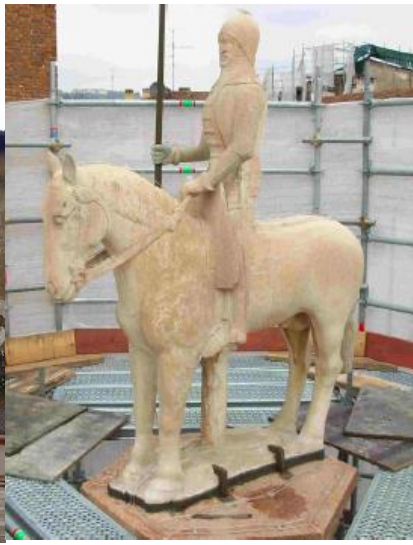
Fig. 9 Cansignorio stone tomb: (a) overall view; (b) the equestrian statue; (c) sensors layout (left: static transducers on cracks; right: mono-axial accelerometers)

The Scaliger Tombs is a group of five Gothic funerary monuments in Verona, Italy, celebrating the Scaligeri family, who ruled Verona from the 13th to the late 14th century. Throughout the centuries, several repair interventions were necessary to preserve the delicate structure of the stone tomb, such as those carried out in the XVII, XIX and XX centuries (Fig. 9a and 9b).

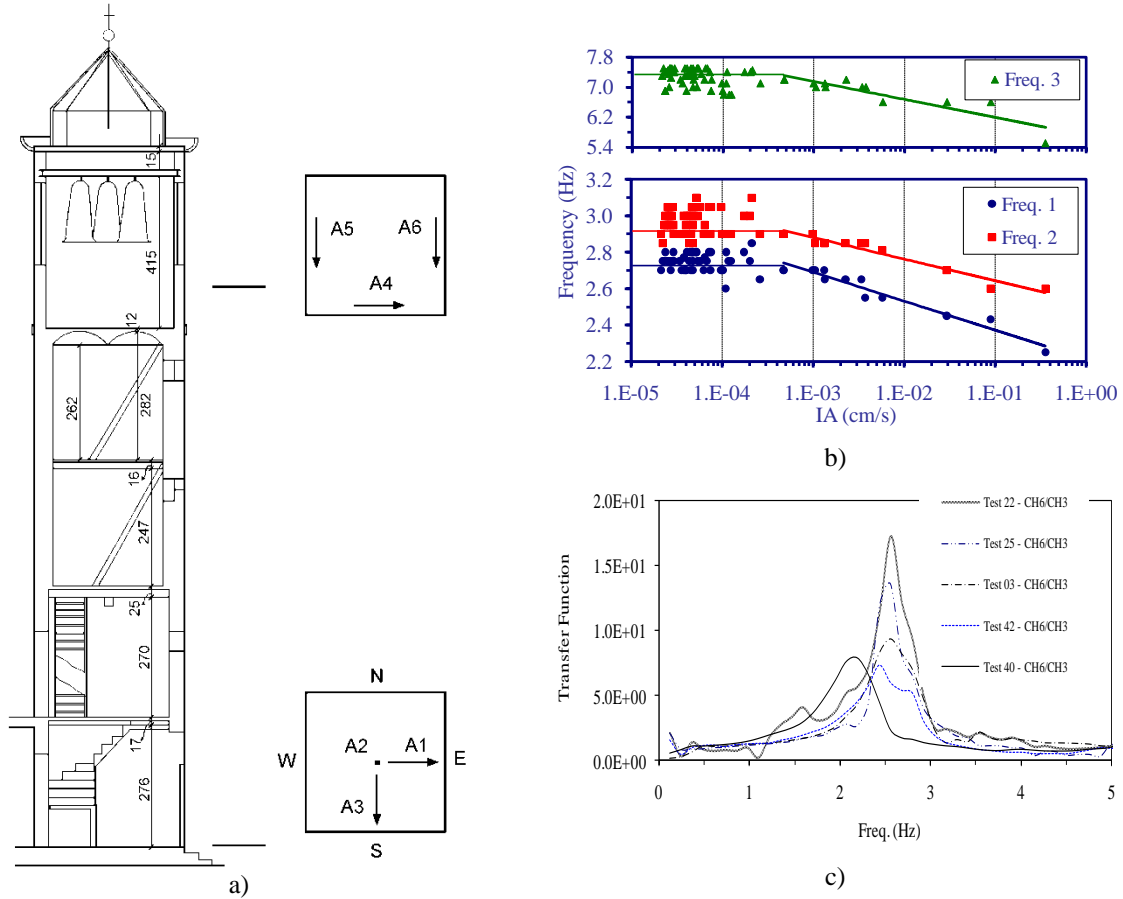
Fig. 10 The Bell Tower of S. Giorgio in Trignano: (a) accelerometers layout; (b) frequencies versus IA; (c) transfer functions for events having increasing intensity

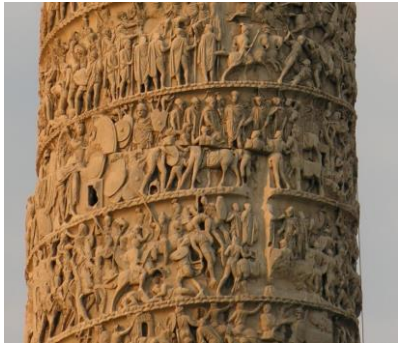
Fig. 17 The Aurelian Column: relative dislocation between two adjacent blocks

In the XVI century, the presence of sliding and rotation among adjacent blocks was noticed in the Aurelian Column, possibly as a result of earthquakes (Fig. 17). The historical investigations revealed that strong earthquakes, such of January 22nd, 1349, with epicenter in Abruzzo, caused serious damage in Rome and probably also to the column. This is just an example of the importance of monuments in the study of the historical seismicity of the Italian territory. The analysis and interpretation of the historical documents should also account for all the changes occurred in monuments, due to material degradation, changes in loads, seismic actions, traffic-induced vibrations, presence of other buildings. A suitable study should pass through the complete historical analysis and the structural health analysis in the present status. This can be done only by means of a reliable experimental analysis and an accurate numerical modelling, and should also allow the check of its present structural capacity and the definition of a suitable intervention. It is worth noting that ambient and traffic-induced vibrations, which contribute to the bad health status of structures, could become very dangerous when acting on structures already damaged by earthquakes.
