Image analysis for stone durability: two different techniques / Bellopede, Rossana; Baudana, Fiorenza; Zichella, Lorena; Marini, Paola. - ELETTRONICO. - (2018). (Globalstone Congress 2018 Ilheus BA (Brazil) 26-29 April 2018).

Image analysis for stone durability: two different techniques

Rossana Bellopede, Fiorenza Baudana, Lorena Zichella,
Paola Marini

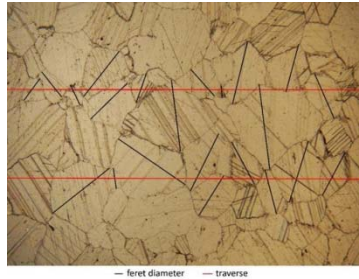
Fig. 2 Linear traverse method for determination of the grain size distribution

The AGA Analysis (AGA) was carried out in accordance with the EN 16306 Annex C (2013) by means of the free software ImageJ in order to calculate the number of adjacent grains (AG) around median-sized grains. This analysis method gives information on the microstructure of natural stone and its potential durability (Åkesson et al. 2010); it has been suggested as a screening method. Initially, the value of the median grain size has been calculated, measuring the Feret diameter (longest axis) of at least 100 grains along the plotted linear traverses (Figure 2). Afterwards, at least 50 median sized grains were chosen and a manually count of the number of their adjacent grains was carried out; the mean value of all counts represents the AGA index. According to Annex C of EN 16306, values from 8 upwards represent marbles with good characteristics, an AGA of 7 is intermediate, and 6
