## UAV STRATEGIES VALIDATION AND REMOTE SENSING DATA FOR DAMAGE ASSESSMENT IN POST-DISASTER SCENARIOS

**KEY WORDS:** UAV photogrammetry, Rapid Mapping, Remote Sensing, Seismic emergency, 3D models, Damage assessment

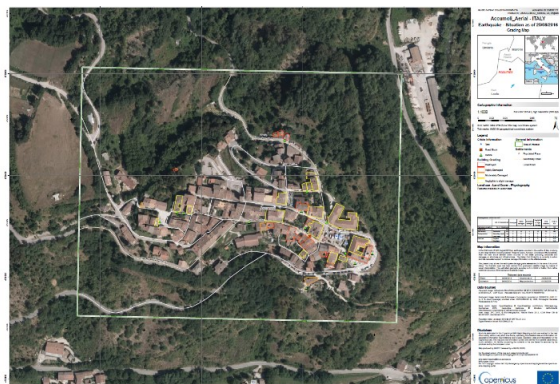
**Figure 1.** Post-event Grading Map for Accumoli (RI), Italy. Aerial image from © European Commission (acquired on 25/08/2016, GSD 0.1m, 0% cloud coverage) provided under COPERNICUS by CGR, *Compagnia Generale Riprese aeree*.

Once the service is activated, three different products as is reported in (Boccardo, 2013) could be obtained: *reference maps*, *delineation maps* and *grading maps* (Figure 1 provide an assessment of the damage grade and of its evolution if requested. In this specific paper the focus will be oriented to the produced grading maps in the area of central Italy that are available, according to the EMS rapid mapping procedure, in a time range between 3 and 12h.

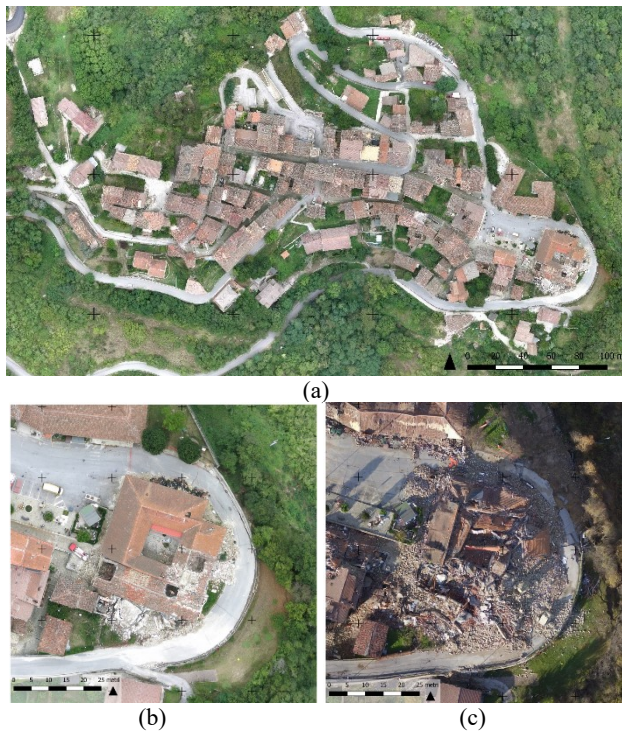
**Figure 2.** Digital orthoimage by UAV in Accumoli, flight height 130m (September 2016), GSD= 5cm/px. Comparison between T1-T4 in the eastern area of Accumoli: zoomed excerpt of T2, September (b) and T4, December (c).

reported in the following Table 2; some examples of the processed products are shown in Figure 2.

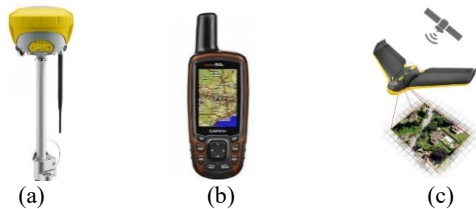
**Figure 4.** Tested strategies for georeferencing the UAV photogrammetric blocks. (a) GNSS RTK Geomax Zenith35 receiver, ~10.000€; (b) Garmin GPSMAP® 64s handheld receiver, ~300€; (c) exterior orientation associated to the UAV images by *GeoTag*.

The use of consumer grade GPS/GNSS handheld receiver, Figure 4(b), has proved to be faster than the traditional RTK procedure, involving undoubtedly cheaper and easy-to-use instruments; however, this won't firstly overcome the related safety issues, as the operator will have to traverse dangerous areas anyway. The comparison of residual errors on check points (CPs), in Table 4, has been performed on the cartographic product, separately computed by use of GCPs measured by the two GNSS receivers, the geodetic RTK and the handheld receiver. The results demonstrated the expected problem of accuracy, in meters magnitude, affecting those types of receivers.

The use of the positioning information embedded in the acquired UAV images as exterior orientation, Figure 4(c), can be another valuable solution in case of impossibility to directly measure GCPs on the ground. The UAV device used in this case is the eBee™ Basic version, equipped with consumer GPS on board receiver; neither the RTK version nor the recent PPK version have been tested. It can provide, by the so-called *geotag*, the exterior orientation, i.e. the direct georeferencing of image shooting position. The comparison of the parallel use of geodetic GNSS receiver and images *geotag* is performed and validated, as reported in Table 5, and show more limited errors results in comparison with those ones from Table 4.

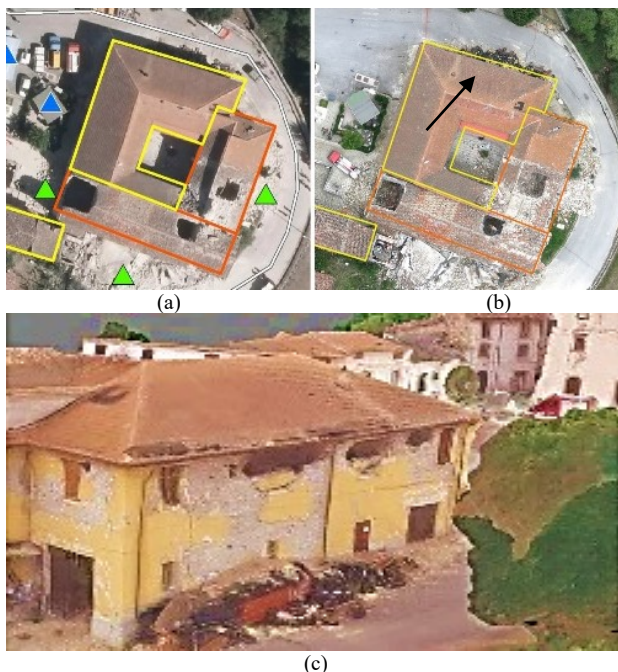
**Figure 11.** BDA on Accumoli site, in a sample building. The aerial image of Copernicus (a), the UAVs orthophoto (b) and a view of the considered damaged façade in the 3D model inspection (c).

A straightforward example of the significant contribute of UAVs for BDA is reported below. In this case one of the main buildings of Accumoli doesn't show almost any roof damages from a nadir point of view and was then classified by the Copernicus EMS as "Negligible to slight damage", Figure 11(a) but the UAVs 3D model contributed to a more accurate analysis in two ways.

Firstly, the orthophoto generated after the field survey, with a higher detail, Figure 11(b) allows to identify some debris that were not visible from the airborne image; secondly, the 3D model achieved with the integration of oblique images Figure 11(c) permits to perform an inspection of the façades, revealing some highly damaged portions of the buildings that were otherwise not identifiable. Moreover, a significant contribute of UAVs mapping in Central Italy was related with the Geotechnical reconnaissance. In the report created by the GEER team (GEER, 2016b) it's clearly visible a good example, specifically for the Accumoli site, where a system of cracks in the ground was identified between the UAV photogrammetric mapping of September and December.
