## UAV STRATEGIES VALIDATION AND REMOTE SENSING DATA FOR DAMAGE ASSESSMENT IN POST-DISASTER SCENARIOS

**KEY WORDS:** UAV photogrammetry, Rapid Mapping, Remote Sensing, Seismic emergency, 3D models, Damage assessment

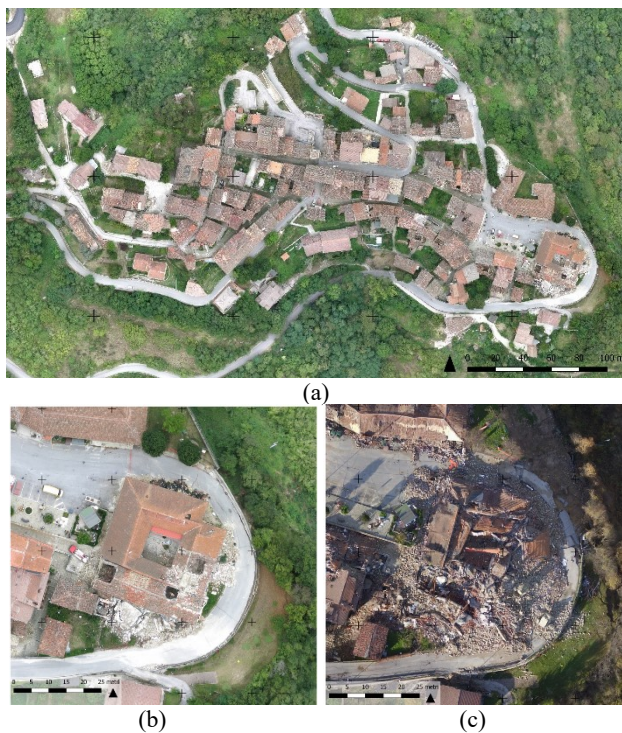
**Figure 2.** Digital orthoimage by UAV in Accumoli, flight height 130m (September 2016), GSD= 5cm/px. Comparison between T1-T4 in the eastern area of Accumoli: zoomed excerpt of T2, September (b) and T4, December (c).

reported in the following Table 2; some examples of the processed products are shown in Figure 2.
