UAV strategies validation and remote sensing data for damage assessment in post-disaster scenarios

UAV STRATEGIES VALIDATION AND REMOTE SENSING DATA FOR DAMAGE ASSESSMENT IN POST-DISASTER SCENARIOS

A. Calantropio¹, F. Chiabrando¹, G. Sammartano¹, A. Spanò¹, L. Teppati Losè¹

KEY WORDS: UAV photogrammetry, Rapid Mapping, Remote Sensing, Seismic emergency, 3D models, Damage assessment

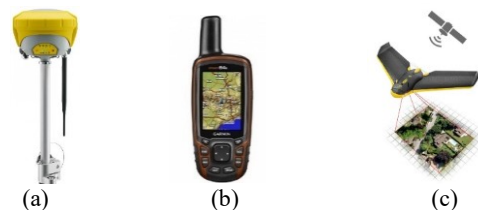
Figure 4. Tested strategies for georeferencing the UAV photogrammetric blocks. (a) GNSS RTK Geomax Zenith35 receiver, ~10.000€; (b) Garmin GPSMAP® 64s handheld receiver, ~300€; (c) exterior orientation associated to the UAV images by *GeoTag*.

The use of consumer grade GPS/GNSS handheld receiver, Figure 4(b), has proved to be faster than the traditional RTK procedure, involving undoubtedly cheaper and easy-to-use instruments; however, this won't firstly overcome the related safety issues, as the operator will have to traverse dangerous areas anyway. The comparison of residual errors on check points (CPs), in Table 4, has been performed on the cartographic product, separately computed by use of GCPs measured by the two GNSS receivers, the geodetic RTK and the handheld receiver. The results demonstrated the expected problem of accuracy, in meters magnitude, affecting those types of receivers.

The use of the positioning information embedded in the acquired UAV images as exterior orientation, Figure 4(c), can be another valuable solution in case of impossibility to directly measure GCPs on the ground. The UAV device used in this case is the eBee™ Basic version, equipped with consumer GPS on board receiver; neither the RTK version nor the recent PPK version have been tested. It can provide, by the so-called *geotag*, the exterior orientation, i.e. the direct georeferencing of image shooting position. The comparison of the parallel use of geodetic GNSS receiver and images *geotag* is performed and validated, as reported in Table 5, and show more limited errors results in comparison with those ones from Table 4.
