Delamination of plasters applied to historical masonry walls: analysis by acoustic emission technique and numerical model

# Delamination of plasters applied to historical masonry walls: analysis by acoustic emission technique and numerical model

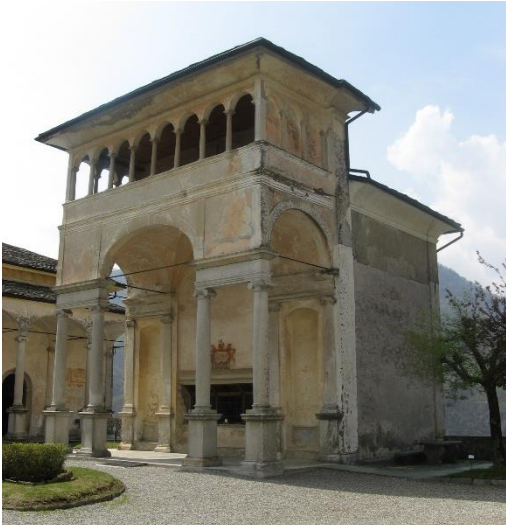
Figure 1. Chapel of the Christ at the court of Herod.

The authors have developed a new experimental methodology to assess the mechanical adhesion of new dehumidified mortars applied to historical masonry surfaces. This experimental methodology was carried out at the Politecnico Laboratory, and tested at the Sacro Monte di Varallo, one of the most famous UNESCO heritage site in Italy [2]. This historical site, whose construction has been extended from the 15<sup>th</sup> to the 18<sup>th</sup> century, contains 45 chapels that show the Christ's life by particular frescoes and sculptures (figure 1). The main problem of historical plasters' preservation is linked to the rain infiltrations and to the freezing-thawing cycles that compromise their adhesion to stone masonries. Through compression static tests on stone-mortar composite specimens, it was possible to prequalify the dehumidified mortar with greater durability guarantees. Sometime the long-term detachment determined the failure of the restoration work. The test validates the mechanical compatibility between the repair mortars and historical masonries stone, as a guarantee also for durability over time against atmospheric agents. The Acoustic Emission (AE) monitoring technique was employed during static
