Detachment monitoring of repair mortar applied to historical masonry stone by acoustic emission technique

Alessandro Grazzini¹, Giuseppe Lacidogna², Silvio Valente³ and Federico Accornero⁴

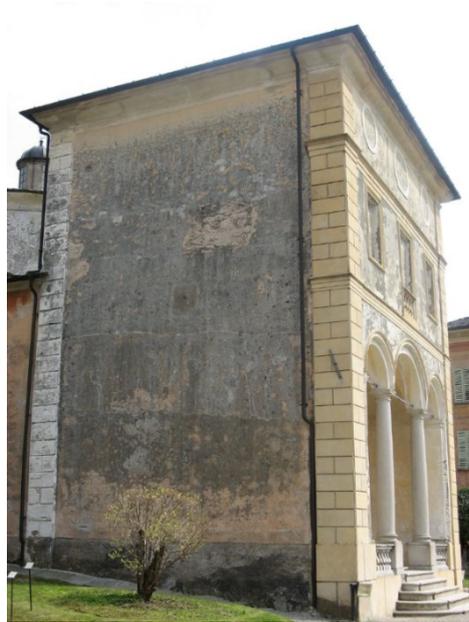
Figure 1. Chapel of Christ at Ann's court

Fig. 1 shows the main problem of deterioration on historical façades due to the rising capillary damp and the freezing-thawing cycles. The original plasters risk the detachment due to the cyclic action of the abundant rain. The Acoustic Emission monitoring technique, employed during static shear test, allowed assessing damage evolution and classification [5]. This experimental research analyzed the detachment of historical plasters without frescoes: in this case, it is possible to replace a new lime mortar dehumidified plaster [2, 3].

A new experimental procedure, developed at the Non-Destructive Testing Laboratory of the Politecnico di Torino, was tested on specific mixed stone block-mortar specimens. The goal was to assess the mechanical adhesion of the new de-humidified mortars to the historical masonry walls, in order to select in laboratory the best repair material with respect to the durability of the restoration work [4]. The experimental methodology was tested near the “Sacro Monte di Varallo” (UNESCO heritage site in Piedmont - Italy). The “Sacro Monte” is an artistic-religious complex, built between the 15th and 18th centuries, which contains 45 chapels with frescoes and sculptures (see Fig. 1). The chapels were built by means of stone or brick walls, with wooden roofs [2, 3].

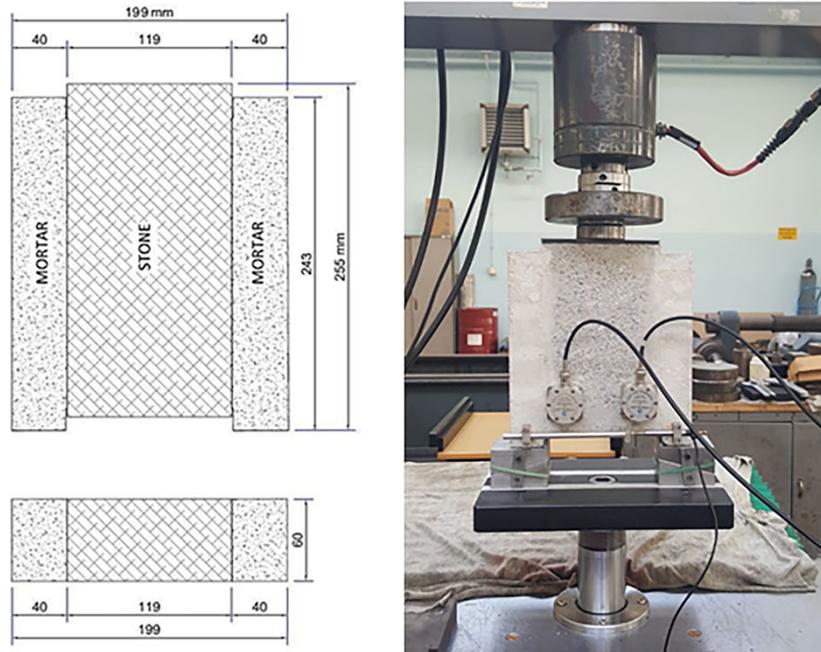
Four specimens were assembled by joining stone blocks (similar to those of the Sacro Monte masonry) to symmetrical layers of repair mortar on the two shorter vertical sides of each stone block (Fig. 2). The static test of this particular specimen, monitored by means of the AE technique, was able to assess the adherence behavior between the dehumidified mortar and the masonry structure [4]. The stone surfaces were treated by means of a

Figure 2. Geometry of mixed specimen

The dehumidifying mortar layers were applied by a symmetrical discontinuity at the bottom and the top of the specimen (Fig. 2). These notches are useful to trigger the detachment process and assess the adherence capacity of each dehumidified mortar applied to a specific masonry wall. The specimens were instrumented with an inductive horizontal displacement transducer, as shown in Fig. 2. The vertical displacements were recorded by the piston's stroke of the test machine. The shear tests were carried out through monotonous compression load

The analysis of experimental and numerical results shows four stress singularity points in the mixed specimen: two notch tips at the top, and two at the bottom (see Fig.2). For the material properties assumed, only two cohesive cracks start to propagate from the bottom side, which are the weakest points in the stress fields. A teflon sheet, inserted at the contact surface between the mortar and the steel wedges, is able to reduce the contact friction. This friction is disregarded in the numerical model that assumed the materials as homogeneous. For this reason the curve is continuous (see Fig.6). On the contrary, the properties of the rock specimen were very variable, so the experimental curve shows many discontinuities (see Fig.7). Therefore, the numerical model represents an ideal behavior, but it is not able to identify the snap-back instabilities recorded in experimental tests during the detachment progression. This process instead is well represented by the sudden increments of the AE hits [1, 2].

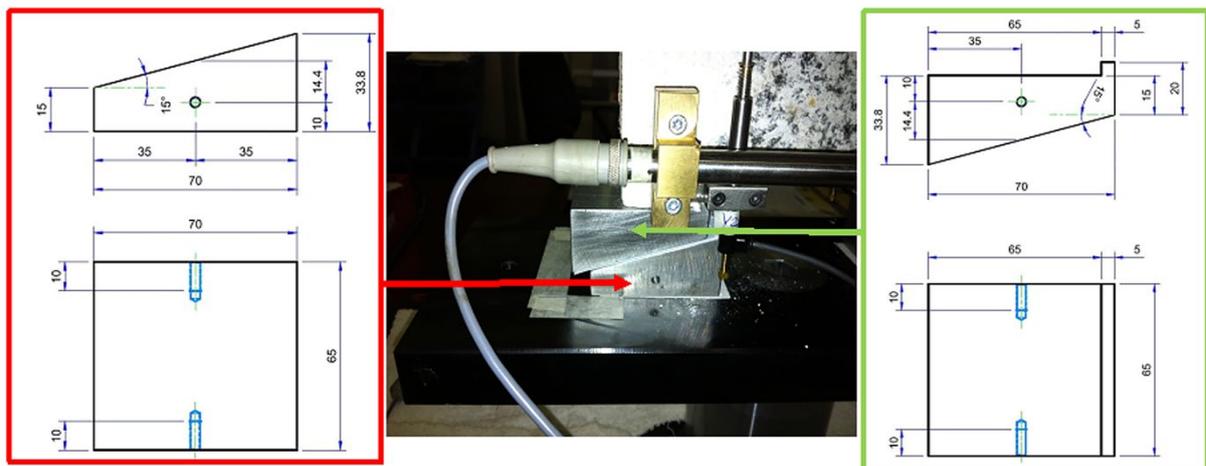
Figure 3. The geometry of the wedges

by controlling the horizontal opening. The mortar layers rested on a double system of steel wedges, as showed in Fig. 3. The steel wedges were coupled by a Teflon layer thick 1 mm in order to for reduce the horizontal friction. The specimens were labeled with “SM” (stone block-mortar), followed by a number indicating the order [1, 2].

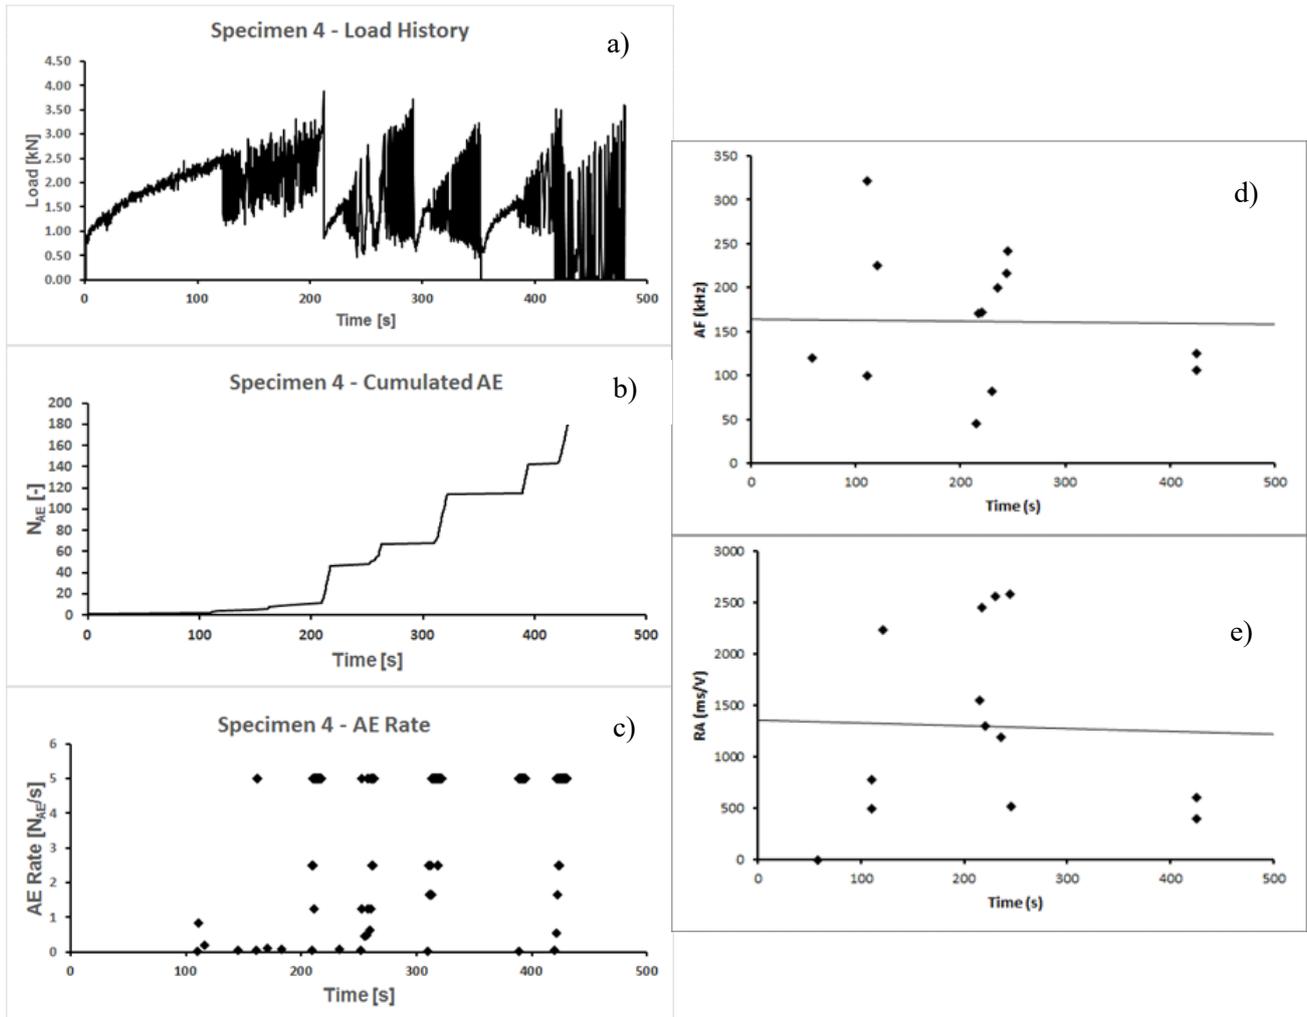
Briefly, the AE results were shown only for specimen SM4. The load vs. time diagram of the specimen SM4, together with AE cumulated curve and AE rate, is shown in Fig. 4(a-b-c). During the first part of the shear test, the load increases proportionally over time and few AE signals were recorded. However, an increase of the AE signals appeared during each sharply decrease of the load vs. time curve. In fact, the AE signals are related with the energy released in adherence surface during the de-bonding of the mortar (snap-back instabilities) [7].

The linear regression of the signal frequencies (AF) and the signals rise angles (RA) were traced (Fig. 4d-e). Considerable variations from the mean trend were observed in correspondence of specific phases during the test. In the first phase rise angles shows low values, while the frequencies have the higher values more distant from the average trend. This situation is associated to a prevalent tensile crack (Mode I) in the de-bonding

process. In the second phase, the highest values of the RAs were recorded, while the frequencies continue to oscillate with the lowest values. This behavior shows how the delamination process shifts from tensile to shear crack mode, characterized by the sliding of the mortar with respect to the stone block (Mode II). In the final phase not RAs or AF prevails, so there is no prevailing fracture mode before the specimen collapses definitively [1].

Figure 4. Diagram vs time of SM4: Load (a), Cumulated AE (b), AE rate (c), Average Frequency AF (d), Rise Angle RA (e).

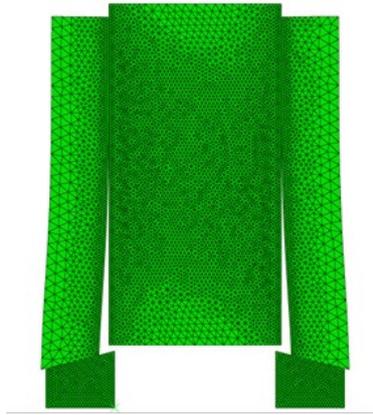
The numerical analyses were executed using the ABAQUS code by applying a pre-defined downward velocity to the upper face of the stone block. The deformed finite element mesh is shown in Fig.5.

Figure 5. Finite element mesh at the maximum load. The displacements have been enlarged 100 times.

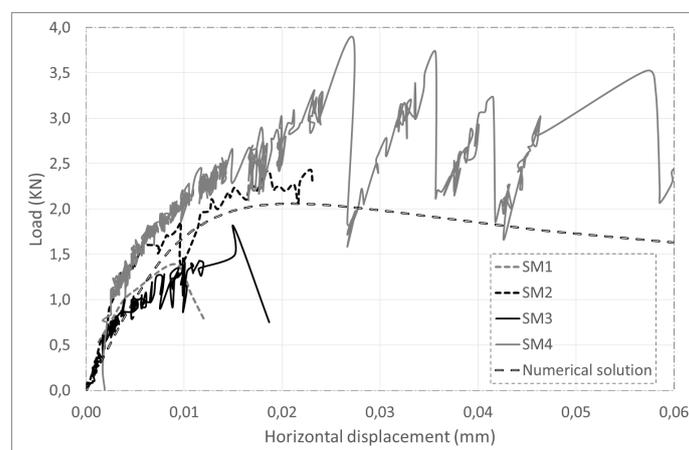
Figure 6. Load vs horizontal displacement curves of experimental test compared to numerical solution.
