Specific Energy Absorption Evaluation on GFRP Laminate Plate by Optical, Thermographic and Tomographic Analysis

Specific Energy Absorption Evaluation on GFRP Laminate Plate by Optical, Thermographic and Tomographic Analysis / Virgillito, Enrico; Airale, A. G.; Ferraris, A.; Sisca, L.; Carello, M.. - In: EXPERIMENTAL TECHNIQUES. - ISSN 0732-8818. - ELETTRONICO. - 43:1(2019), pp. 15-24. [10.1007/s40799-018-0257-y]

E. Virgillito, A. G. Airale, A. Ferraris, L. Sisca, M. Carello

Department of Mechanical and Aerospace Engineering - Politecnico di Torino

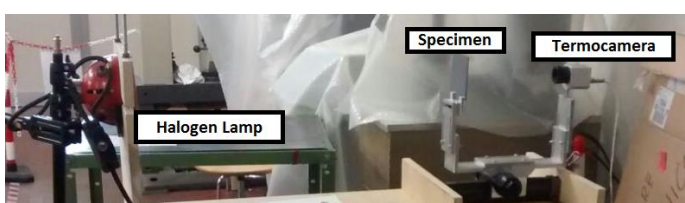
Figure 1: Test Equamente

The studied material is epoxy resin IMP503 reinforced with glass fiber pre-preg E-glass Twill 2x2 (194 g/m²) produced via autoclave vacuum bag with thickness of 2 mm. All specimen are 100mmx100mm respecting to technical standard [17] and other common practices [4]. Since the material is transparent to light, it is possible to use optical method to study energy absorption, which also allows for obtain delamination and other fracture mechanisms. This method is validated by numerous articles [18]. Two tests with impact speed of 1.5 and 6 m/s were performed, so the strain-rate effects on the materials was evaluated. In order to compare the tests at different speeds, it was necessary to set similar amount of energy for each test by varying the mass acting on the Indenter and taking into account the limitations of the test equipment. The impact tests were performed using standard ASTM D7136 [17], which define the standard for free-fall drop dart testing for composite materials. To test the specimens, Instron Ceast 9350 was used (Figure 2). The machine is an impact tests instrument designed to provide energy from 0.59 to 757 J, drop height from 0.03 to 29.4 m (emulated), impact velocities from 0.77 a 24 m/s and a drop mass from 5.0 to 70.0 kg. The dart assembly is composed of a several steel plates with a spherical tip of 16.8 mm diameter. Impact vertical speed is then evaluated from the Δt measured by passing 2 optical sensors. The calculation of the exact velocity need to be performed, in order not to overestimate the transition velocity of the impacting mass. The potential energy is considered without friction loss. The specimens are plates completely constrained on a circular hole of 76 mm in diameter by the clamping fixtures and tests were performed with an anti-rebound device. For the measurements, structure designed and built by our research group was used in order to standardize the acquisition of images from both thermal and optical cameras. It allows to fixed the light source and to vary the distances between source-specimen, the specimen-camera and their height. The following images shows the structure during thermal and optical analysis (Figure 1).

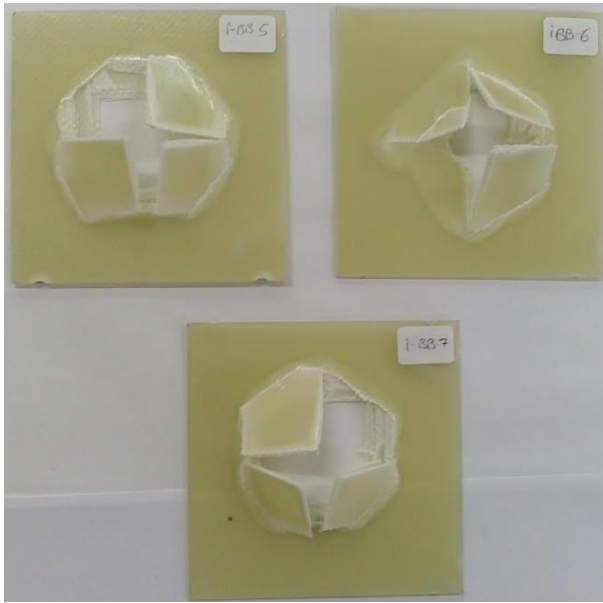
Figure 3: iBB 1.5 m/s

Data shows below in Table 1 have been filtered because the rapid variation of the kinematic energy excites vibrations, which depends on the stiffness and mass of both the specimen and the impactor. The acquisition rate was 1 MHz, which is appropriate for sufficient number of sampled points for a phenomenon normally lasts less than 100 milliseconds. E-Glass Epoxy (iBB) specimens are tested with impact speeds of 1.5m/s and 6 m/s, and their curves Energy-Displacement and Force-Displacement are shown in Figure 4 and Figure 5. It could be seen that specimens are more brittle at lower impact speeds.

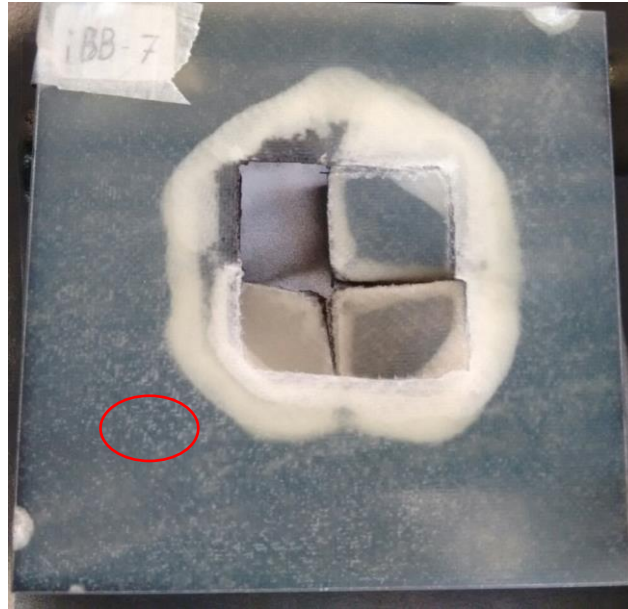
Figure 7: Micro-porosity inside a specimen

In our case $\rho_f = 2.57 \text{ kg/m}^3$, $\rho_m = 1.1 \text{ kg/m}^3$, $w_f = 0.667$ and $w_m = 1 - w_f = 0.333$ (all data are provided by material datasheets), $\rho_c = 1.78 \text{ kg/m}^3$ is calculated. After analysis the result, this method is proved unreliable for this application. The biggest issue is that the defects of productions (present in the very nature of the production process and cannot be avoid) had heavily influenced the characteristics of the material, changing the density as it is easy to note from Figure in the red circle (white dots have smaller density, where cavity is present). In the end the mass was calculated corresponding to the effective volume obtained by image correlation with knowing the initial mass of the specimen before the test.

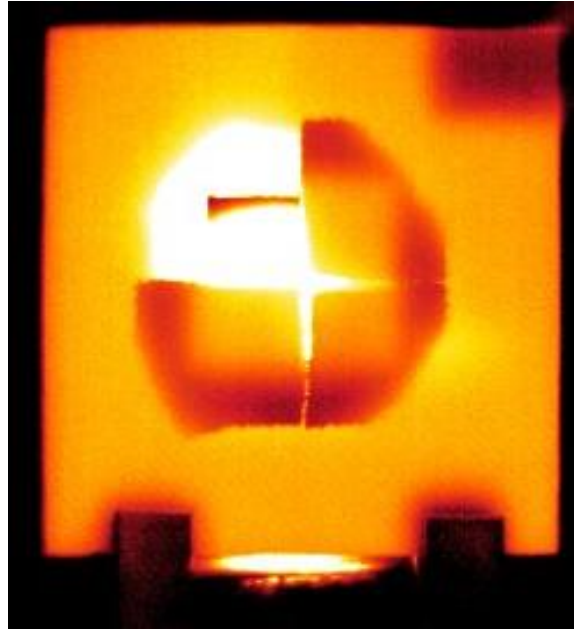
Figure 8: SEA Thermographic analysis

Since delaminated area has interspace between the layers, transmission of heat is differently than the non-damaged part, which can be observed by using IR camera. The Thermal graphic method provides more detailed information for failure phenomenon than the optical method. Through software TImage®, it is possible to create a map of points (image correlation), where each pixel and has an associated temperature. Comparing all the frames taken during the measurement, a temperature different between the first frame to the last frame can be observed with a value at least $\Delta T > 2^\circ \text{C}$. The results were obtained from 2D images of the surface of the specimens, and same assumption of constant damage along the is made to evaluate the effective volume. However, this technique can be applied to any type of material. The effective volume calculated is shown with SEA in **Errore. L'origine riferimento non è stata trovata.**:

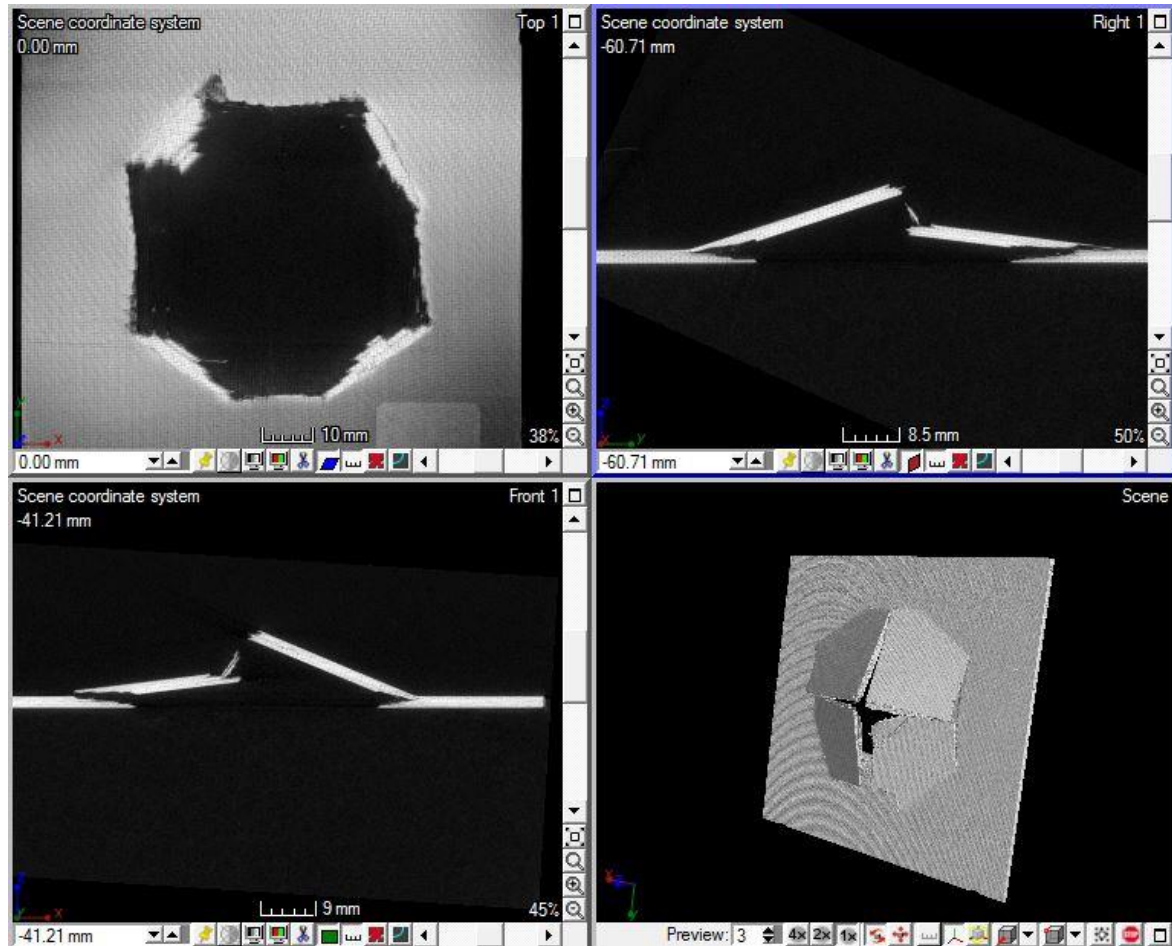
Figure 9: Specimen analysis through VG-Studio Viewer

The final test method used to determine the effective volume is the X-ray Micro-tomography, since it allows to analyze the internal structure of the material and recreate the actual state of the specimen without destroying them. Computed tomography was born as medical inspection technique and natural evolution of x-ray radiography [14]. As for radiography, computed tomography is based on attenuation that an electromagnetic wave (a sufficiently high energy and frequency x-ray) undergoes when crossing a body. For tomography, multiple analysis are taken by changing the position of the x-ray source (or the specimen). By combining all the radiographic images through a program, a 3D model of the specimen is generated. The tomographic analysis were performed using an “phoenix v|tome|x” of General Electric® using a copper target and applying a voltage of 280 kV and a current of 180 μ A in order to obtain a resolution in all three dimensions of 116 μ m resolution. To analyze the images obtained, it was used the software VG-Studio Viewer®. The results obtained through tomographic method, as shown in With three-dimensional models of specimens obtained after impact, it is possible to analyze layer by layer the failure mechanisms of GFRP. The results have precision in the order of μ m. Effective area that dissipated the impact energy is shown in Figure 10. It allows to analyzing the specimen throughout its thickness to recognize the phenomena that contributed to the fracture (delamination, fiber and matrix cracking). A precise volume and SEA can be evaluated for each individual specimen.

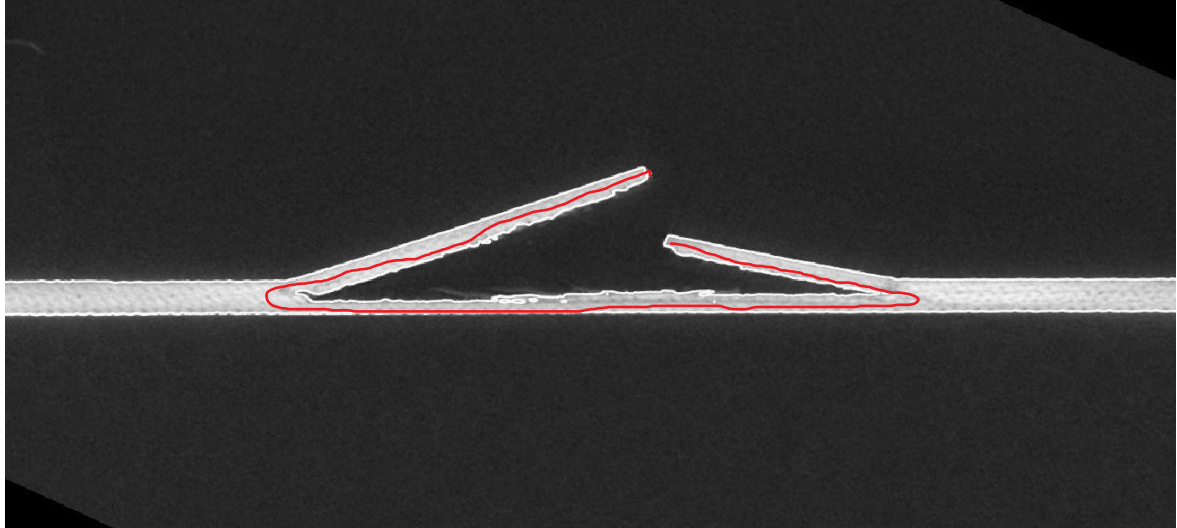
Figure 10: Fracture analysis

With three-dimensional models of specimens obtained after impact, it is possible to analyze layer by layer the failure mechanisms of GFRP. The results have precision in the order of μm . Effective area that dissipated the impact energy is shown in Figure 10. It allows to analyzing the specimen throughout its thickness to recognize the phenomena that contributed to the fracture (delamination, fiber and matrix cracking). A precise volume and SEA can be evaluated for each individual specimen.

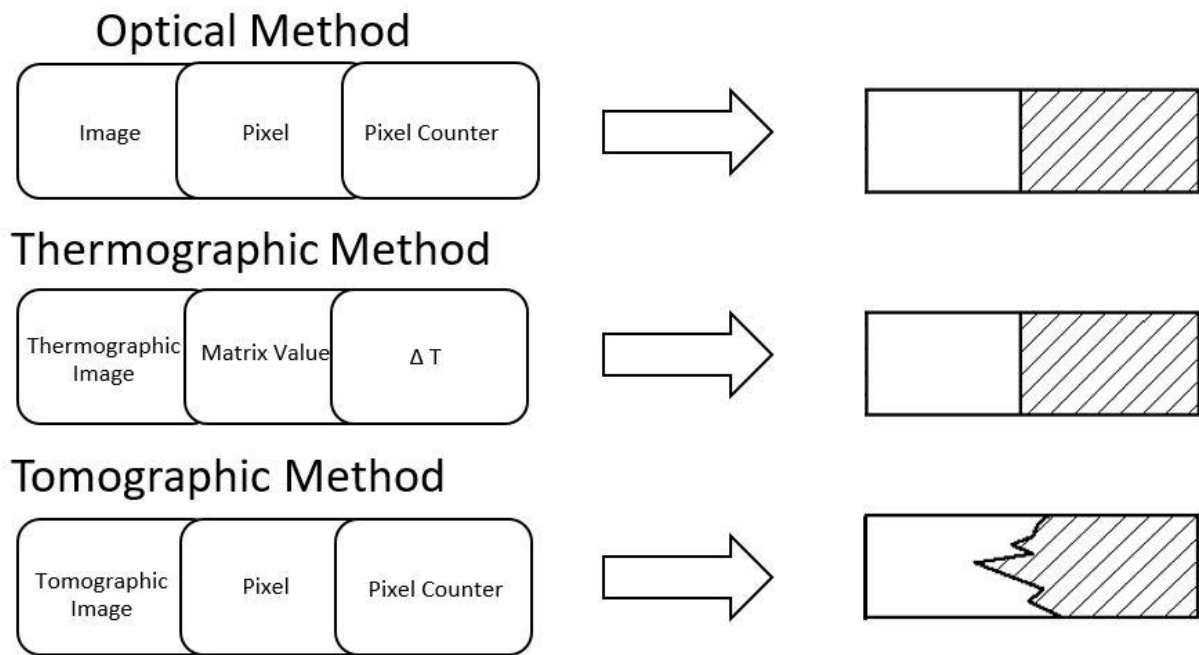
Figure 11: Measurement methods.

A fast, easy and effective way to obtain this property has been defined as using tomographic method. This is obtained through comparison of three different commonly used analysis method (Optical, Thermographic and Tomographic) as shown in Figure 11:

- The optical method for the evaluation of the SEA greatly underestimate the effective volume of the material, such consequentially effects of the evaluation of SEA. This technique is proved to be inaccurate and unreliable. It is also limited that can be applied exclusively for transparent material (at least in the interested zone).
- Both the Thermographic method and Tomographic method does not have limitations for material transparency. The result obtained by both methods are very similar to each other. They are both suitable for the evaluation of SEA.
- As shown in Table 6, the $\Delta \%$ referred to Tomographic method could be up to 20 % in Optical method, meanwhile it's below the 5 % in Thermographic case.
