Seismic resilience of road bridges: lessons learned from the 14 November 2016 Kaikōura Earthquake

A.I. Sarkis & A. Palermo

ABSTRACT: The 14th of November 2016 Kaikōura Earthquake sequence has highly affected the transport infrastructure in New Zealand. From the perspective of life-safety, the overall bridge performance was satisfactory; however, based on the observed undesirable sub-system performance of the damaged bridges, further investigation into possible improvements of the current design philosophy was warranted.

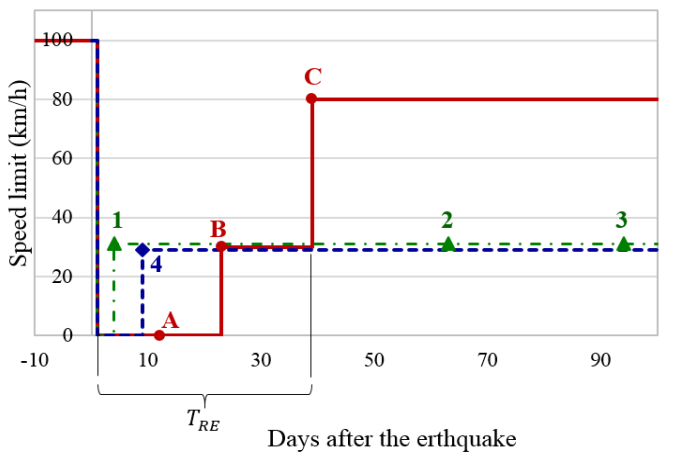
Figure 7 illustrates the recovery rate of the Inland Route and the bridges under study during the first one hundred days following the earthquake using the maximum speed allowance as a functionality indicator for normal, Class 1, vehicles. The earthquake occurred at 12:02 am on the 14th of November, causing the Inland Route to be immediately closed by the Civil Defense Emergency Management. The route remained closed until it was given access for the NZ Defense Force convoys to get through with emergency supplies to Kaikōura, on November 25th, 12 days after the earthquake (point A in Figure 7).

Figure 7. Functionality based on the maximum speed limit for the Inland Route and the four bridges under study.

The route remained fragile and hazardous, closed to the general public until the 6th of December, day 23 after the earthquake (point B in Figure 7), when controlled emergency and resident access was allowed with a speed limitation of 30km/h, 70% less than the pre-earthquake speed limit of 100km/h. Works undertaken during these days to make the severely damaged road safe enough included clearing the road of more than fifty slips, stabilizing slopes, and assessing the damage to the bridges.

It was only until the 21st (point C in Figure 7) of December when the public were granted unrestricted access to the Inland Road, bringing the first unrestricted road connection back to Kaikōura, for a total recovery time T_{RE} of 38 days after the earthquake.

The Lower Mason River Bridge was opened to traffic on November 17th, day 4 after the earthquake, (point 1 on the graph) with a speed restriction of 30km/h and a sign “one heavy vehicle at a time”.

The recovery process for the Lottery Bridge was very similar to the Lower Mason, since they share similar structure type and damage. Pier columns were unable to be inspected on the first days after the earthquake due to the bed and water level, yet, damage was anticipated to be less than at Lower Mason due to the shorter bridge columns. Excavation of pier piles occurred on November 25th confirming that damage was of a lesser extent, and pier jacketing was issued and completed around mid-February (point 3 in Figure 7).
