Seismic resilience of road bridges: lessons learned from the 14 November 2016 Kaikoura Earthquake

# Seismic resilience of road bridges: lessons learned from the 14 November 2016 Kaikōura Earthquake

A.I. Sarkis & A. Palermo  
*University of Canterbury, Christchurch, New Zealand*

**ABSTRACT:** The 14<sup>th</sup> of November 2016 Kaikōura Earthquake sequence has highly affected the transport infrastructure in New Zealand. From the perspective of life-safety, the overall bridge performance was satisfactory; however, based on the observed undesirable sub-system performance of the damaged bridges, further investigation into possible improvements of the current design philosophy was warranted. This paper describes the structural performance of the most severely damaged bridges during the Kaikōura Earthquake. The study is based on observations made during site inspections, on subsequent computational analyses performed and on a functionality database collected during the period following the event. The paper also introduces resilience indicators as a tool to predict the lifecycle performance and functionality of bridges. Finally, conclusions on the resilience and functionality of the b

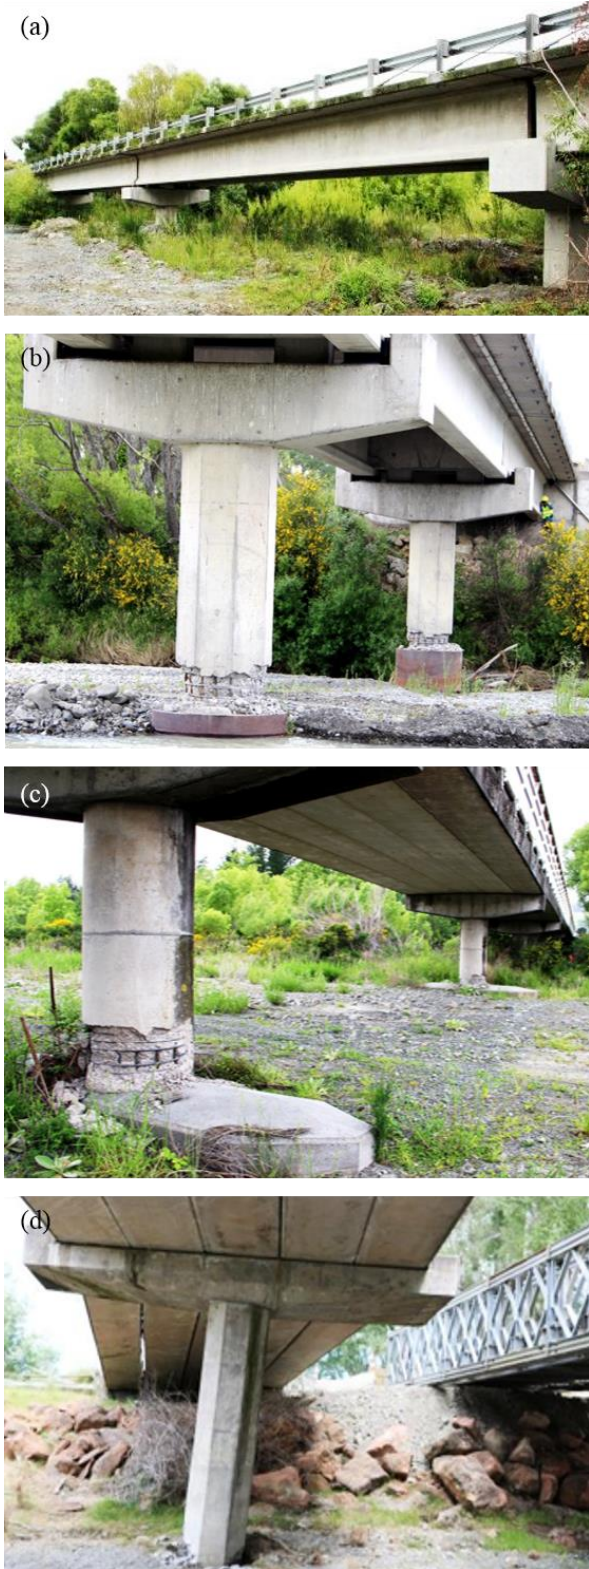
The Lottery River, Lower Mason River, Mason River, and Wandle River bridges (Figure 3) are structurally similar to one another. They are all multi-span precast concrete bridges supported on single column piers with hammer head pier caps. Further structural details are summarized in

under transverse loading such that they can displace an appreciable amount on the supporting elastomeric bearings before contacting the shear keys. As a result, the bridges make use of the low lateral stiffness of the bearings to elongate the period of the structure. Figure 3. Bridges under study: (a) Lottery River Bridge; (b) Lower Mason River Bridge; (c) Mason River Bridge; (d) Wandle River Bridge (Palermo et al., 2017).

In the way they resist lateral loading, the Lottery River (Figure 3a) and Lower Mason (Figure 3b) bridges are identical. The transverse interaction has

Similarly, the Mason River Bridge (Figure 3c) is split in two with a central movement joint. There are transverse shear keys at the abutments and internal longitudinal shear keys and linkage bars over all of the piers except the central pier. At the central pier, provision is made for longitudinal movement with loose linkage bars but steel plate lateral support stubs cast into the piers restrain the transverse movement. Therefore, the overall transverse response can be thought of as the deck having a curved displaced shape where the largest transverse displacement occurs at the central pier (Palermo et al., 2017).

The Wandle River Bridge (Figure 3d) is curved in plan and has a slope in the longitudinal direction. Linkages, shear keys and elastomeric bearings restrain the transverse and longitudinal movement over the piers, but only linkage bars resist both the transverse and longitudinal movement at the abutments. Longitudinal movement towards the backfill at the abutments is resisted by the abutment back-wall which is cast against the beams.

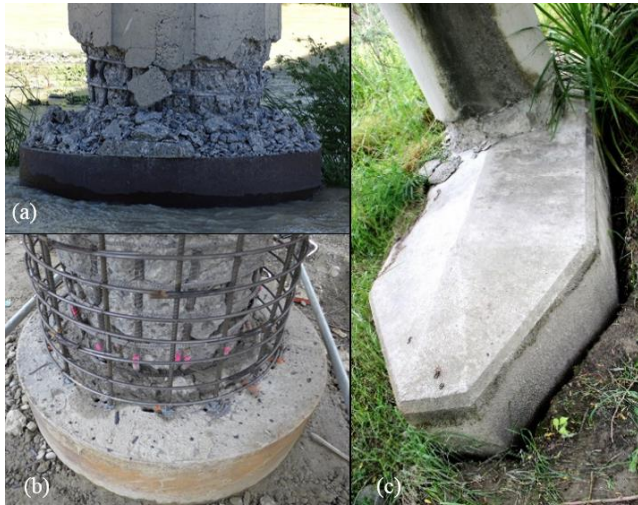
The structural scheme can play a part in the repair strategy, costs and hence resilience. In the case of monolithic bridges, repair of PH should be considered at the design stage. On the Lottery and Lower Mason bridges, the 1.5m diameter cylinder foundations located directly beneath the 1.0m diameter columns of the piers simplified the repair (Figure 8a). New reinforcement could be doweled into the existing pile and the pier re-cast, restoring the moment capacity of the column (Figure 8b). In contrast, for the Mason Bridge, repair is more difficult due to the shape and size of the pier cap (Figure 8c), as the geometry will make it very difficult to dowel in additional bars in

Figure 8. Plastic hinge repair: (a) PH in Lower Mason Bridge; (b) repair of PH by epoxy grout bars; (c) geometry at Mason River Bridge PH zones.

and re-cast concrete. The result will be a significant repair cost and potential downtime for the structure.

Designing and detailing monolithic connections taking into account the repair strategy for different design level events would optimize the recovery after an earthquake event. Furthermore, if the bridges were
