Seismic resilience of road bridges: lessons learned from the 14 November 2016 Kaikōura Earthquake

A.I. Sarkis & A. Palermo

ABSTRACT: The 14th of November 2016 Kaikōura Earthquake sequence has highly affected the transport infrastructure in New Zealand. From the perspective of life-safety, the overall bridge performance was satisfactory; however, based on the observed undesirable sub-system performance of the damaged bridges, further investigation into possible improvements of the current design philosophy was warranted.

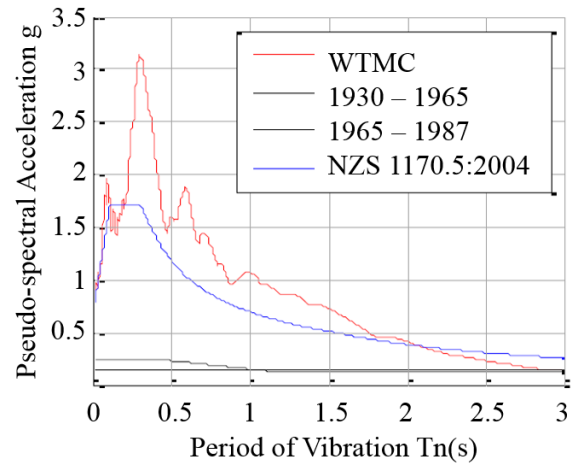
Figure 2 shows the geometric mean (of the two horizontal components) of the 5% damped elastic horizontal pseudo-spectral accelerations measured in Te Mara Farm Waiau station (WTMC), located close to Waiau (see

Figure 1). Overlaid are the NZ elastic design spectra used during three design eras. The present day elastic design spectra was taken from NZS1170.5:2004, it was obtained for a Bridge Manual Importance Level 2 (1/1000-year annual probability of exceedance, ULS) structure, soil class C, and having a Hazard factor $Z = 0.45$, with no near fault effects. The two oldest design spectra, based on working stress design, were taken from Kaiser et al. (2017), and modified for compatibility with limit state design by Palermo et al (2017).

Figure 2. Geometric mean of the pseudo-spectral acceleration measured at WTMC strong motion station (Palermo et al., 2017)

The bridges studied were designed in the period ranging from 1980 to 1987, hence, using the design spectra from the 1965-1987 era. The corresponding design spectra was greatly exceeded, as it can be seen in Figure 2. Most bridges had elastic periods of vibration within the range of 0.2 s to 1.0s, which is the period of vibration where the ground shaking at WTMC exceeded even the modern design spectra (Figure 2). The bridges had a transverse period of
