REVERSE INFORMATION MODELING FOR HISTORIC ARTEFACTS: TOWARDS THE DEFINITION OF A LEVEL OF ACCURACY FOR RUINED HERITAGE

C. Santagati¹, M. Lo Turco², R. Garozzo¹

KEY WORDS: Laser scanning, digital photogrammetry, 3D modeling, H-BIM, Level of Geometry, Level of Accuracy

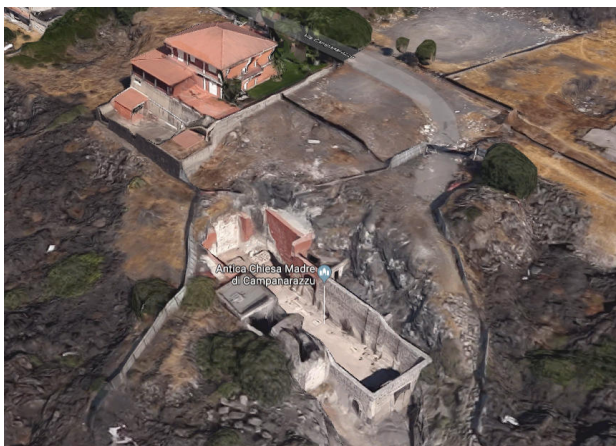
Figure 3. Church of Santa Maria delle Grazie after the digging campaign and the first walls consolidation works. (Google Map)
The church raised on a hill and was accessible via a 18 steps staircase. The longitudinal axis of the church is disposed on the East-West directrix along which lies the main entrance. The only surviving elements of the portal were the left abutment and pedestal (figure 4).

During the time, professionals and amateurs get into the volcanic caves and discovered that several architectural elements of the church under the lava flow were still preserved (Politano et al, 1999). This led the Superintendence of Cultural and Environmental Heritage of Catania to start a digging campaign carried out between 2001 and 2009 which interested the excavation of about 12 of basalt lava. At the end of the works, the entire layout of the church appeared partially preserved as well as walls, altars, flooring, plus a series of fragments of decorative elements (figure 3).

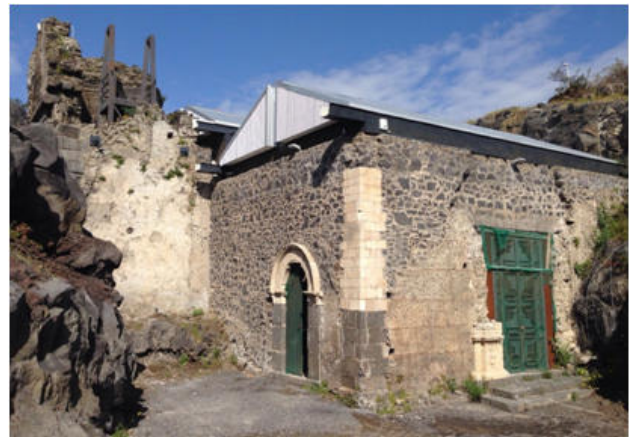
Figure 4. Main and lateral entrance to the church

Regarding the other two entrances, one gives access to the nave, the other one to the presbytery. The portal of the first one, located in the southern wall, has been reassembled by the Superintendence. It represents an interesting example of Aragonese-Catalan architecture built between the XVth and the XVIIth centuries. The second one is only visible from the inside and is still "walled" with lava stones placed as protection by the inhabitants before leaving the site.

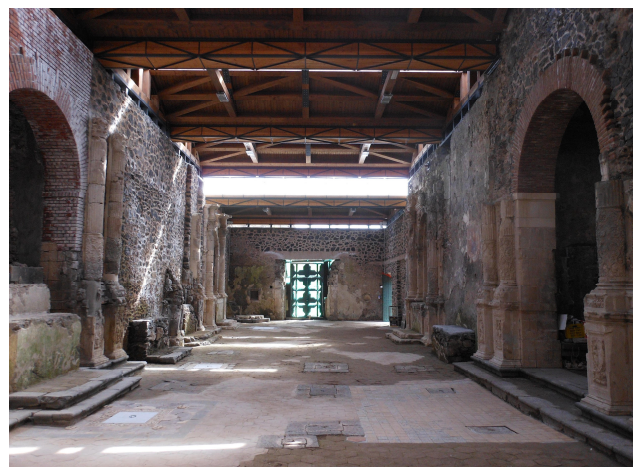
Figure 5. Interior of the church

The interior of the church was enriched by altars, built in XVIIth century. The floor, made in hexagonal terracotta tiles, is punctuated by the presence of hatches (some in lava stone, other in marble) that closed the access to the underlying burials (figure 5).

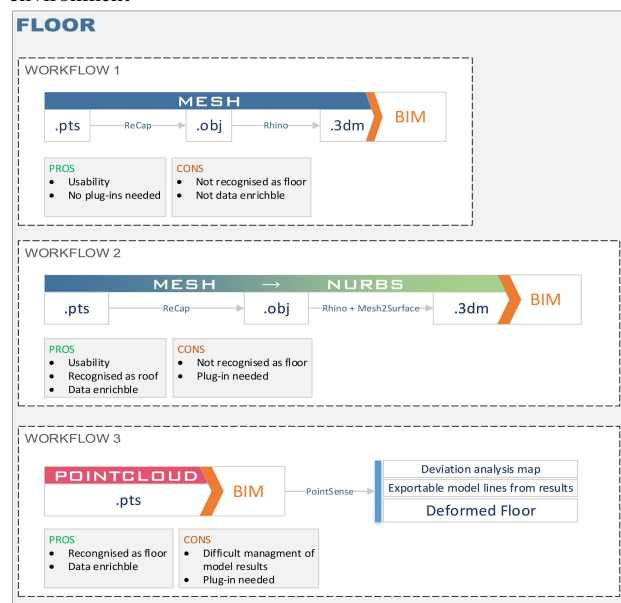
Figure 11. Synthetic schema that shows the results of the 3 workflows on the floor in terms of pros and cons

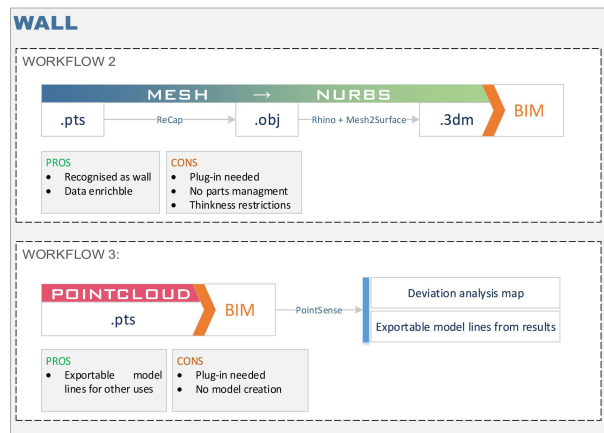
Figure 13. Synthetic diagram that shows the results of workflow 2 and 3 on the walls in terms of pros and cons

4.2.3 Results Workflow 3: Once loaded the point cloud into the project and modelled the wall in the Revit environment, taking as reference a horizontal section made at the ground connection, it was possible to generate only the range maps and deformation polylines exportable: deformation with PointSense is allowed only for walls and roofs. The analysis was therefore limited to the extrapolation of these data.
