Quantifying the seismic resilience of bridges: a pathway towards a Resilience-Based Design

A.I. Sarkis & A. Palermo

ABSTRACT: The loss of functionality of road networks during the past Canterbury (2010-2011) and Kaikoura (2016) earthquakes has questioned New Zealand's established seismic resilience. The excessive direct and indirect costs due to downtime and non-structural damage highlighted the need to move towards new performance indicators. Resilience holds the key to describe the performance of modern structures by requiring low failure probabilities, reduced consequences from failures, and less recovery time. Combining the concepts of resilience directly with the structural design process can increase the confidence in implementing damage-resistant technologies to reduce the damage of bridges in an earthquake. Furthermore, translating resilience measures with concise and meaningful terms to decision makers will lead to a better understanding of the benefits of mitigation.

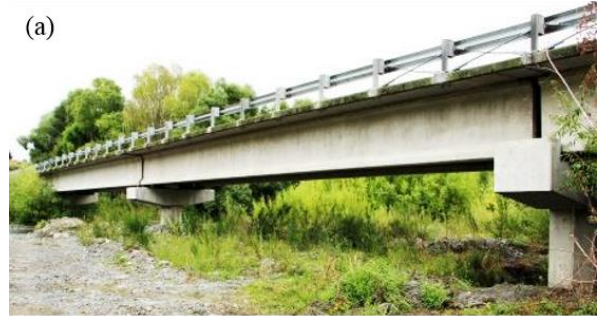
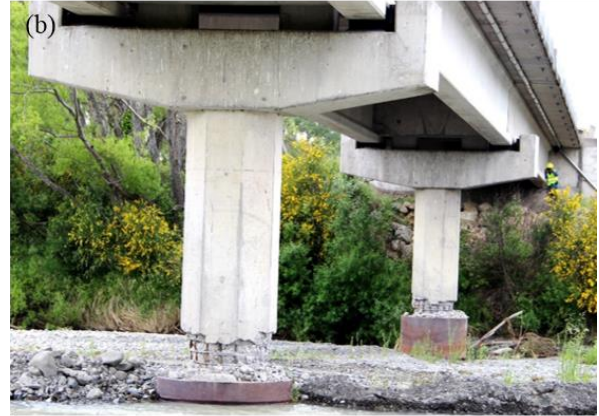
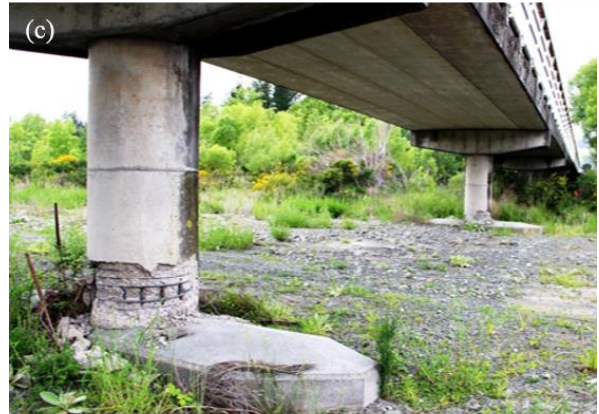
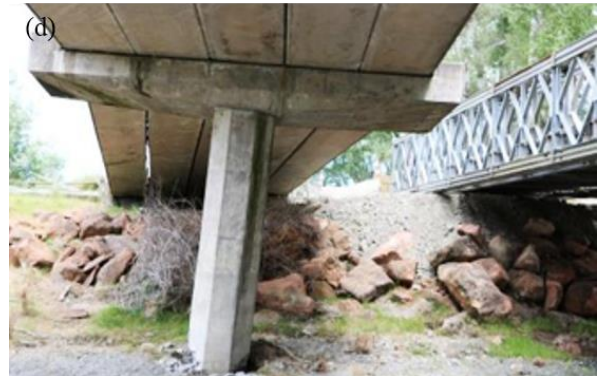
Figure 3. Bridges under study: (a) Lottery River Bridge; (b)

The Lottery River, Lower Mason River, Mason River, and Wandle River bridges (Figure 3) are structurally similar to one another. They are all multi-span precast concrete bridges supported on single column piers with hammer head pier caps. Further structural details are summarized in

In the way they resist lateral loading, the Lottery River (Figure 3a) and Lower Mason (Figure 3b) bridges are identical. The transverse interaction has been isolated by the omission of transverse shear keys at the central pier (Palermo et al., 2017). In addition, they use a rudimentary form of seismic isolation under transverse loading such that they can displace an appreciable amount on the supporting elastomeric bearings before contacting the shear keys. As a result,

Lower Mason River Bridge; (c) Mason River Bridge; (d) Wandle River Bridge (Palermo et al., 2017).

The longitudinal interaction between each half of the bridge has been isolated by a movement joint with knock off detail. The deck beams are tied together longitudinally except over the central pier. The beams rest on wide seats, thus, all piers resist longitudinal lateral loading, except the central pier, which is effectively much more flexible. Until the beams contact the shear keys, the overall transverse response

Similarly, the Mason River Bridge (Figure 3c) is split in two with a central movement joint. There are transverse shear keys at the abutments and internal longitudinal shear keys and linkage bars over all of the piers except the central pier. At the central pier, provision is made for longitudinal movement with loose linkage bars but steel plate lateral support stubs cast into the piers restrain the transverse movement. Therefore, the overall transverse response can be thought of as the deck having a curved displaced shape where the largest transverse displacement occurs at the central pier (Palermo et al., 2017).

The Wandle River Bridge (Figure 3d) is curved in plan and has a slope in the longitudinal direction. Linkages, shear keys and elastomeric bearings restrain the transverse and longitudinal movement over the piers, but only linkage bars resist both the transverse and longitudinal movement at the abutments. Longitudinal movement towards the backfill at the abutments is resisted by the abutment back-wall which is cast against the beams.
