Indoor and outdoor atmospheric corrosion monitoring of cultural heritage assets

## Indoor and outdoor atmospheric corrosion monitoring of cultural heritage assets

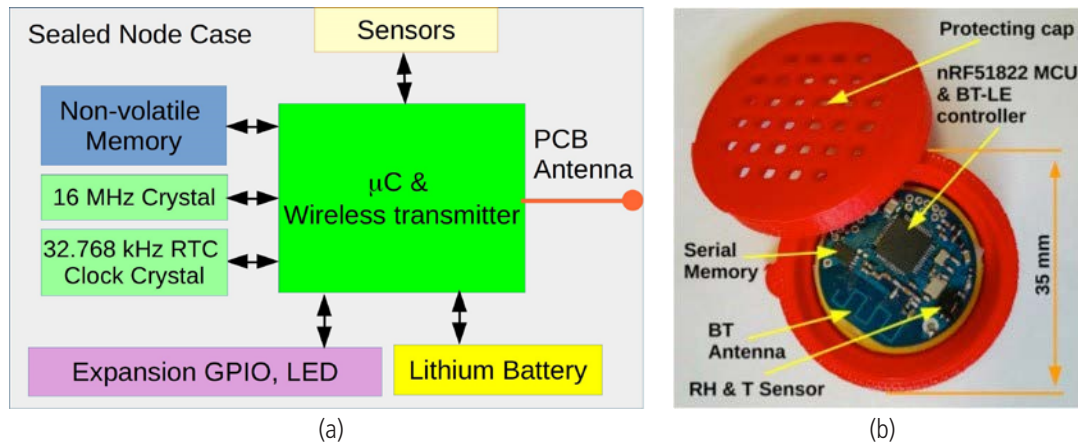
The simplified block diagram of the nodes is shown in Fig. 2, together with the image of a realized prototype. The core of the sensing node is System-on-Chip CC2510 (by Texas Instrument), which features a 8-bits low-power microcontroller and a 2.4 GHz radio transceiver. The firmware running on the microcontroller performs all the operations required for collecting and transmitting the data. A non-volatile flash memory allows an on-board permanent data storage, guaranteeing a permanent backup of more than 125000 measurements. Temperature and relative humidity are measured by a digital sensor type SHT21 (by Sensirion), which provides an uncertainty of 0.3 °C and 2% for T and RH, respectively. The sensor communicates with the microcontroller using a I2C interface and it is periodically disabled in order to reduce power consumption. The node sampling rate can be

selected by the user from 1 s to 3600 s. The clock crystal is used for generating the microcontroller main clock and the transceiver carrier, while an antenna allows the wireless communication. The nodes are battery operated and enclosed in a 3D-printed box (25 x 16 mm), which can be realised in different shape, material and color in order to be compatible and less invasive for the different environments.

**Fig. 2** - The simplified block diagram of the sensor node (a), sensor prototype (b)

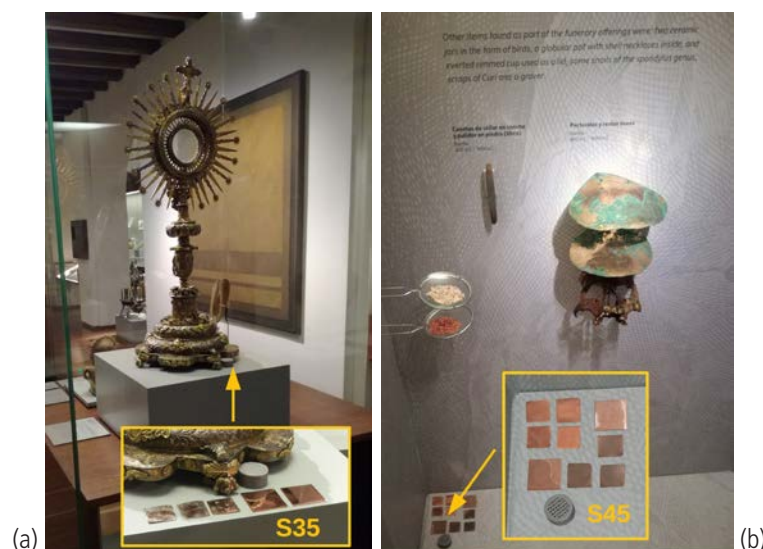
Fig. 3 shows two of the showcases, under study, with bronze and gold artefacts, where the sensor nodes S35 and S45 have been placed. Sensor S35 is located in room 13, "Custodia", a large room at the first floor. The image inset also shows a details of the Cu coupons. Sensor S45 is located in room 6, Boveda 'El oficio del Orfebre', in the showcase 'Tumba de pozo con camara', an armored room, at the ground floor.

**Fig. 3** – Sensors and Cu reference samples positioning in the National Museum of Colombia. (a) sensor S35 located in room 13; (b) sensor S45 located in room 6.

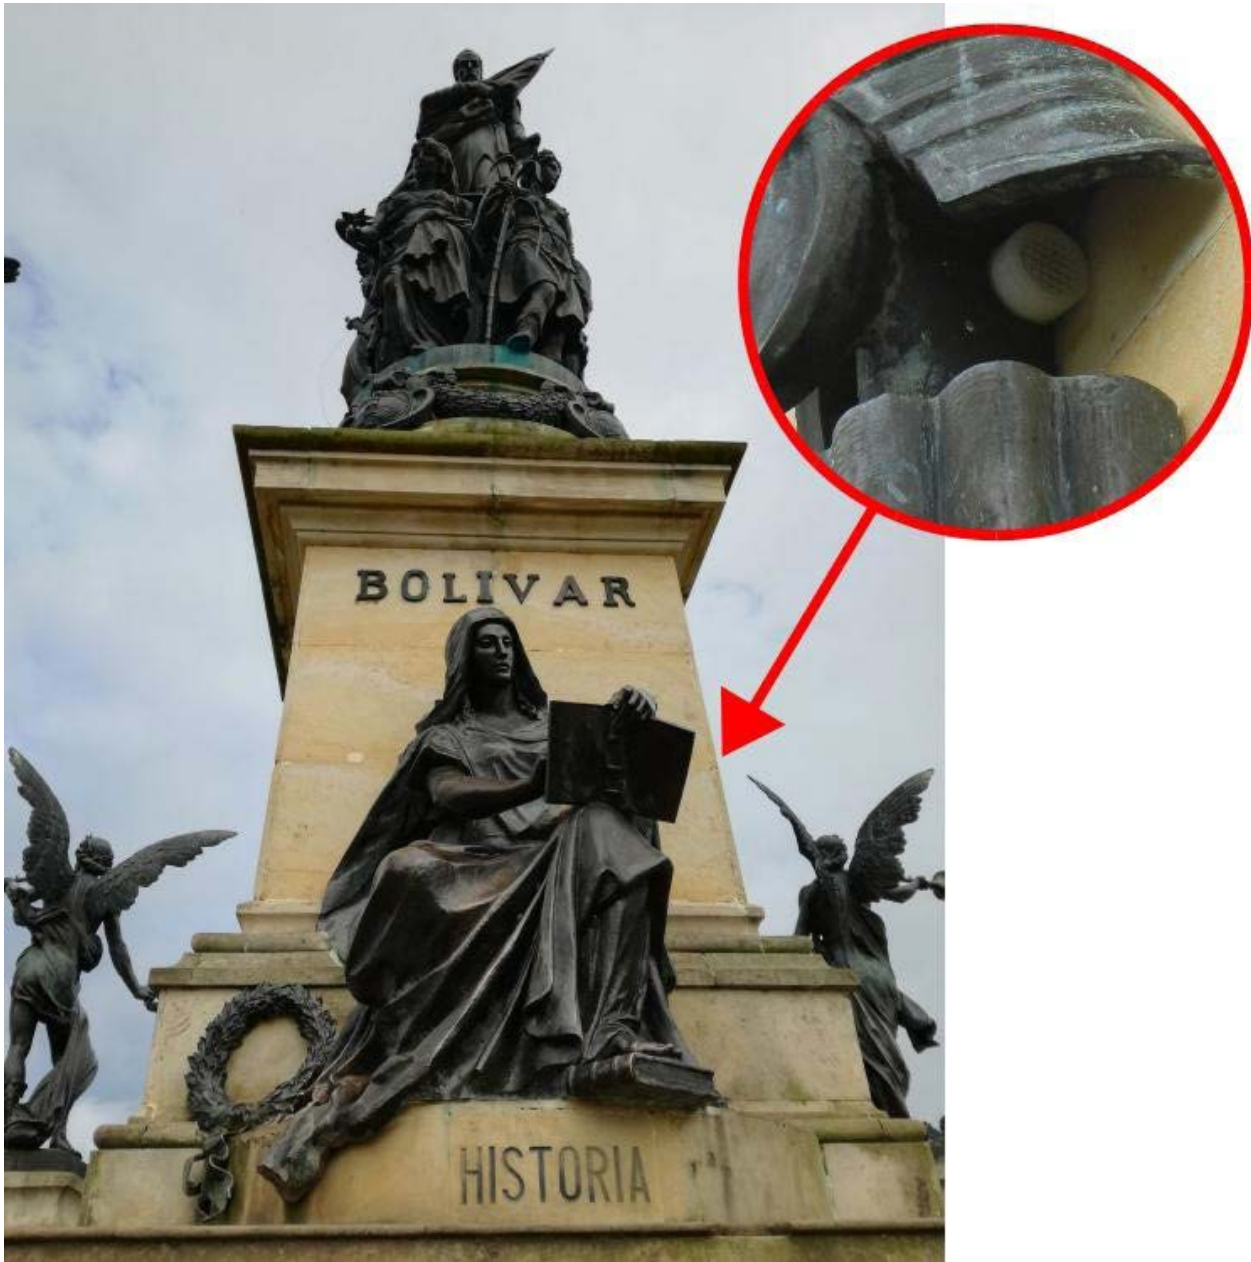
statue of Francisco de Paula Santander, the monument of Pedro Pascasio Martínez and, on the hill, the Von Miller Monument are also part of this important historical site. The Von Miller Monument, shown in Fig. 6, is a bronze monument composed by five allegoric female figures, symbolic of Colombia, Venezuela, Peru, Ecuador and Bolivia, holding Simón Bolívar (1783-1830), the liberator from the Spanish government and the first president of Gran Colombia.

**Fig. 6** – The Simon Bolivar bronze statue in the Puente de Boyacá, an historical site built in the early 18<sup>th</sup> century, memorial of independence in 1920.

The bronze statues of the Von Miller monument are apparently in a quite good conservation state even if tourists are allowed to climb the monument, risking of removing the surface patina grown on the metal by the interaction with the atmosphere. However, this anthropic damage is less important respect to

the atmospheric conditions the statues are exposed to. Actually, the monument is located at an altitude of about 2800 m and is exposed to a subtropical climate. In this geographical region, temperature remains all over the year in the range 7- 17°C, with an alternation of more or less dry and rainy seasons, but with a

high possibility of rain every day. As a matter of facts, the relative humidity can reach 90-100% every day all over the year, leaving the monument exposed to atmospheric corrosion in very aggressive conditions.

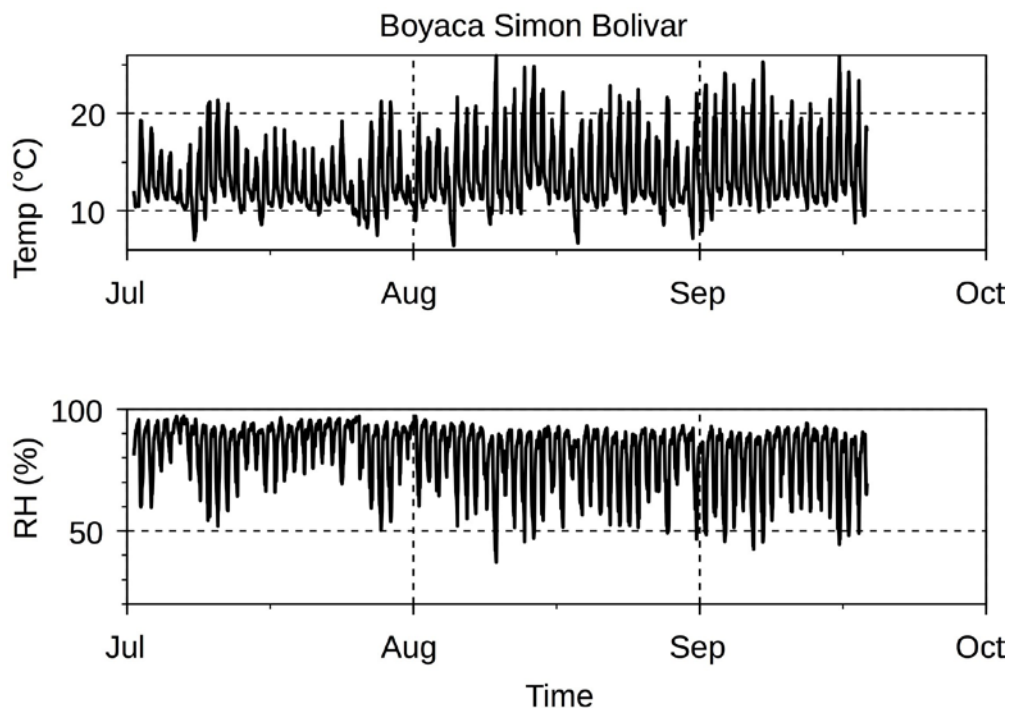
The monitoring activity started in July 2017 at the Puente de Boyacá. The measurement data, acquired by the node S49 on the Von Miller Monument (Simon Bolivar statue) for more than two months, are reported in Fig. 7. The collected data show very large daily variations of both temperature and relative humidity of about 20°C and 50 %RH. Specifically, the measurements let one to observe how the humidity can get close to 100% during the night with the risk of water condensation on the statues.

These environmental conditions are very harsh, being the site at 2800 m on the sea level in a tropical region, and can severely affect the conservation of the metallic statues mainly due to the possibility of repeated water condensation.

**Fig. 7** – Temperature and relative humidity recorded by the sensor S49 at Puente de Boyacá (Von Miller Monument).
