Experimental Fatigue Test for Pre-Qualification of Repair Mortars Applied to Historical Masonry

Experimental Fatigue Test for Pre-Qualification of Repair Mortars Applied to Historical Masonry / Grazzini, A. - In: Advanced Engineering Testing / Aidy A.. - STAMPA. - London : IntechOpen, 2018. - ISBN 978-1-78984-243-2. - pp. 3-22 [10.5772/intechopen.79543]

Alessandro Grazzini

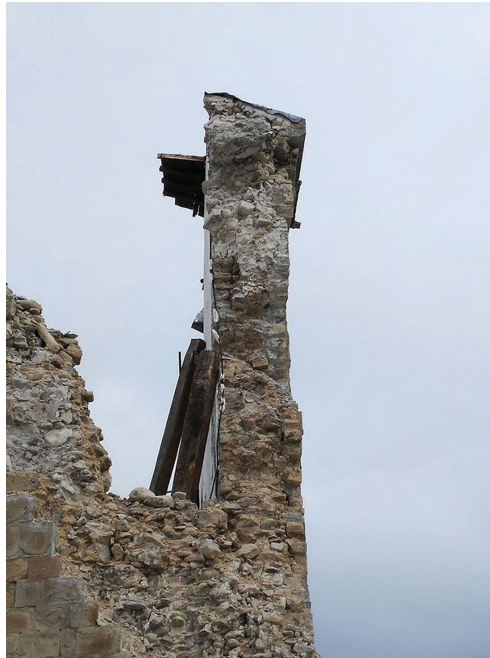
Figure 1. Collapse of the St. Agostino church in Amatrice after the Central Italy earthquake 2016 (image courtesy of the Curia of Rieti).

Recent earthquakes have shown the clear failure of restoration work performed with the use of concrete materials, the excessive stiffness of which has completely distorted the original characteristics of historical masonry buildings. **Figure 1** shows the ineffectiveness of the cementitious insertion materials inside historical walls of the St. Agostino church, collapsed during the last great Italian earthquake of Amatrice, just in correspondence with the previous stitching made by cement injections.

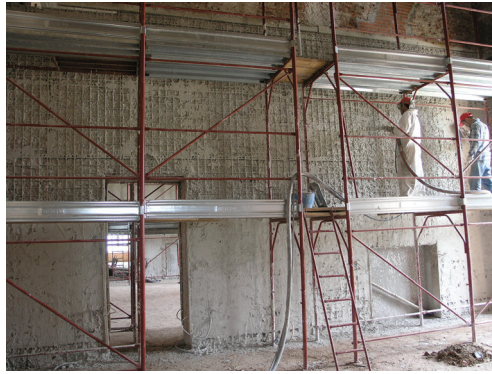
Figure 15. Application of mortar D as the reinforced plaster to Venaria's masonries.

came from the real application of mortar D as reinforced plaster retrofitting of some walls of the Royal Palace of Venaria (**Figure 15**). After 10 years, this plaster does not present any pathology of incompatibility.

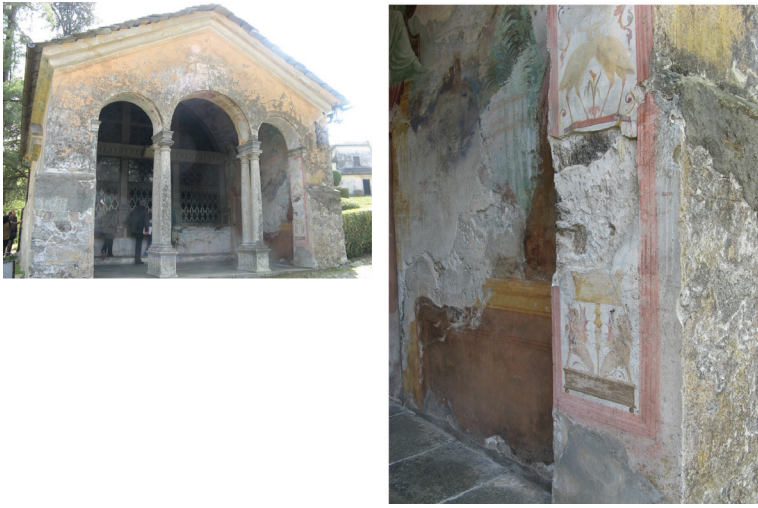
Figure 16. Decay of historical plasters because of the rain infiltrations (Sacro Monte of Varallo).

An innovative laboratory procedure, developed at the Non-Destructive Testing Laboratory of the Politecnico di Torino, is described for test mechanical adhesion of new repair mortars. Compression static tests were carried out on composite specimen stone block-repair mortar, which specific geometry can test the de-bonding process of mortar in adherence with a stone masonry structure. The methodology is being used at Sacro Monte di Varallo Special Natural Reserve. Situated at the top of the hill above the town of Varallo in Piedmont (Italy), Sacro Monte is an artistic-religious complex consisting of 45 chapels, which contain with frescoes and sculptures that tell the story of the life of Christ (**Figure 16**).

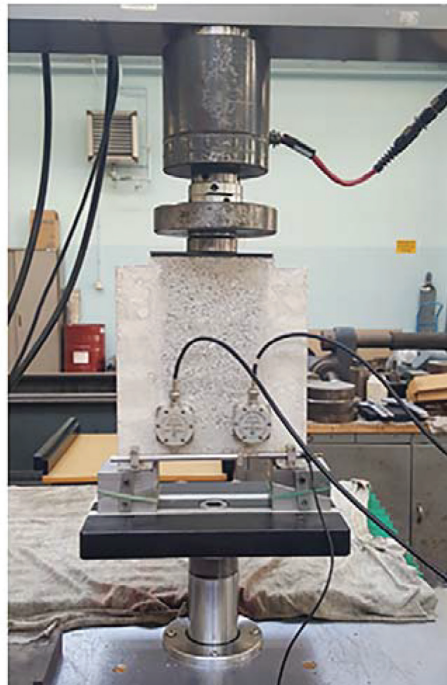
Figure 17. Geometry of composite specimen and test setup.

For carrying out tests, a particular geometry of the composite specimen has been proposed. Four mixed specimens were made, applying a 40 mm mortar layer to both shorter faces of the stone brick suitably cut with the dimensions shown in **Figure 17**. The mechanical characteristics of the repair mortar and the stone brick were chosen equivalent to those of the stone masonry at the Sacro Monte di Varallo. The experimental test can carry out also by masonry brick, if the historical walls were made by bricks. The hydraulic lime mortar was a pre-blended transpiring product, for dehumidifying repair work on historical masonry
