Experimental Fatigue Test for Pre-Qualification of Repair Mortars Applied to Historical Masonry

Experimental Fatigue Test for Pre-Qualification of Repair Mortars Applied to Historical Masonry / Grazzini, Alessandro - In: Advanced Engineering Testing / Aidy A.. - STAMPA. - London : IntechOpen, 2018. - ISBN 978-1-78984-243-2. - pp. 3-22 [10.5772/intechopen.79543]

Alessandro Grazzini

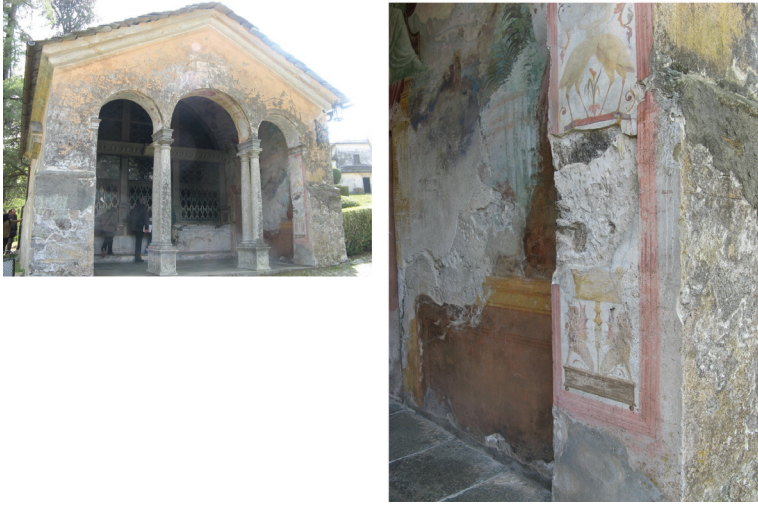
Figure 16. Decay of historical plasters because of the rain infiltrations (Sacro Monte of Varallo).

An innovative laboratory procedure, developed at the Non-Destructive Testing Laboratory of the Politecnico di Torino, is described for test mechanical adhesion of new repair mortars. Compression static tests were carried out on composite specimen stone block-repair mortar, which specific geometry can test the de-bonding process of mortar in adherence with a stone masonry structure. The methodology is being used at Sacro Monte di Varallo Special Natural Reserve. Situated at the top of the hill above the town of Varallo in Piedmont (Italy), Sacro Monte is an artistic-religious complex consisting of 45 chapels, which contain with frescoes and sculptures that tell the story of the life of Christ (**Figure 16**).

The main problem of historical plasters' preservation is linked to the rain infiltrations and to the freezing-thawing cycles that compromise their adhesion to stone masonries. Through compression static tests on stone-mortar composite specimens, it was possible to prequalify the dehumidified mortar with greater durability guarantees. Sometimes the long-term detachment determined the failure of the restoration work. The test validates the mechanical

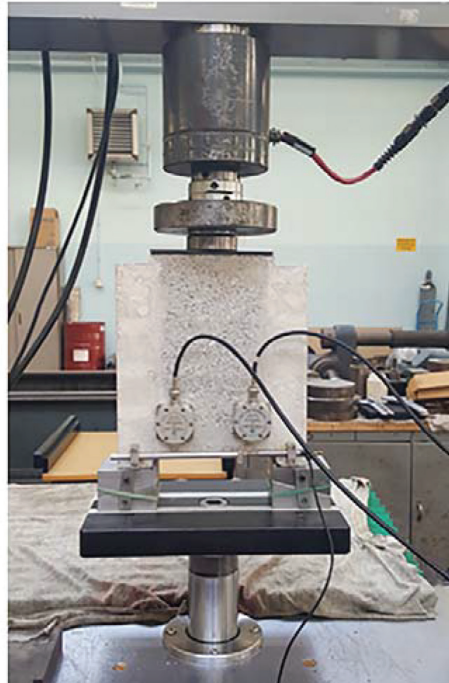
Figure 17. Geometry of composite specimen and test setup.

For carrying out tests, a particular geometry of the composite specimen has been proposed. Four mixed specimens were made, applying a 40 mm mortar layer to both shorter faces of the stone brick suitably cut with the dimensions shown in **Figure 17**. The mechanical characteristics of the repair mortar and the stone brick were chosen equivalent to those of the stone masonry at the Sacro Monte di Varallo. The experimental test can carry out also by masonry brick, if the historical walls were made by bricks. The hydraulic lime mortar was a pre-blended transpiring product, for dehumidifying repair work on historical masonry
