Experimental Fatigue Test for Pre-Qualification of Repair Mortars Applied to Historical Masonry

Experimental Fatigue Test for Pre-Qualification of Repair Mortars Applied to Historical Masonry / Grazzini, Alessandro - In: Advanced Engineering Testing / Aidy A.. - STAMPA. - London : IntechOpen, 2018. - ISBN 978-1-78984-243-2. - pp. 3-22 [10.5772/intechopen.79543]

Alessandro Grazzini

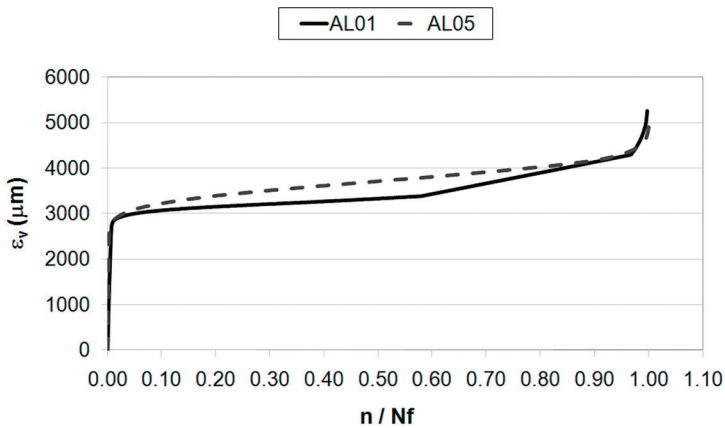
Figure 6. AL series cyclic tests: max vertical deformation.

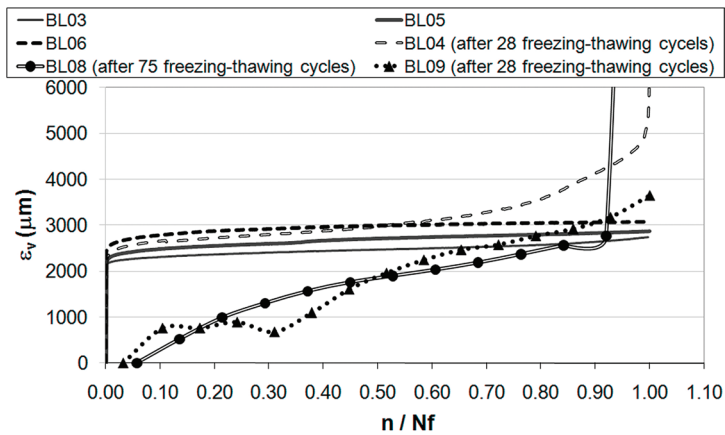
Figure 7. BL series cyclic tests: max vertical deformation.

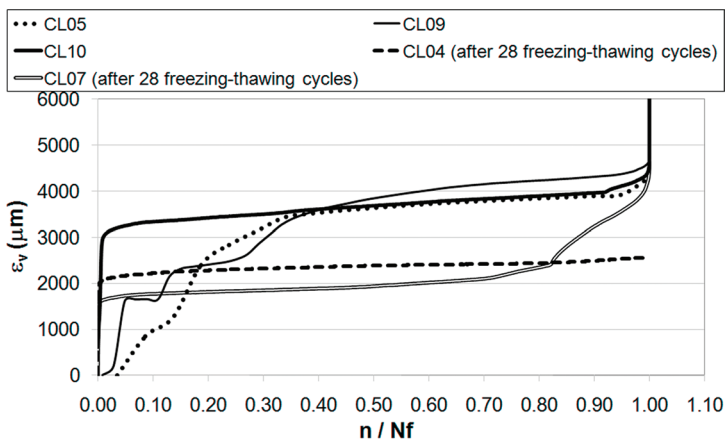
Figure 8. CL series cyclic tests: max vertical deformation.

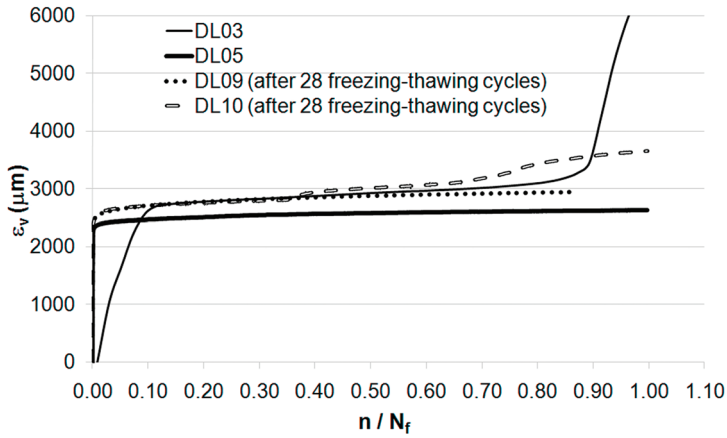
Figure 9. DL series cyclic tests: max vertical deformation.

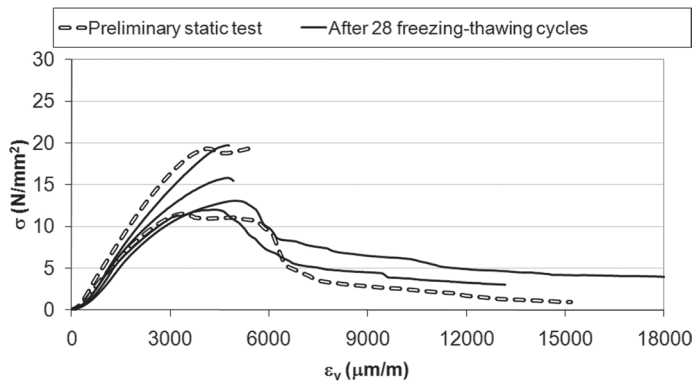
Figure 11. AL series static tests.

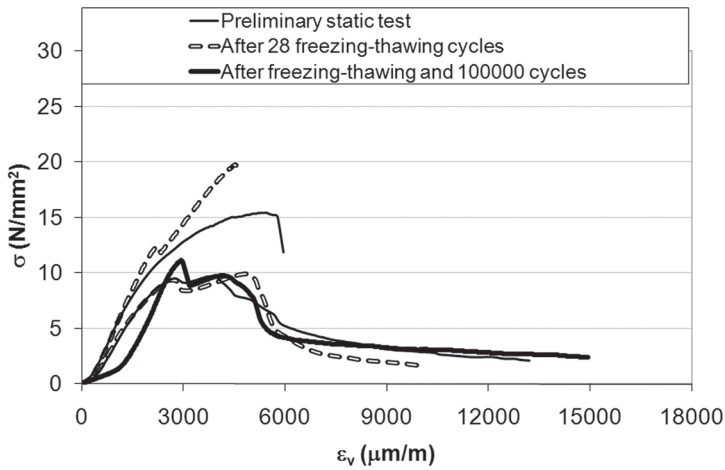
Figure 13. CL series static tests.

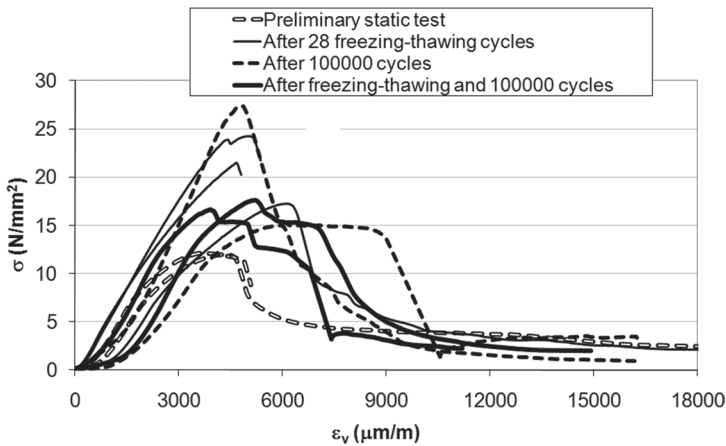
Figure 14. DL series static tests.

The values obtained for a majority of the series remained within the average of the two preliminary tests, save for the series DL (Figure 14), which displayed a considerable increase in strength. In most cases, static curves after freezing-thawing revealed a more brittle behavior. Test pieces of BL and DL series that passed 1,00,000 cycles mark were tested to failure: the DL series displayed a noticeable increase of their mechanical properties. Some CL and DL test pieces were subjected both to freezing-thawing test and to cyclic loading: CL maintained a static behavior similar to the weakest preliminary test result; instead in the DL series, an appreciable increase of strength was mated to a lesser degree of brittleness compared to the test pieces subjected to cyclic loading only.
