In Situ Analysis of Plaster Detachment by Impact Tests

Alessandro Grazzini

An experimental analysis of the stability of the decorated plaster covering three masonry vaults of the Birago Palace (16th century, planned by Filippo Juvarra) in the center of Turin was described by the use of the impact method test. The frescoed vaults of the Pelagi, Blu, and Giunta rooms showed some small cracks branched out in a layer of plaster that needed an evaluation regarding the risk of detachment (Figures 1–3). Surveys carried out on several points of the vaulted surfaces allowed mapping of the points of potential detachment of the de-coated plaster.

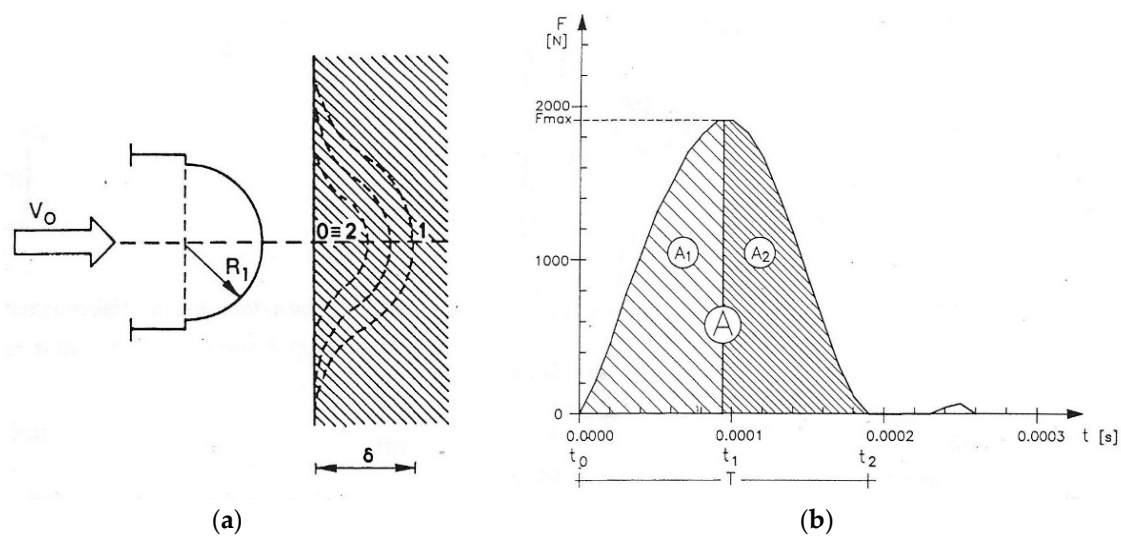
Considering the instant t_0 in which the mass touches the surface and the instant t_1 in which the maximum contact deformation δ occurs and in which the velocity v_0 is canceled (Figure 6a), the corresponding momentum variation results:

The force impulse is given by the area A_1 subtended to the curve (F, t) obtained experimentally as shown in the Figure 6b.

Figure 6. (a) Geometry of the mobile mass; (b) force–time curve obtained from an impact test.

Figure 6b shows that the return coefficient is given by the following equation:
