3D DIGITAL AND PHYSICAL RECONSTRUCTION OF A COLLAPSED DOME USING SFM
TECHNIQUES FROM HISTORICAL IMAGES

C. Beltrami¹, D. Cavezzali², F. Chiabrando³, A. Iaccarino Idelson⁴, G. Patrucco^{3*}, F. Rinaudo³

1.1 The collapsed dome of S. Pietro Church in Tuscania

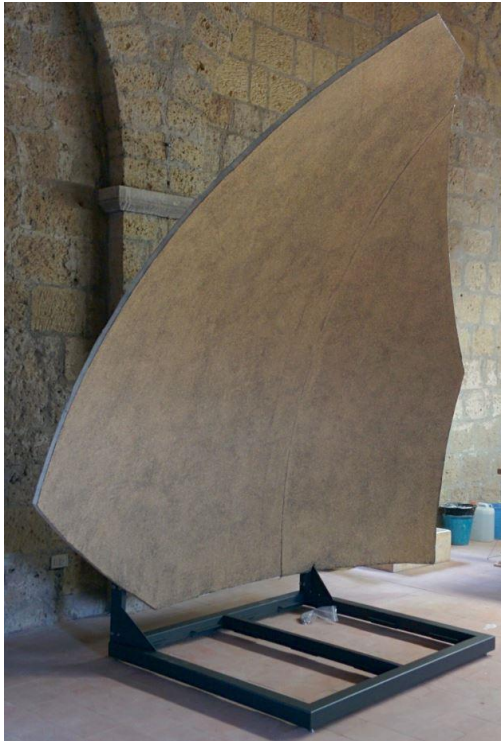
Figure 12. The support panel and structure.

The panels were built with a layered sandwich structure, Carbon fibre/epoxy – end grain balsa wood - Carbon fibre/epoxy. Each layer is soft and flexible during the construction and, while the epoxy resin completes its curing, needs to be held in place within a vacuum envelope on the surface of the counterform. In this case, a portion of sphere shaped with hot wire from large blocks of polystyrene.

The sandwich structure provides the required rigidity of the wide panels, independently from the display stands in steel, thanks to the choice of the carbon (416 g/m²) and of the thickness of the balsa core material (20 mm). On the rear of the cutting line, a broad molded rabbet plate was built with a lay-up of 8 layers of carbon, to be used for securing all the way the joining area with bolts. The structures were built by Equilibrarte srl under the direction of Antonio Iaccarino Idelson and Carlo Serino. In the following Figure 12 the final result is shown.

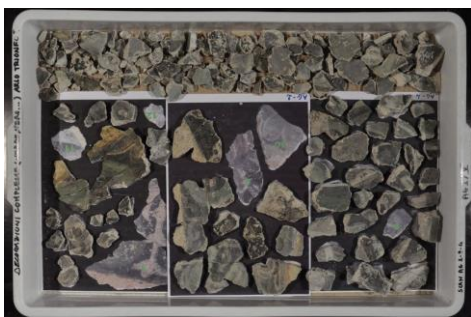
Figure 13. Example of classified fragments.

After the earthquake of 1971, the fragments of the fresco collected from the area of the apse of the Church of S. Pietro in Tuscania have been subjected to a long and meticulous preliminary examination. During this preliminary study every fragment has been cleaned, consolidated and carefully observed in order to be classified and stored in accordance with chromatic, consistency and conservation status criteria (Figure 13).

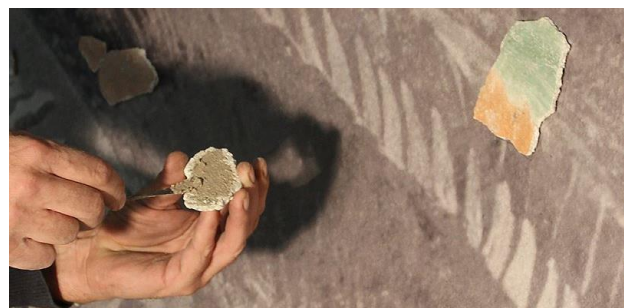
Figure 14. On the left: assembling of the fragments on the support structure.

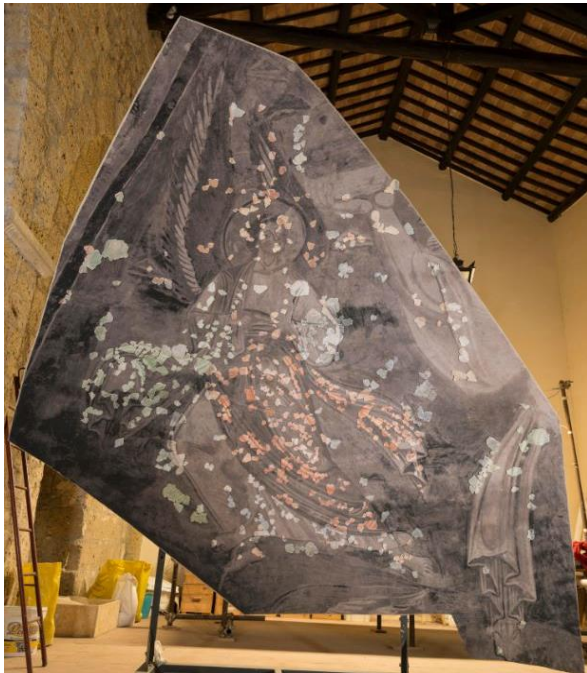
Figure 15. The support structure built by the restorers on which it is possible to see the remaining pieces of the original fresco.
