3D DIGITAL AND PHYSICAL RECONSTRUCTION OF A COLLAPSED DOME USING SFM  
TECHNIQUES FROM HISTORICAL IMAGES

## 3D DIGITAL AND PHYSICAL RECONSTRUCTION OF A COLLAPSED DOME USING SFM TECHNIQUES FROM HISTORICAL IMAGES

The case study presented in this paper refers to the collapsed dome of the Basilica of San Pietro in Tuscania. In 1971 an earthquake caused the loss of a portion of the dome and the destruction of a medieval fresco present on its surface (depicting the Pantocrator Christ encircled by four angels). Some parts of the fresco have not gone destroyed after the collapse and have been collected and preserved. In 2006 the first step of a conservation project was designed and carried out by the Istituto Superiore per la Conservazione ed il Restauro (ISCR) in order to perform a restoration of the destroyed masterpiece and to try to rebuild the original shape of the dome. The project was started with Dr. Werner Schmid in 2005, who

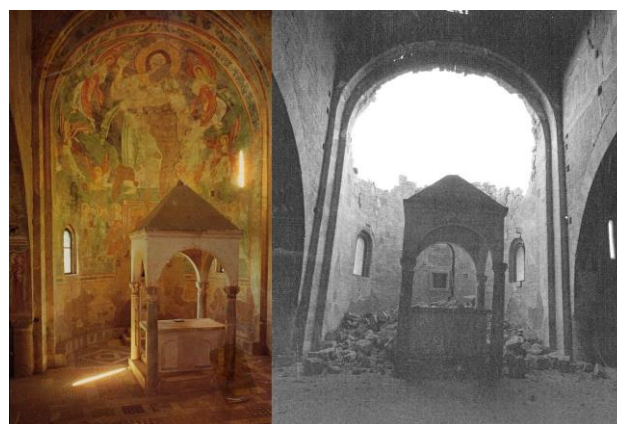
Figure 2. On the left, the apse of the Basilica of San Pietro in Tuscania before the earthquake of 1971. On the right, the collapsed dome after the earthquake that struck the church.

In 1971, as stated above, an earthquake struck the central part of Italy involving also Tuscania and San Pietro church; although the structural parts of the building did not suffer for significant damages, during the earthquake event the dome of the apse

collapsed (Figure 2 - right) with its medieval fresco. After the collapse a concrete dome has been rebuilt in the place of the original one; as regards the original fresco, some of its fragments have been recovered and classified in order to proceed with the restoration operations.

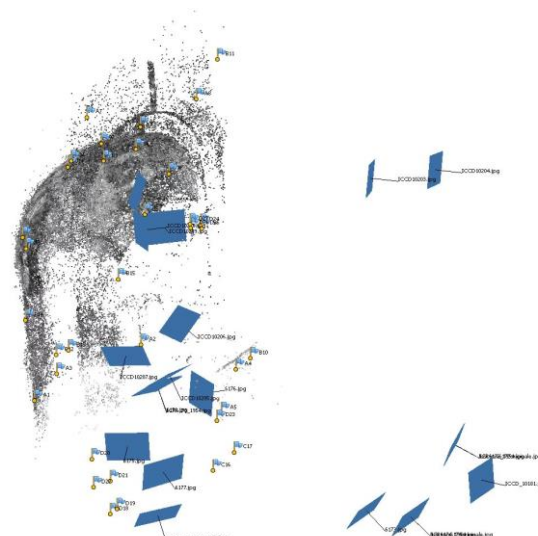
Figure 3. Image alignment and sparse cloud generated from historical images.

To perform the digital reconstruction of the geometry of the dome, the photogrammetric block (composed by 23 historical images) have been processed through a commercial SfM based photogrammetric software (e.g. Agisoft Photoscan platform). Images have been selected from those found to better fulfil the requirements of the presented study (as regards image quality and resolution). Even though the images obviously have not been acquired for metric purposes in accordance with the well-known criteria that need to be observed during a photogrammetric acquisition, the overlapping between the selected frames was acceptable for image relative orientation and sparse cloud matching (Figure 3). Since it was not possible to trace back any information about the cameras used to acquire the images retrieved from the various archives, the calibration of the cameras has been evaluated by the self-calibration approach implemented in Agisoft Photoscan.

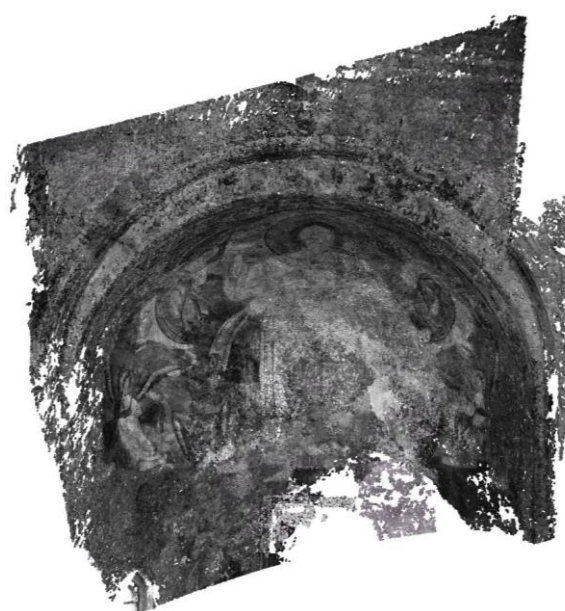
Figure 4. Dense cloud obtained from processed historical images.

As it is possible to observe in Figure 4, the obtained point cloud is characterised by a high noise and the density is not homogeneous. The density of the obtained point cloud has been analysed with open-source software CloudCompare: from Figure 5 and Table 3 is possible to observe the high value of the standard deviation, especially in those regions in which the overlap of the images is lower (Figure 6 - right). This is due to the fact that the images have not been acquired for 3D metric documentation purposes and therefore the overlapping in the external areas of the fresco is lower than the central ones.

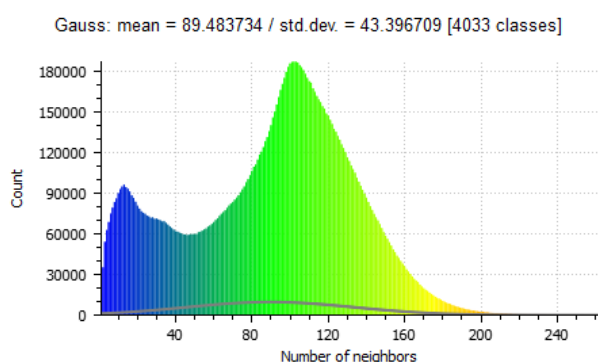
Figure 5. Density analysis (histogram).

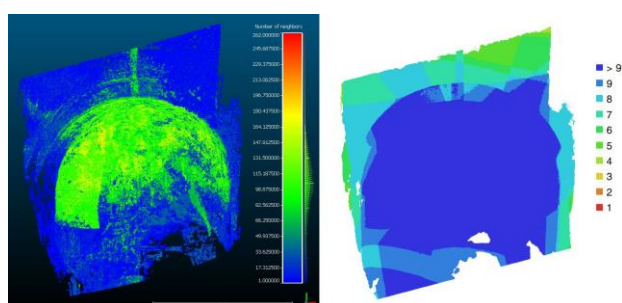
Figure 6. On the left, point cloud density analysis displayed on the point cloud. On the right, image overlap scheme.

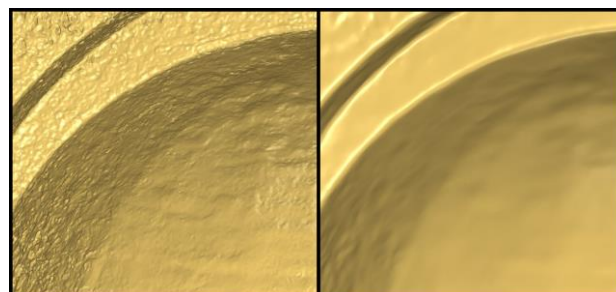
Figure 7. On the left: mesh (automatically generated) with topological errors. On the right: final mesh after editing operations.

From the obtained results, a first irregular mesh has been achieved. Since the generated point cloud is extremely noisy, the achieved raw 3D model (automatically generated from the used software) is characterised by several topological errors. Consequently, before further processing operations, an editing phase is necessary with manual and semi-automatic procedures. In the present research, the editing phase has been performed using the 3DReshaper platform by Hexagon, in order to obtain a smooth surface (Figure 7) on which it is possible to correctly projecting a high-resolution texture.

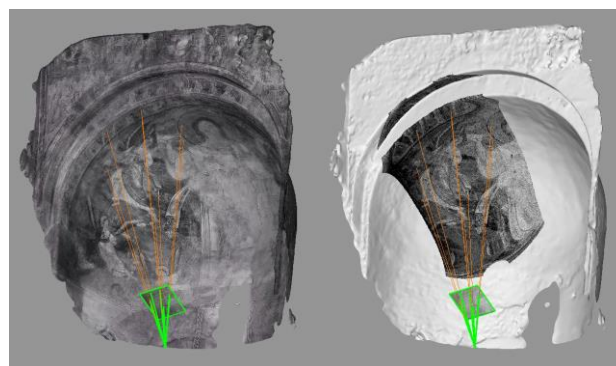
Figure 8. On the surface of the 3D mesh the high-resolution frame has been projected.

The images have to be printed in 1:1 scale, so re-texturing the 3D model is necessary since texture generated from historical images does not have an adequate resolution and a sufficient level of detail for the requirements of the restorers. In order to obtain a better quality of the final product a very high-resolution image has been used. The selected image is a high-resolution digitisation (45628 x 34540 pixel) using a planar scanner of the original film (a b/w film 4.5x6 cm, stored in ISCR's archive). In any case, although low-resolution texture was not suitable for the final aims of this study, it was still very useful in order to provide the references during the collimation process of the homologues points, in order to orient the frame from ISCR's archive and to project it on the surface of the 3D mesh (Figure 8).

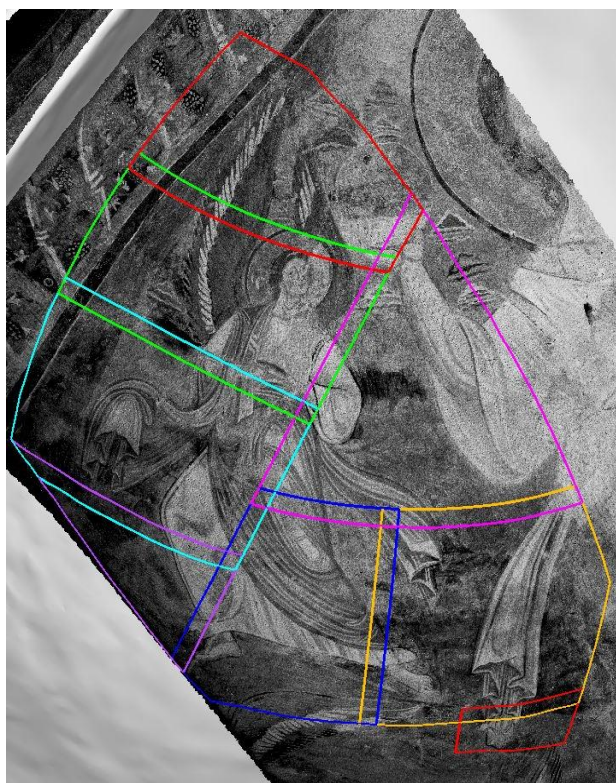
Figure 9. Segmentation of the texturized mesh in eight parts (angel on the right side of the Pantocrator Christ).

Once the test area of the second angel (placed in the right of the Pantocrator Christ) has been identified, in accordance with the requirements of the restorers, the mesh with the high-resolution texture has been segmented in 8 parts (Figure 9) in order to start with the next processing steps: orthoprojection and printing requirements of the restorers. Between each area and the adjacent ones, an overlapping of approximately 10 cm has been provided, in order to facilitate the subsequent reassembly operations.

For this reason the 3D model has been segmented in eight portions in order to minimise the distortions in the areas where the tangency between the mesh and the interpolated tubular shape is reduced. If the segments (belonging to a surface approximated to a sphere) were bigger, the distortions on the external parts would be excessive and the orthoprojections would not be fit for the purposes of the restorers.

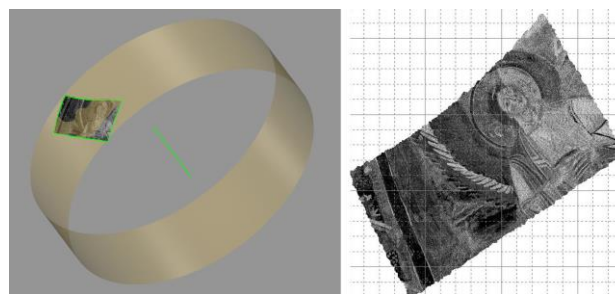
Figure 10. On the left: best fitting cylinder of one of the segmented 3D mesh and its central axis. On the right: orthoprojection of a portion of the 3D mesh.

To perform these projections, the unrolling tools of 3DReshaper commercial platform has been applied to achieve a cylindrical orthoprojection. For each segment, the best-fitting cylinder has been interpolated (least square interpolation) (Figure 10 - left) and the central axis has been extracted in order to unroll the tubular shape along it.

Each segmented mesh has been unwrapped around the axis of revolution (which in this case is the barycentre axis of the best fitting cylinder) in order to obtain a high-resolution two-dimensional projection in 1:1 scale of the desired part of the model (Figure 10 - right). Since the mean value of the discrepancies between each portion of the 3D mesh and the interpolated cylinder is millimeter-level, the deformations are almost inexistent.

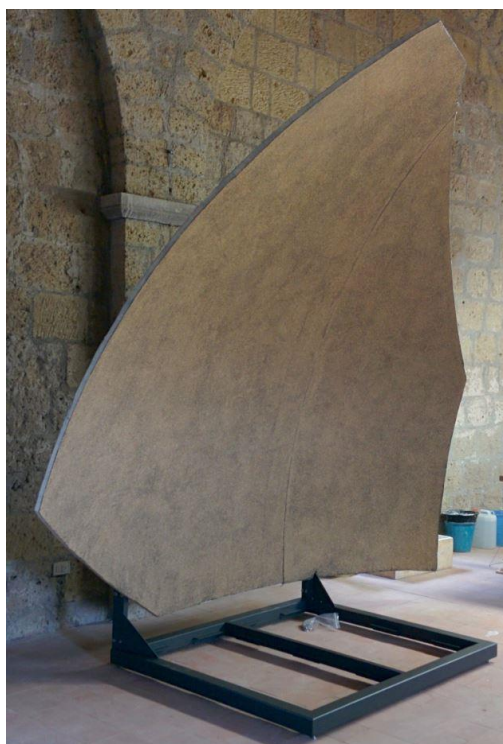
Figure 12. The support panel and structure.

The panels were built with a layered sandwich structure, Carbon fibre/epoxy – end grain balsa wood - Carbon fibre/epoxy. Each layer is soft and flexible during the construction and, while the epoxy resin completes its curing, needs to be held in place within a vacuum envelope on the surface of the counterform. In this case, a portion of sphere shaped with hot wire from large blocks of polystyrene.

The sandwich structure provides the required rigidity of the wide panels, independently from the display stands in steel, thanks to the choice of the carbon (416 g/m<sup>2</sup>) and of the thickness of the balsa core material (20 mm).

On the rear of the cutting line, a broad molded rabbet plate was built with a lay-up of 8 layers of carbon, to be used for securing all the way the joining area with bolts. The structures were built by Equilibrarte srl under the direction of Antonio Iaccarino Idelson and Carlo Serino. In the following Figure 12 the final result is shown.

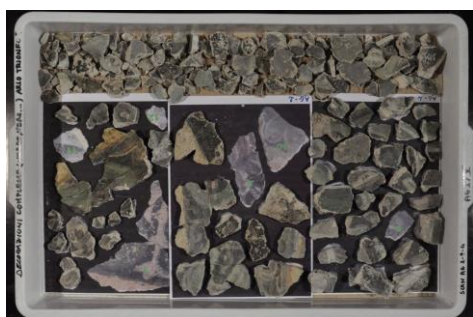
Figure 13. Example of classified fragments.

After the earthquake of 1971, the fragments of the fresco collected from the area of the apse of the Church of S. Pietro in Tuscania have been subjected to a long and meticulous preliminary examination. During this preliminary study every fragment has been cleaned, consolidated and carefully observed in order to be classified and stored in accordance with chromatic, consistency and conservation status criteria (Figure 13).

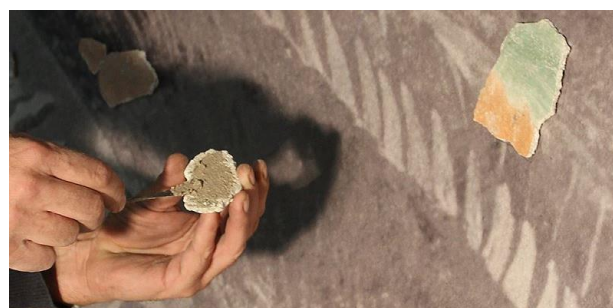
Figure 14. On the left: assembling of the fragments on the support structure.

As already stated, thanks to 3D model of the dome of the apse, it was possible to build the support structures and to orthoproject the original images in order to obtain orthophotos in scale 1:1. The concave side of the structures has been prepared in order to support the printed image as is reported in the previous section. The surface has been covered with a thin layer of mortar with acrylic composition; the mortar has been applied in an irregular way in order to simulate the original appearance of preliminary layers of the fresco. On this surface Graphic Report snc (from Padova) has applied the photographic background (the orthophotos), carried out by using TATTOOWALL@system.

The thin membrane has been attached to the mortar with a specific glue (synthetic emulsionated resin glue screeds) and furthermore the surface of the membrane has been protected with a two-pack paint with opaque effect. At this point all fragments assessed as fit during the preliminary searching have been thickened to 10 mm and then they have been glued to the structure through acrylic mortar with very fine grain size. The adopted method is fully reversible and it allows the possible rectification of the fragments already placed and the progressive insertion of other portions, leaving the door open to a future of new possibilities for research and image enhancement for improving the collective memory.

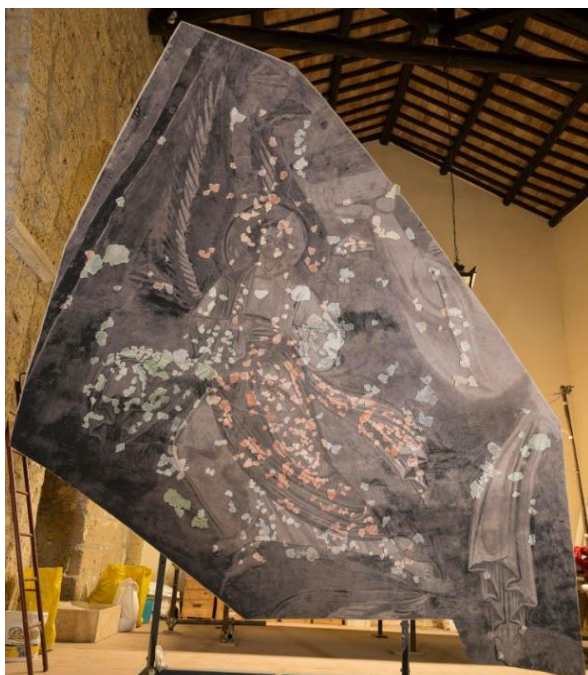
Figure 15. The support structure built by the restorers on which it is possible to see the remaining pieces of the original fresco.

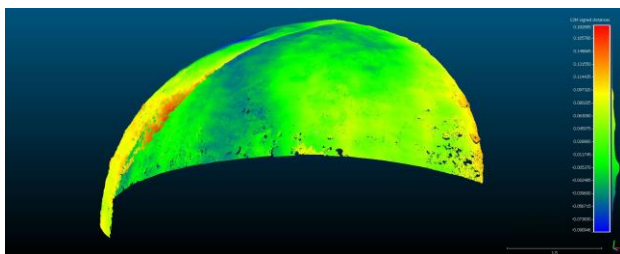
Figure 16. Cloud-to-mesh distances comparison between the dense cloud (1971 dataset) and the sphere interpolated in 2010.

As regards the metric accuracy of the two followed methods (in 2010 and 2017), it has been observed that the accuracy of the obtained metric product is totally coherent. By comparing the point cloud generated thanks to SfM algorithms and the sphere (with a radius of 3.35 m) interpolated by around 4000 points plotted in 2010, the following metric discrepancy (Figure 16-17 and Table 4) could be observed.

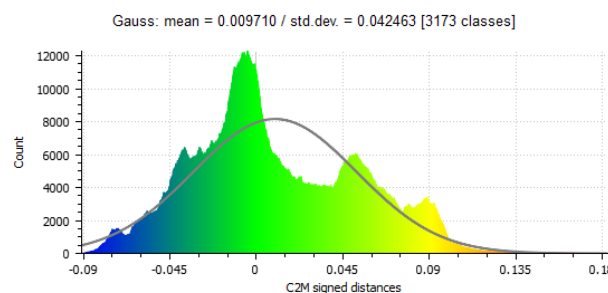
Figure 17. Cloud-to-mesh distances analyses between the sphere interpolated in 2010 and the point cloud obtained in 2017 performed with the open-source software CloudCompare.

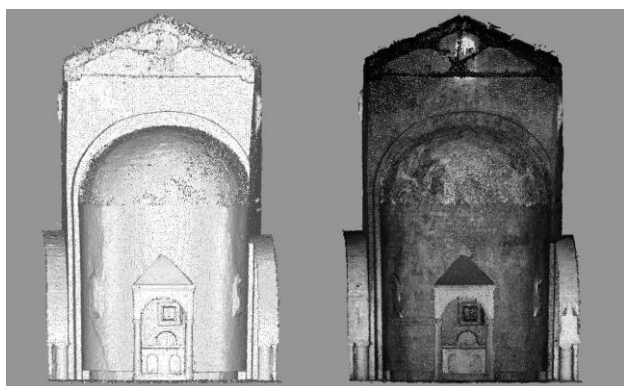
Figure 18. Hybrid point cloud generated from images of both Time 1 and Time 2.

Another pro is the higher completeness of the obtained data. The photogrammetric block (composed of images acquired from different angles) has allowed to rebuild even the part of the dome which were partially occluded by the ciborium in the stereoscopic images used in 2010. In connection with this, one of the most interesting future perspectives can be considered the possibility to perform a co-registration between the historical images (acquired before the earthquake of 1971) and more recent images (in this case acquired during the survey campaign of 2010, following a photogrammetric approach). In this way it is possible to reconstruct the geometry of the original complete apse (not only the shape of the dome) as presumably it should be before the collapse. As is reported in Figure 18 co-registration was possible by applying masks on the images of 2010 (in order to cover the concrete spherical dome built after 1971). In this way the software perform the tie points extraction only in the portions of the images with common elements between Time 1 (before 1971) and Time 2 (survey campaign of 2010).

The photogrammetric block has been assembled by the 23 historical images acquired before 1971 and 43 images acquired in 2010 by a DSLR full frame camera (Canon EOS 5D Mark II), the images acquired in 2010 were transformed in b/w in order to preserve a radiometric coherence between the different dataset.
