Lidar data analyses for assessing the conservation status of the so-called baths-church in hierapolis of phrygia (TR)

## LIDAR DATA ANALYSES FOR ASSESSING THE CONSERVATION STATUS OF THE SO-CALLED BATHS-CHURCH IN HIERAPOLIS OF PHRYGIA (TR)

This paper intends to report some results of these experiences applied in archaeological domain, to the so-called Baths-Church at Hierapolis in Phrygia (Pamukkale, TR). In particular, the generation of accurate models from dense clouds and their reduction to models with simplified geometries too, is explored, with the further aim of testing automated strategies for features detection and editing process that leads to appropriate models for visual and analytical structural assessment. The accuracy and density parameters of the LiDAR clouds will be analysed to derive orthophotos and continuous mesh models, both to obtain the best results from the application of research algorithms such as *region growing* to detect blocks, and to allow visual analysis on digital models and not on site.

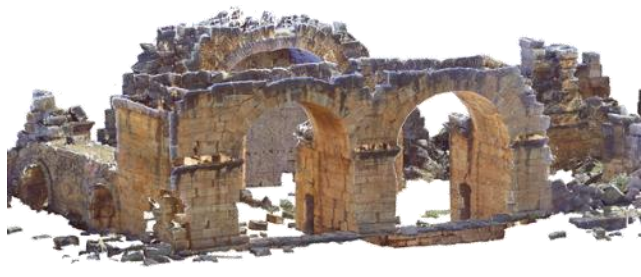
Figure 2. (a) Two general view of the overall LIDAR points cloud (b) the eastern structural system including one-barrel double rings vault, and first and second-phase pillars in some points cloud views; (c) the dimensioned architectural plan of the building. (Invernizzi, Spanò, Alferi, 2014)

Today, compared to the original configuration of the complex, the building is subdivided by three main structural parts, quite well conserved (Figure 2a):
