LIDAR DATA ANALYSES FOR ASSESSING THE CONSERVATION STATUS OF THE SO-CALLED BATHS-CHURCH IN HIERAPOLIS OF PHRYGIA (TR)

C. Marson¹, G. Sammartano², A. Spanò^{2*}, M.R. Valluzzi³

KEY WORDS: LiDAR Data, 3D models, feature detection, structural assessment, damages, decay, cracks detection

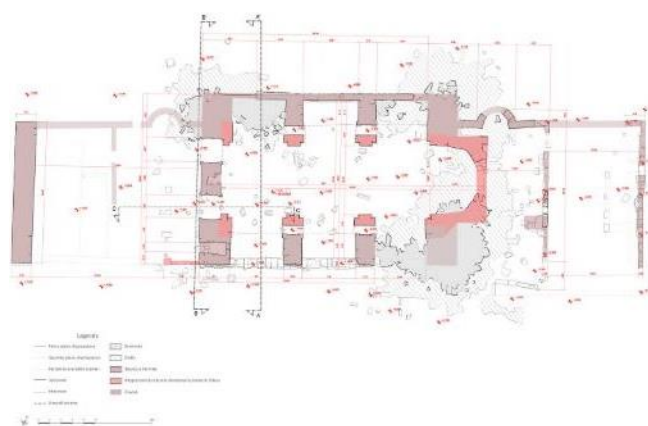
Figure 2. (a) Two general view of the overall LiDAR points cloud (b) the eastern structural system including one-barrel double rings vault, and first and second-phase pillars in some points cloud views; (c) the dimensioned architectural plan of the building. (Invernizzi, Spanò, Alferi, 2014)

Today, compared to the original configuration of the complex, the building is subdivided by three main structural parts, quite well conserved (Figure 2a):
