The important role of diagnostics for the structural recovery of historic buildings

*Original*

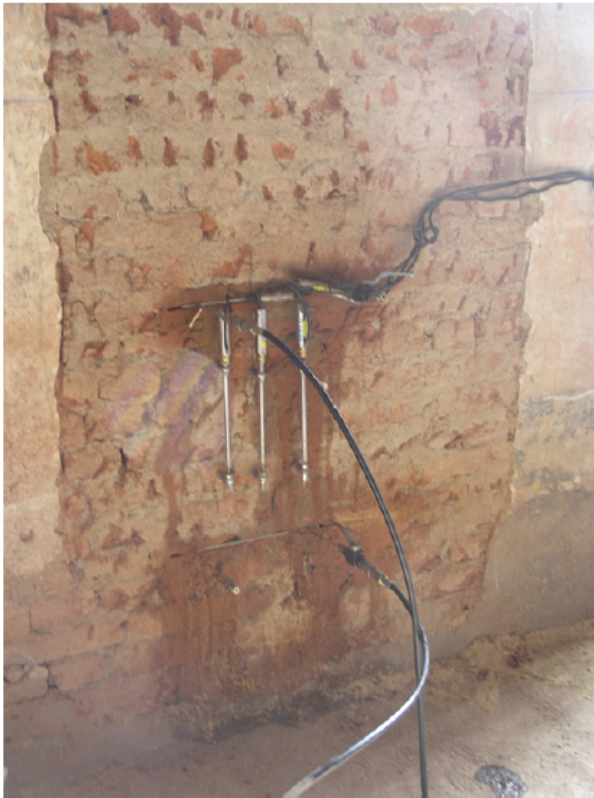
**Figure 4:** Flat jacks test carried out at the Royal Palace of Venaria.

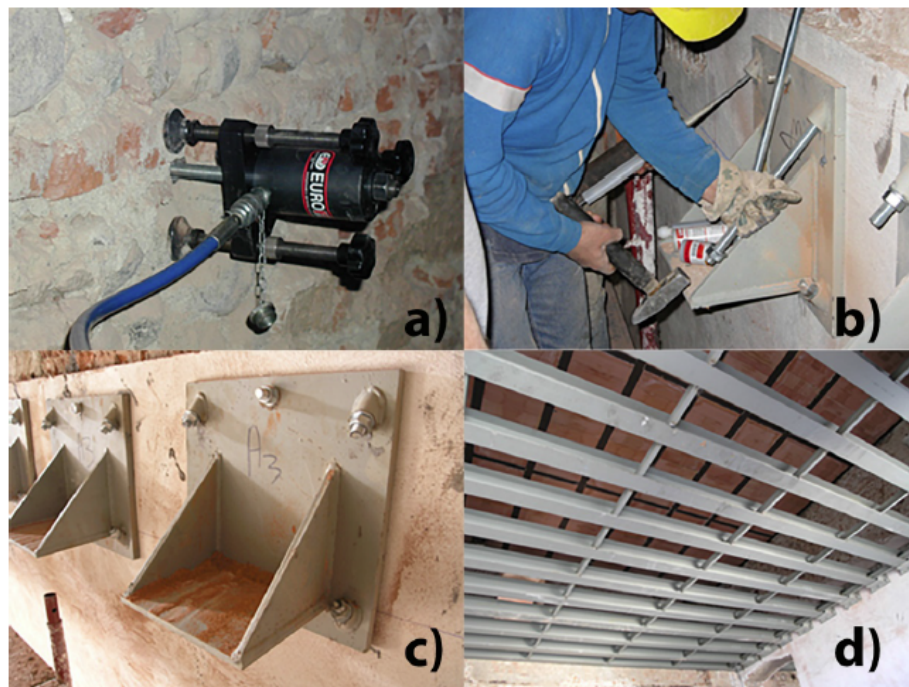
**Figure 9:** (a) Pull-out test; (b) steel anchor for the hang of the beams support; (c) support steel plates anchored; (d) construction of the new mezzanines floors.
