The important role of diagnostics for the structural recovery of historic buildings

*Original*

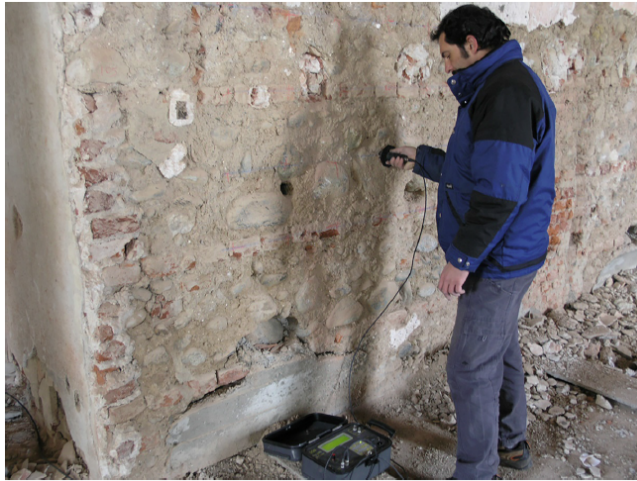
**Figure 5:** Sonic tests carried out at the Royal Palace of Venaria.
