The important role of diagnostics for the structural recovery of historic buildings

*Original*

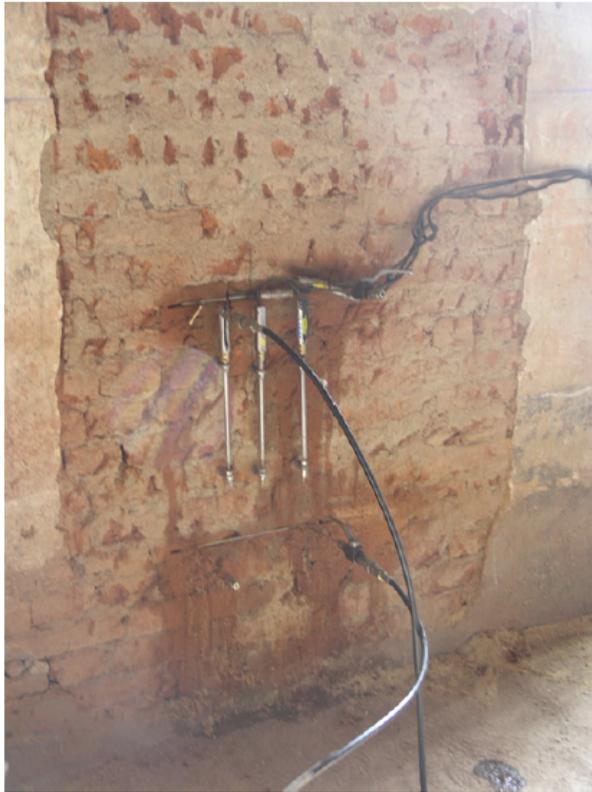
**Figure 4:** Flat jacks test carried out at the Royal Palace of Venaria.

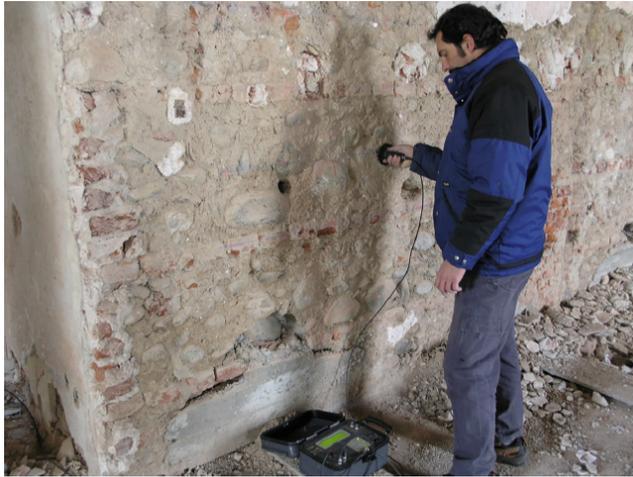
**Figure 5:** Sonic tests carried out at the Royal Palace of Venaria.

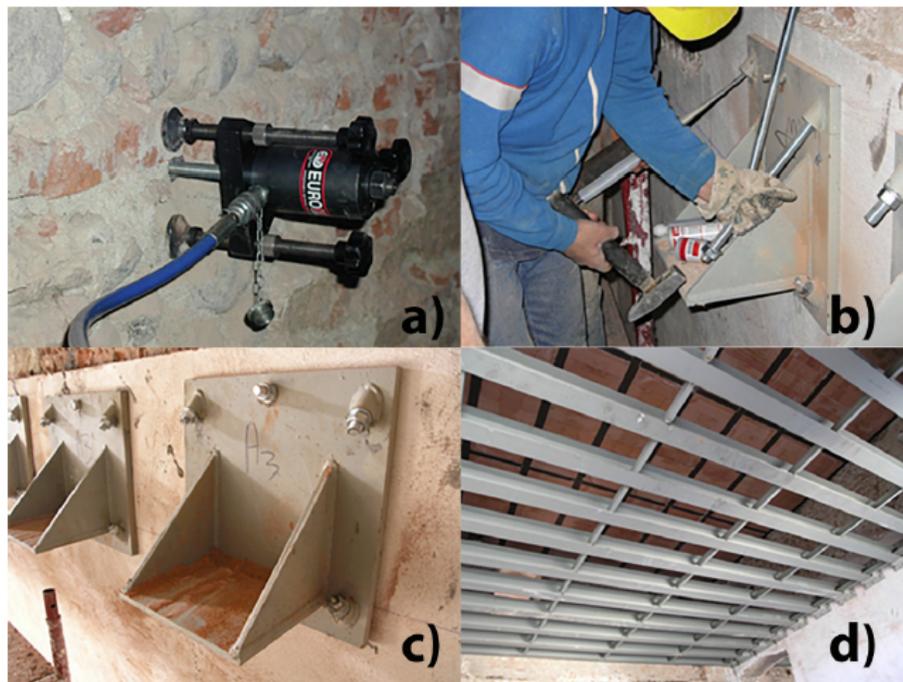
**Figure 9:** (a) Pull-out test; (b) steel anchor for the hang of the beams support; (c) support steel plates anchored; (d) construction of the new mezzanines floors.

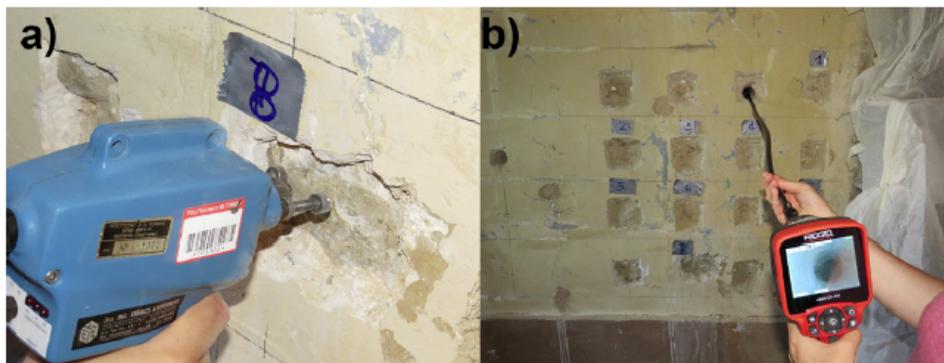
**Figure 11:** (a) Sonic test; (b) endoscopy in the same area of the sonic test.
