The important role of diagnostics for the structural recovery of historic buildings

Availability:

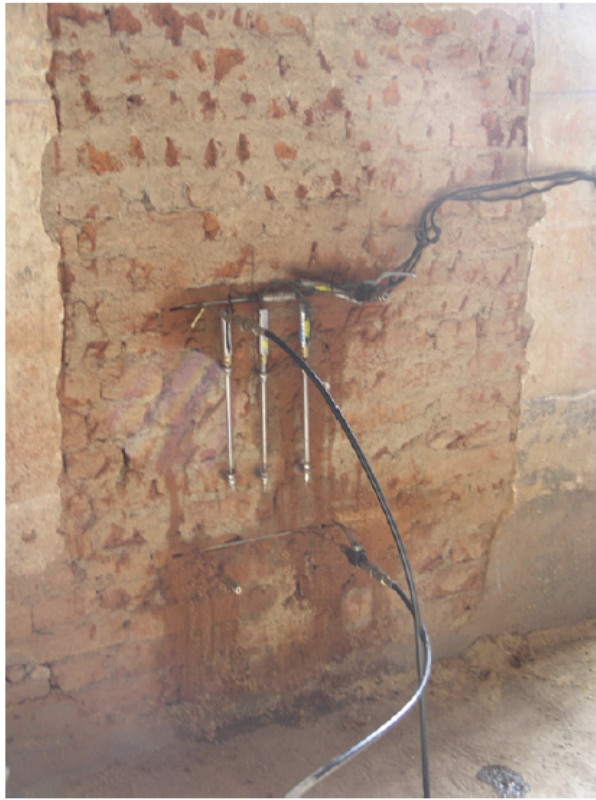
Figure 4: Flat jacks test carried out at the Royal Palace of Venaria.
