25th International Conference on Fracture and Structural Integrity

Fatigue assessment of the collapsed XXth Century cable-stayed Polcevera Bridge in Genoa

Stefano Invernizzi^{a,*}, Francesco Montagnoli^a, Alberto Carpinteri^a

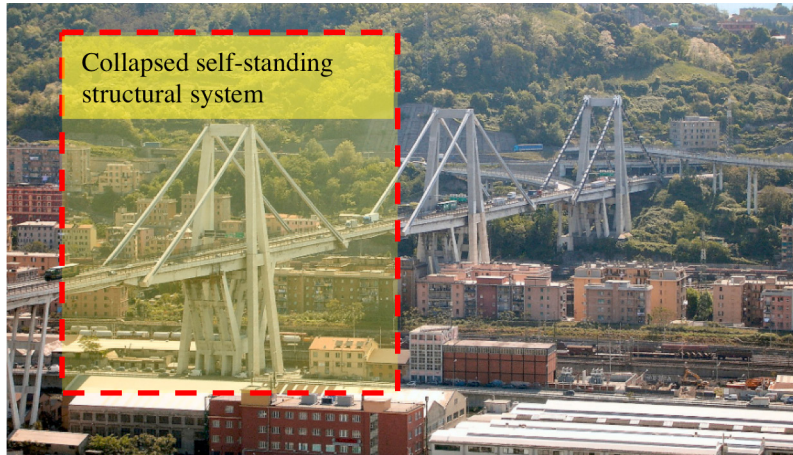
The Polcevera viaduct was a complex structure, which was composed by several minor spans and three main spans, besides all the connecting ramps. The collapsed part of the viaduct was linked with the adjacent parts of the bridge by means of two statically determinate Gerber beams of 36 m span each, which have been involved in the collapse (Fig. 1).

Fig. 1. Three self-standing structural systems of Polcevera Bridge.

Therefore, in order to simplify the analysis and better understand the failure mechanism, our attention has been focused exclusively on the self-standing structural system, which collapsed independently of the remaining parts of the viaduct. Furthermore, the balanced system designed by Morandi was a quite complicated structure itself and it is worth, at the first step, to limit the analysis to the bridge deck.

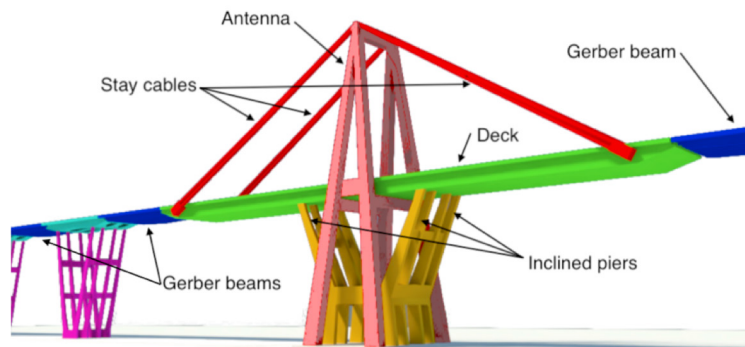
The deck of the self-sustained system was a multi-cell box girder 4.5 m deep and 171.9 m wide, which was supported at four points by inclined piers and two couples of stay cables (yellow and red elements in Fig. 2, respectively) hanged at the top of the A-shaped antenna. Four transverse beams, orthogonal to the girder, had the purpose to link the deck to the piers and to the stay cables.

Fig. 2. Structural components of the self-sustained system.

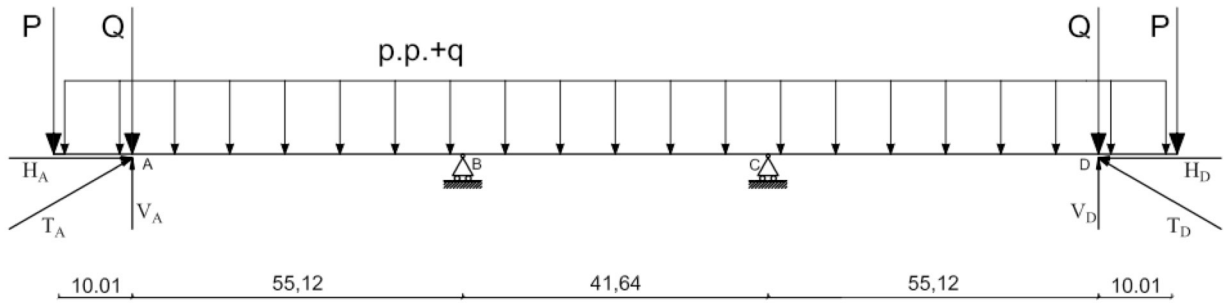
According to Morandi's design concept (Morandi, 1967), the principal stay cables were supposed to support the permanent loads. The tension in the strands was set such as the vertical displacement of the deck at the connection point with the stay cables would vanish. As a consequence, the static scheme shown in Fig. 3 allows for an easy determination of the axial force in the two couples of stay cables due to the permanent loads, whose values are reported in Tab. 1. The tensile forces in the stay cables are obtained by projection of the vertical reaction forces in A and D on the cable direction. The statically indeterminate reactions in A and D are identical due to structural symmetry and can be derived imposing compatibility equations.

Fig. 3. Static scheme used for the evaluation of stresses in the stay cables due to the permanent loads.

Notice that the construction process was highly complex also because of the use of temporary strands, which were removed once the main stays were in place. It is worth noting that, the structural scheme represented in Fig. 3 provides the value of the axial force in the stay cables with a good approximation.

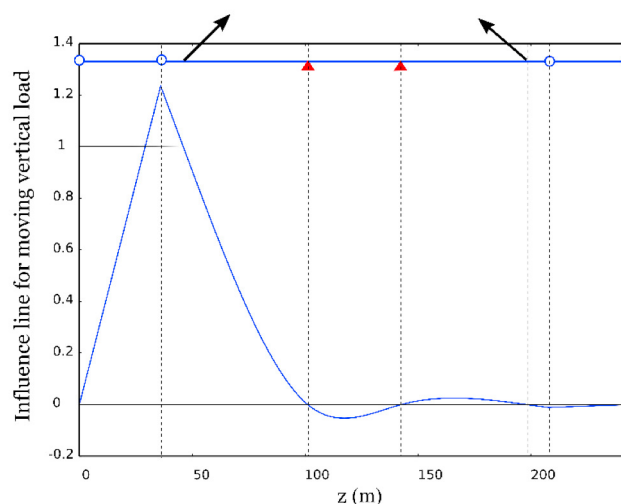
Fig. 4. Influence line of vertical reaction V_A for moving vertical load.

If we consider the couple of stay cables that support the deck at point A, in order to assess the stress range in each cable, it is necessary to calculate the influence line of the vertical reaction due to vertical moving unit load. Thanks to the reciprocity theorem, this is equivalent to trace the deflection line corresponding to the imposed unit deflection at the point A. The stress in the stay cable can be subsequently obtained by projection according to Eq. (1).

Fig. 4 shows the obtained line of influence. Taking into consideration the safety distance between lorries and according to the standard prescription, it appears that each heavy vehicle will correspond to one main load cycle (EN 1991-2, 2003). The amplitude of the cycle can be calculated multiplying the weight of the lorry by the difference between the highest peak and the lowest valley values of the influence line.

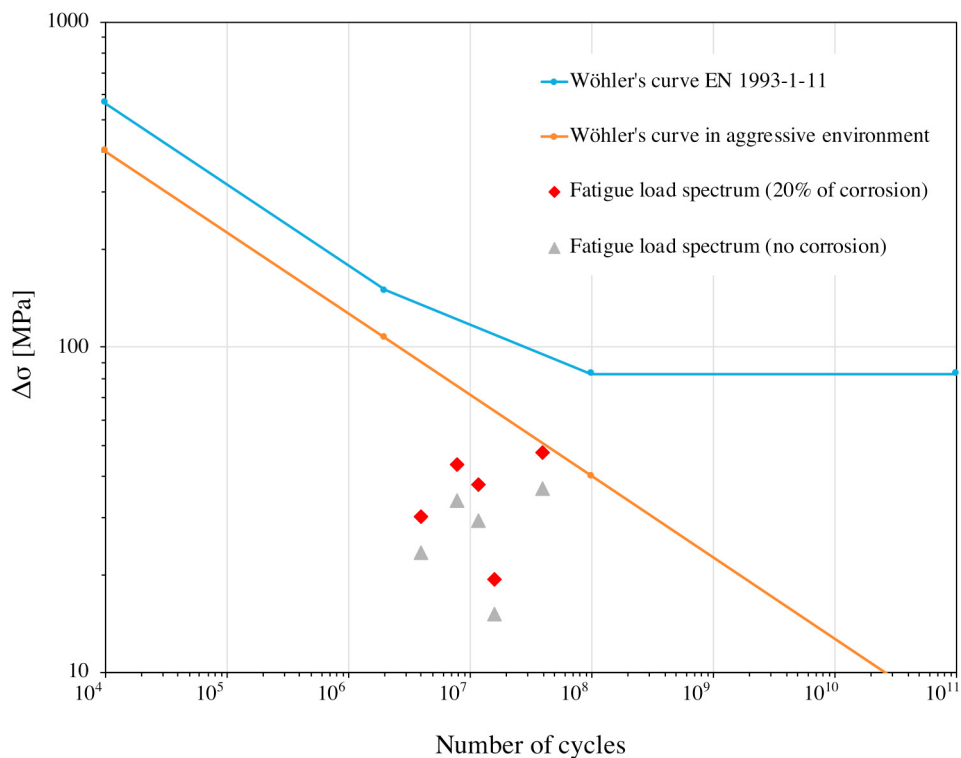
Fig. 5. Application of Palmgren-Miner's rule according to different corrosion scenarios.

Different scenarios can be considered, as shown in Fig. 5. If no corrosion is considered, Wöhler's curve is provided by EN 1993-1-11 (2006) and the failure due to the damage accumulation for the given fatigue load spectrum can be excluded. If the aggressive environment is considered, Wöhler's curve changes, because the curve is translated downwards and because the horizontal asymptote is missing (Lotsberg, 2016). Analogous modification of Wöhler's curve would be obtained if the influence of structural size were additionally considered (Carpinteri & Montagnoli, 2018).

In this context, it is possible to look for the level of absolute corrosion necessary for the damage accumulation to approach unity. Since Eq.(3) can not be inverted directly, the calculation must be performed iteratively. The critical level of corrosion is estimated to be approximately equal to 20%. It is worth noting that the level of corrosion detected during inspections, carried out in 2015, was estimated comprised between 10% and 20% (Relazione Commissione Ispettiva Mit, 2018). In addition, recent analyses carried out on the bridge's stay cable ruins (Filetto et al., 2019) provided that at least 22% of strands showed a very high level of corrosion comprised between 50% and 70%, whereas in the remaining 78% the lower level of corrosion was comprised between 30% and 50%. As a consequence, it is conservative assuming an overall level of corrosion approximately of 35%. It is worth noting that the critical level of corrosion with respect to the static load is much higher, and above 60% (Calvi et al., 2018). In addition, if the decompression of the concrete did not occur, the stress range in the tendons would have been much lower and the critical accumulated damage would have been avoided. Finally, it is evident that the concept of fatigue limit can be unsafe, and that is worthy of deeper investigations in order to better account for the influence of aggressive environment, structural size-scale, and damage accumulation in very-high cycle regime.
